Finalisation of the renovation works

D 3.7

Project acronym	DREEAM
Grant agreement number	680511
Project title	Demonstration of an integrated Renovation approach for Energy Efficiency At the Multi building scale

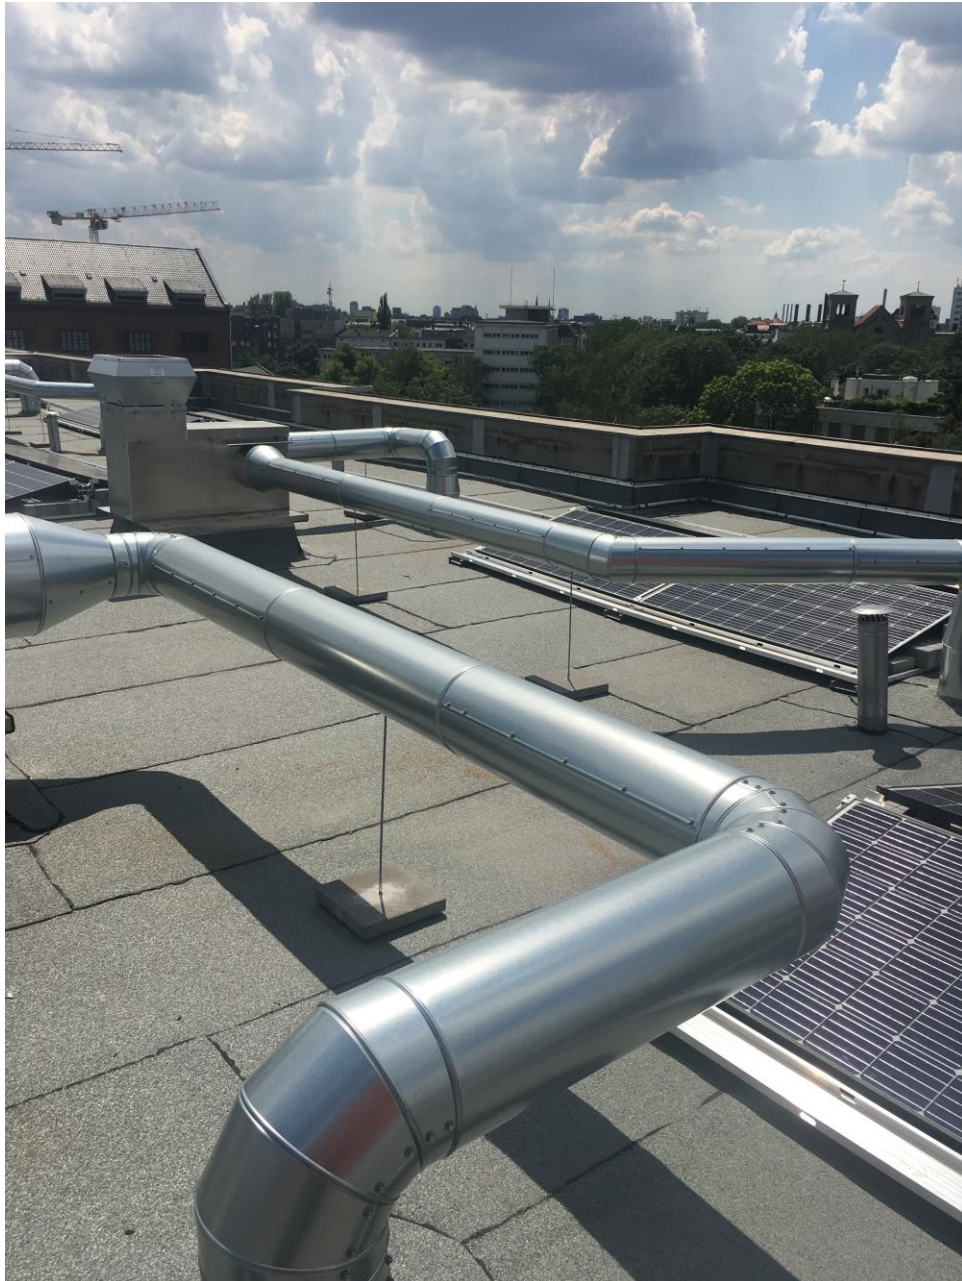
The roof is now finished and features the HVAC units and air ducting, together with the photovoltaic panels as shown in the figure below.

Figure 1. Renovated roof

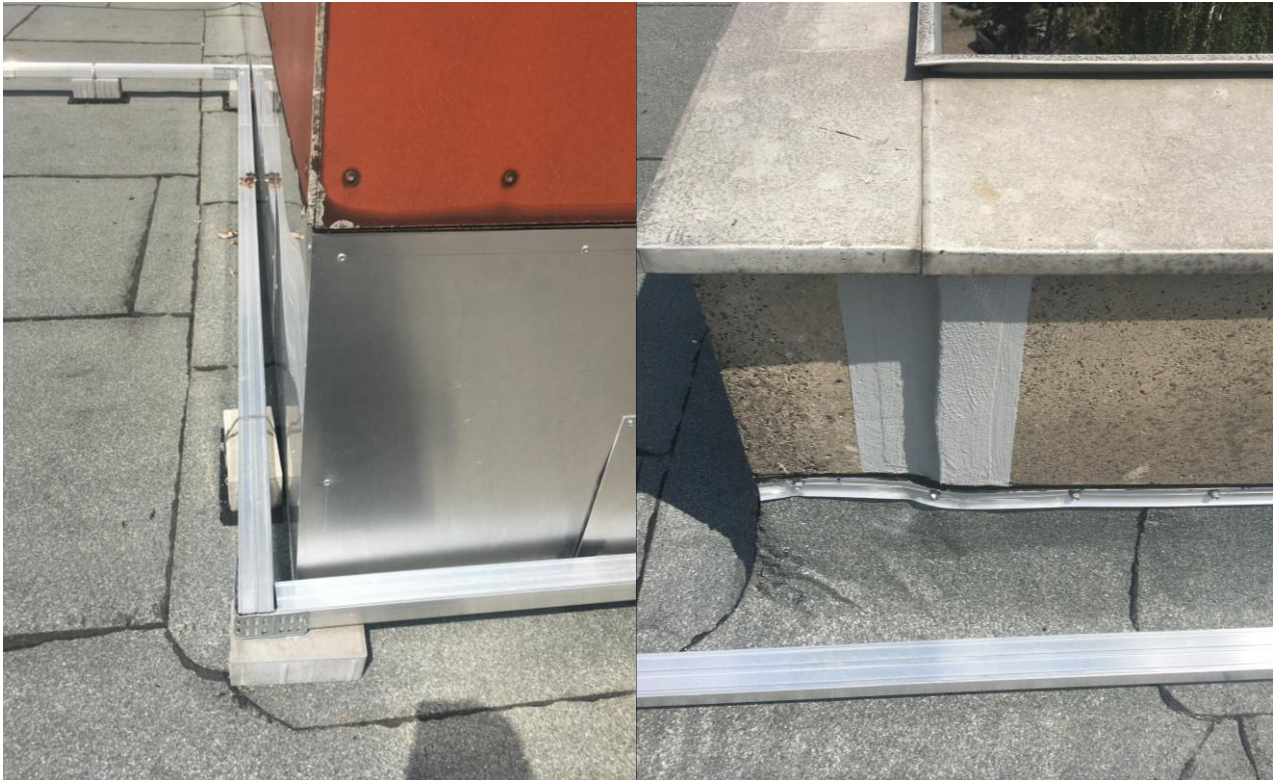
The roof covering was installed correctly to provide adequate moisture protection, as it can be seen from the details shown in the figures below. The unfinished or (few) incorrectly sealed parts that were noticed in the previous visit had been fixed or finished.

Figure 2. Roof covering sealing details

Bitumen layer installed correctly, joints look ok and the parts that were sealed incompletely have been finished.

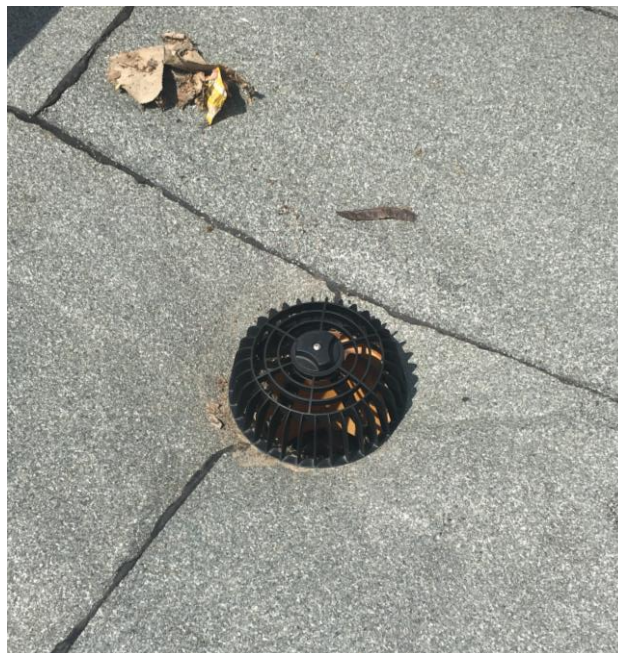
Drainage wells are placed at lower points to ensure that water will not stagnate on the flat surface and create leakage problems.

Figure 3. Drainage well

The details that were identified to be improved (see D3.5) have been sealed correctly, as shown in the current report (see Figure 3 and Figure 4).

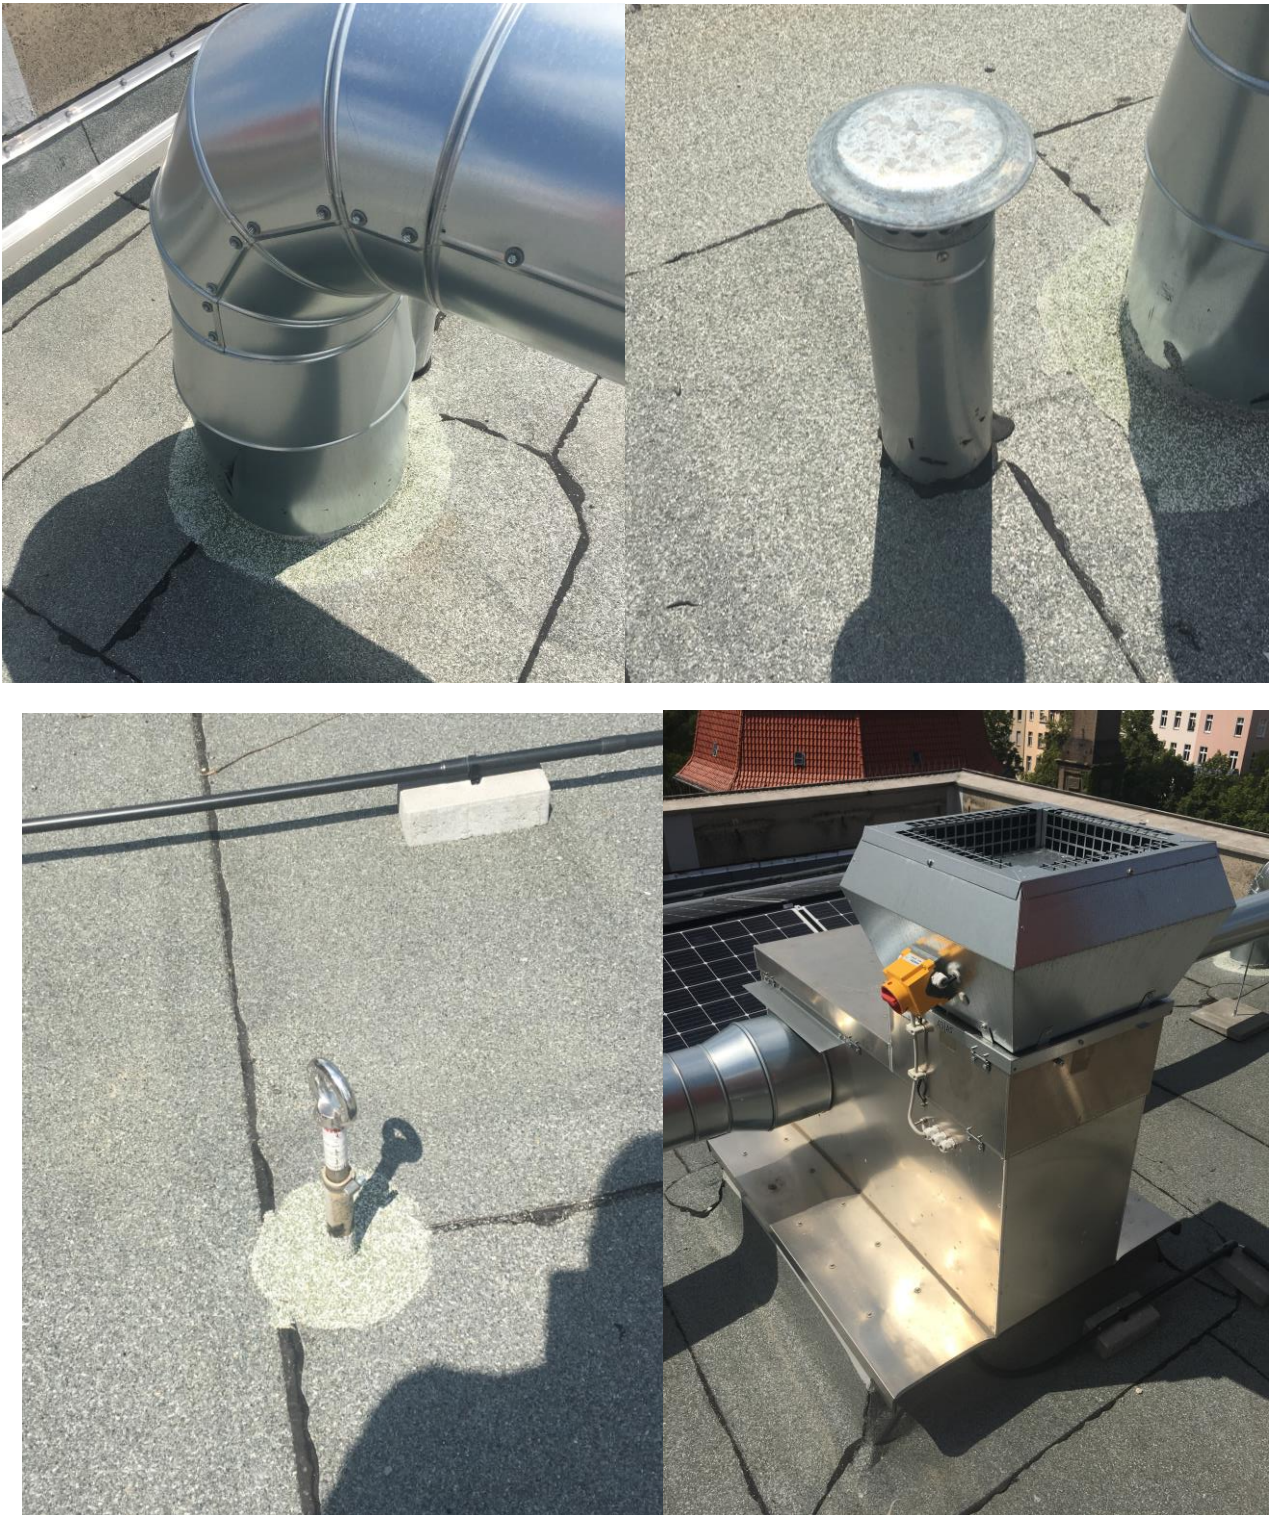
Where the roof had to be perforated to install the air ducts and other components, the hole had been sealed correctly as shown below.

Figure 4. Sealings around perforations in the roof envelope

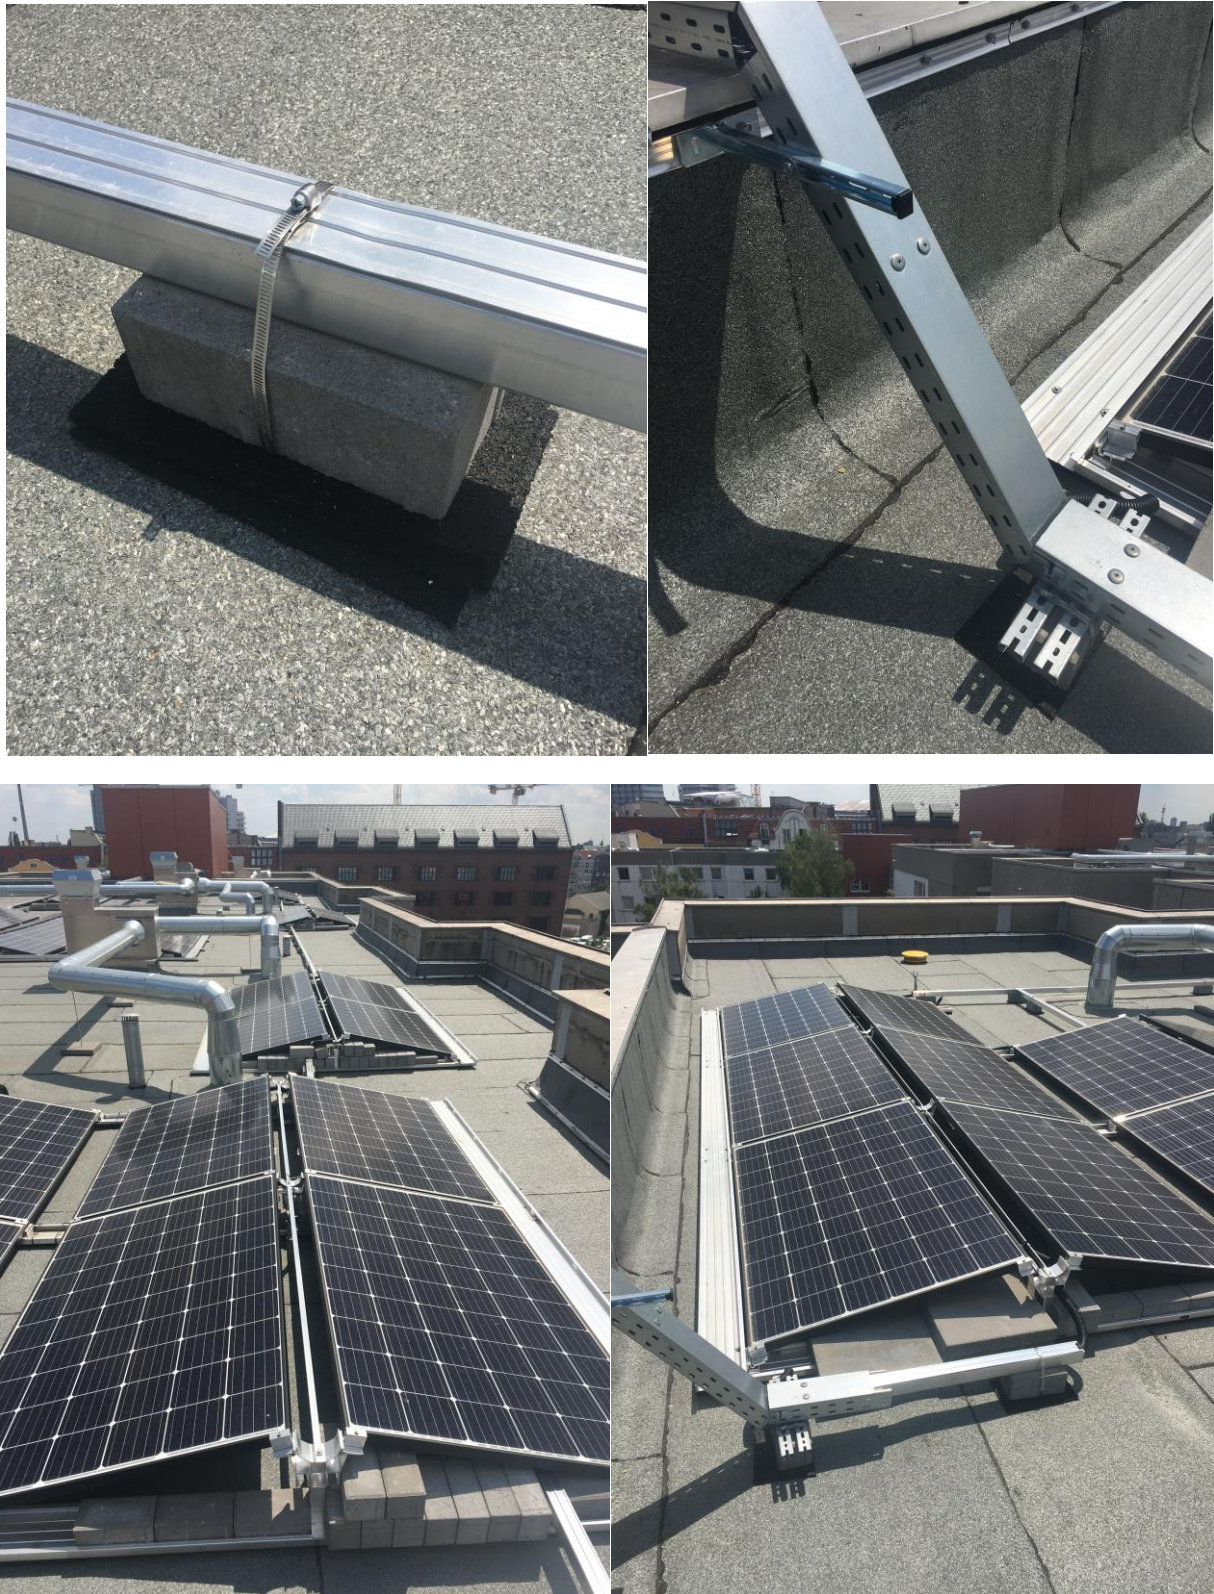
The photovoltaic panels were installed in a way that the metallic structure that holds them fastened to the roof does not impact negatively on the roof, as it can be shown in the figure below. The pressure from the metallic beams is distributed on a wider surface so that the risk for damage the roof covering is minimised.

Figure 5. Photovoltaic panels and details of installation structure

The panels were installed correctly, and the fastenings rest on a support so that their weight is distributed on the roof covering not to create tear, see Figure 5.

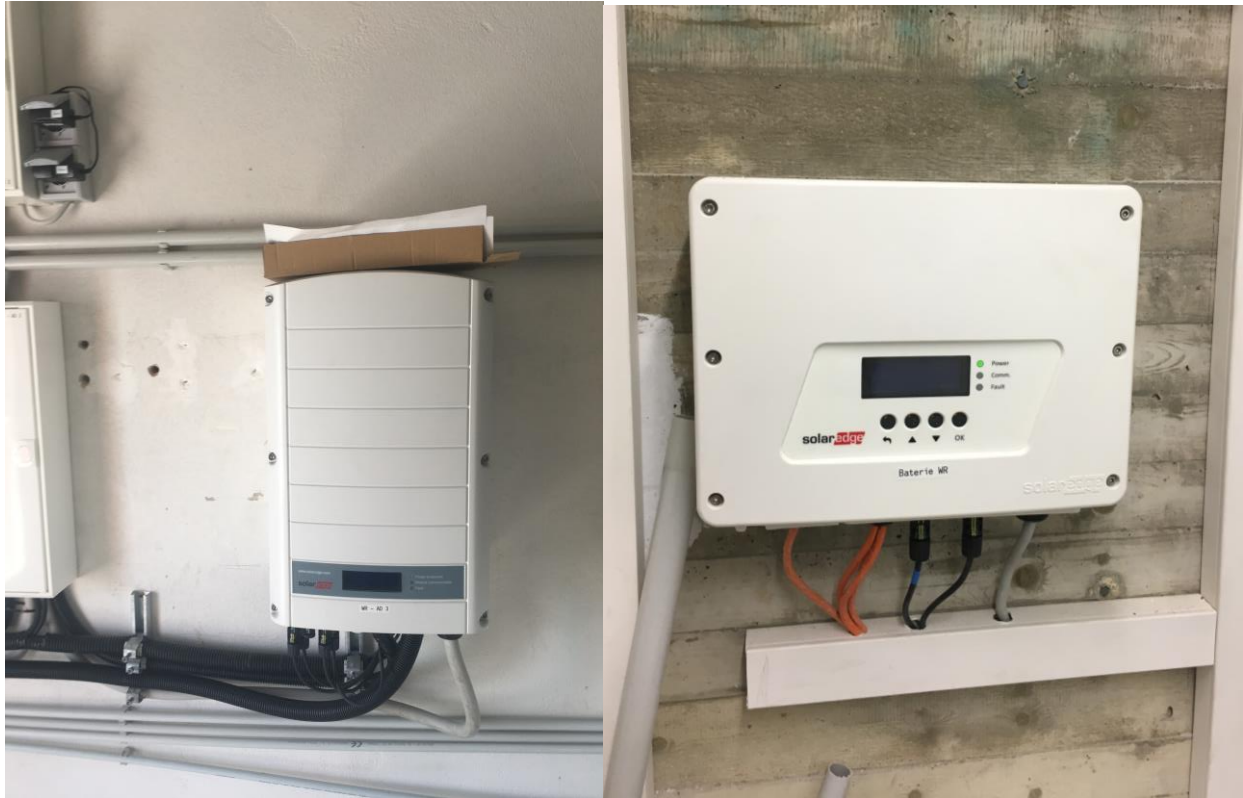
The inverter was also installed: there are still issues to be solved with the electricity provider to put the system into operation. The batteries are also ready to store the produced energy. It is still to be decided how to exploit the produced electricity (to be sold, used in the common areas and in the single apartments, or for a Tesla wall).

Figure 6. Inverter and batteries for the photovoltaic panels

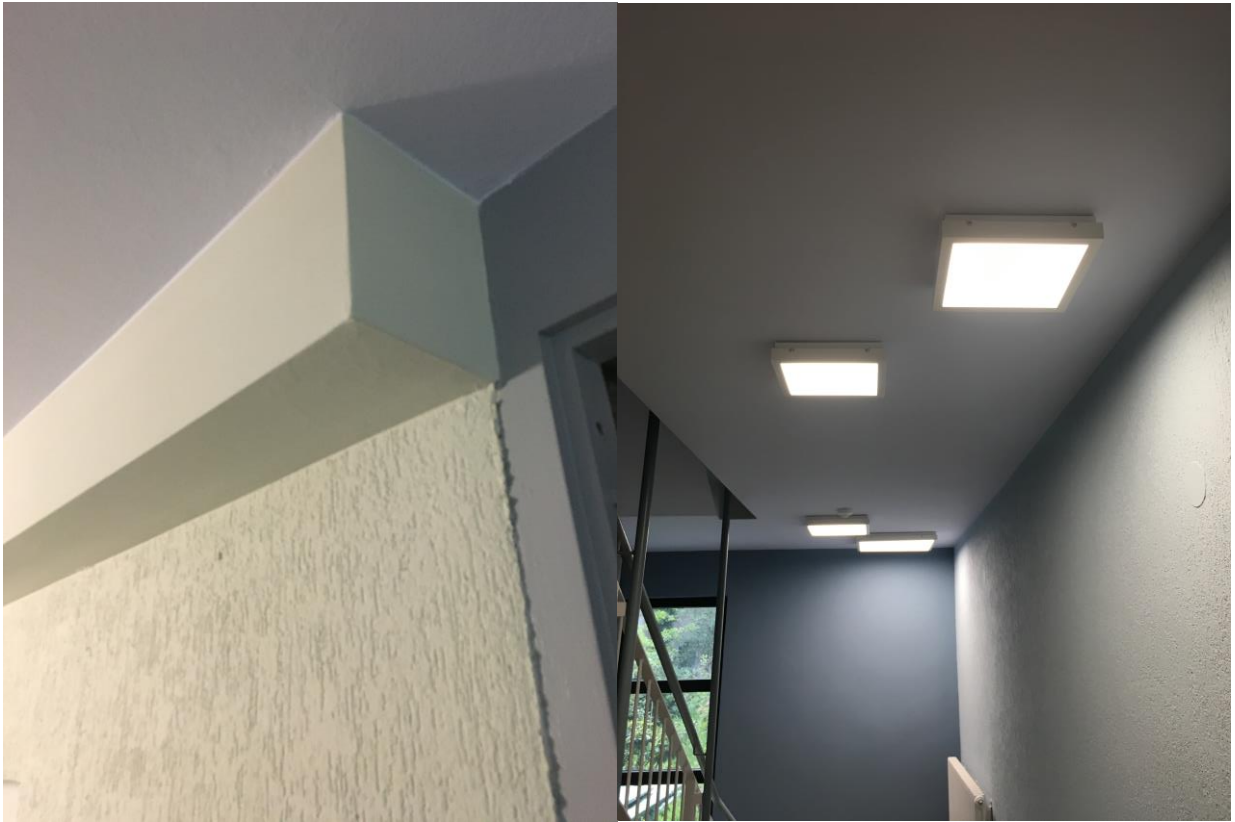
The stairwells have been repainted, as well as the ducting that hosts the cabling, as shown in the figures below. LED lighting was also installed.

Figure 7. Detail of the cable duct and new led lighting

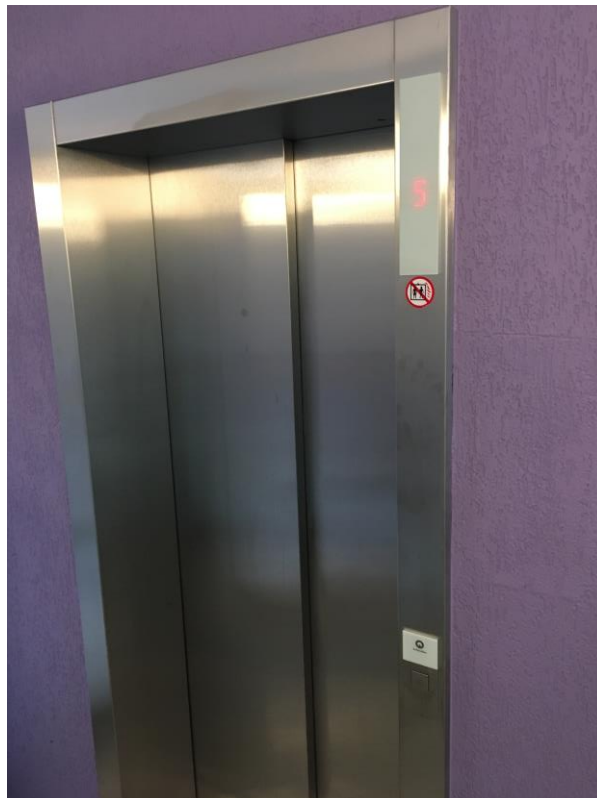
The new lifts were also operating and working.

Figure 8. New lift

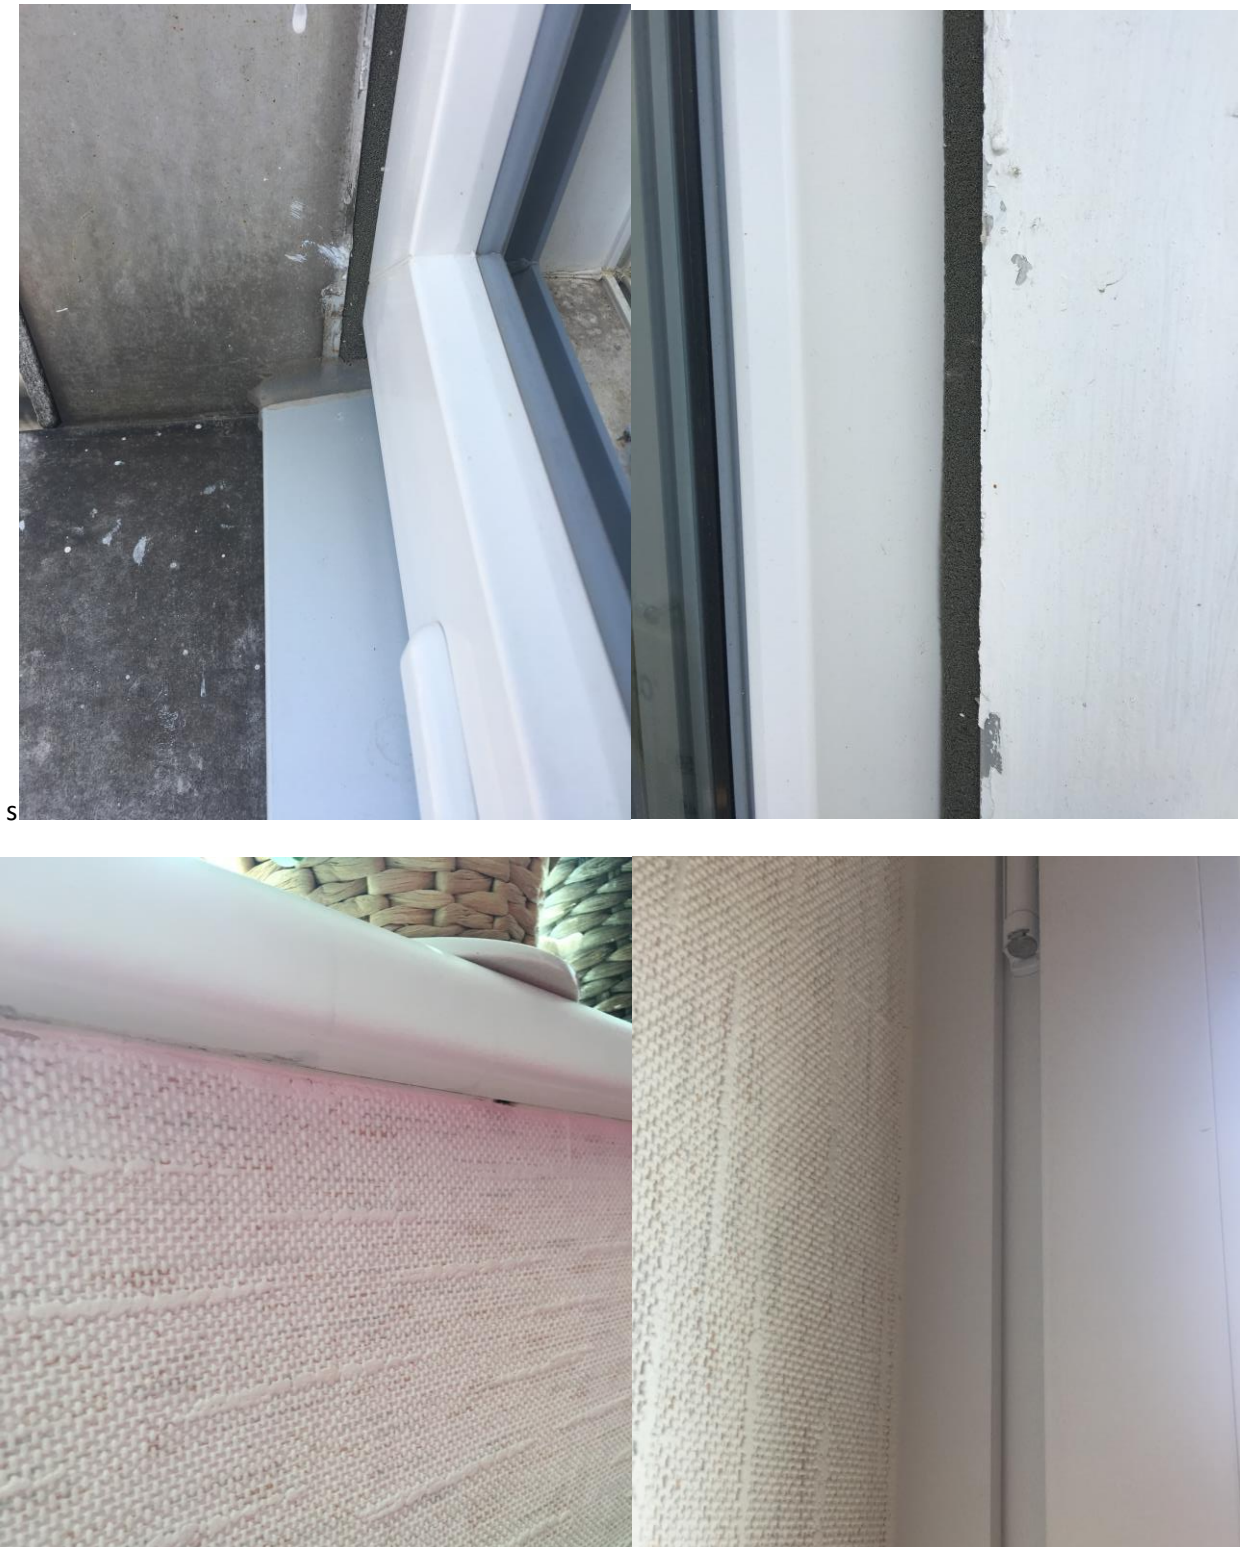
The new windows were installed in a satisfactory way, with the correct sealing on the inside and outside, both on the sides and on the upper and lower part of the frame. The details are shown in the following figures. It can be noticed how the finishing silicone sealing was applied to provide for the double protection against moisture and to provide the desired air tightness.

Figure 9. Sealing details on the outside and inside of windows

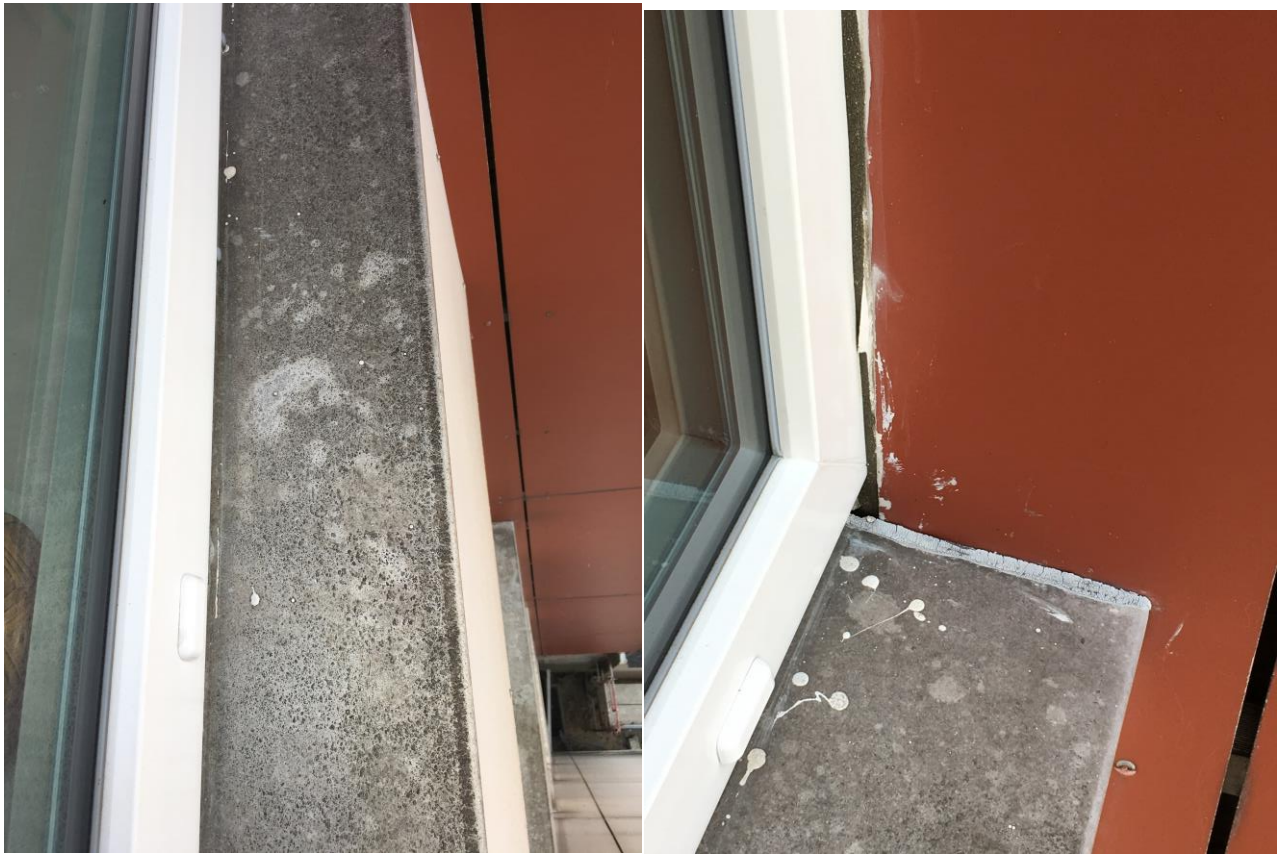
Some slight imperfection in the stairwell windows was noticed, also due to the fact that the façade had not been renovated. The sealing was done correctly but the result does not look perfect due to the old façade panels. The façade with the new windows can be seen in the figure below.

Figure 10. Stairwell window outside sealing details

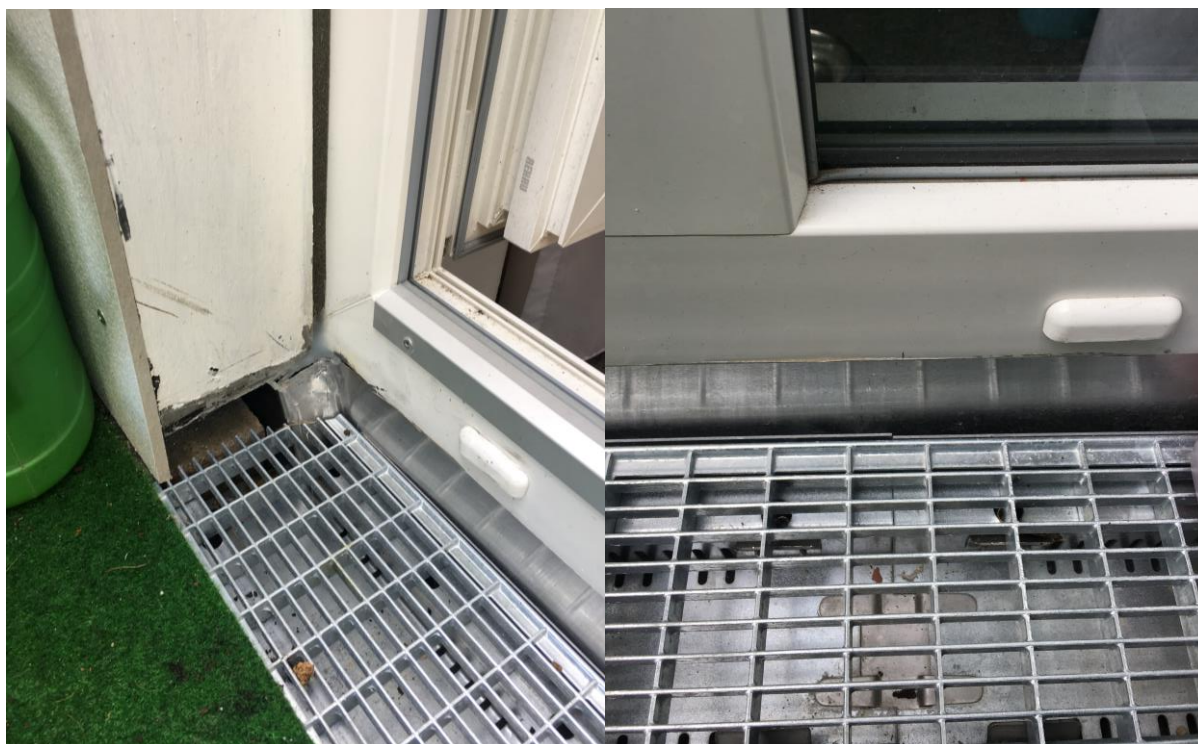
Where the terraces have been renovated, the result is very satisfactory, with an outside grate and water collector for additional drainage, as shown below. By doing so, the risk of leakage inside the apartments is almost eliminated since water cannot stagnate on the terrace and leak from below the door window (provided that the gutter is kept clean with periodical maintenance by the users, especially if there are many plants on the terrace that can clog it with their fallen leaves).

Figure 11. Gutter detail in the door window

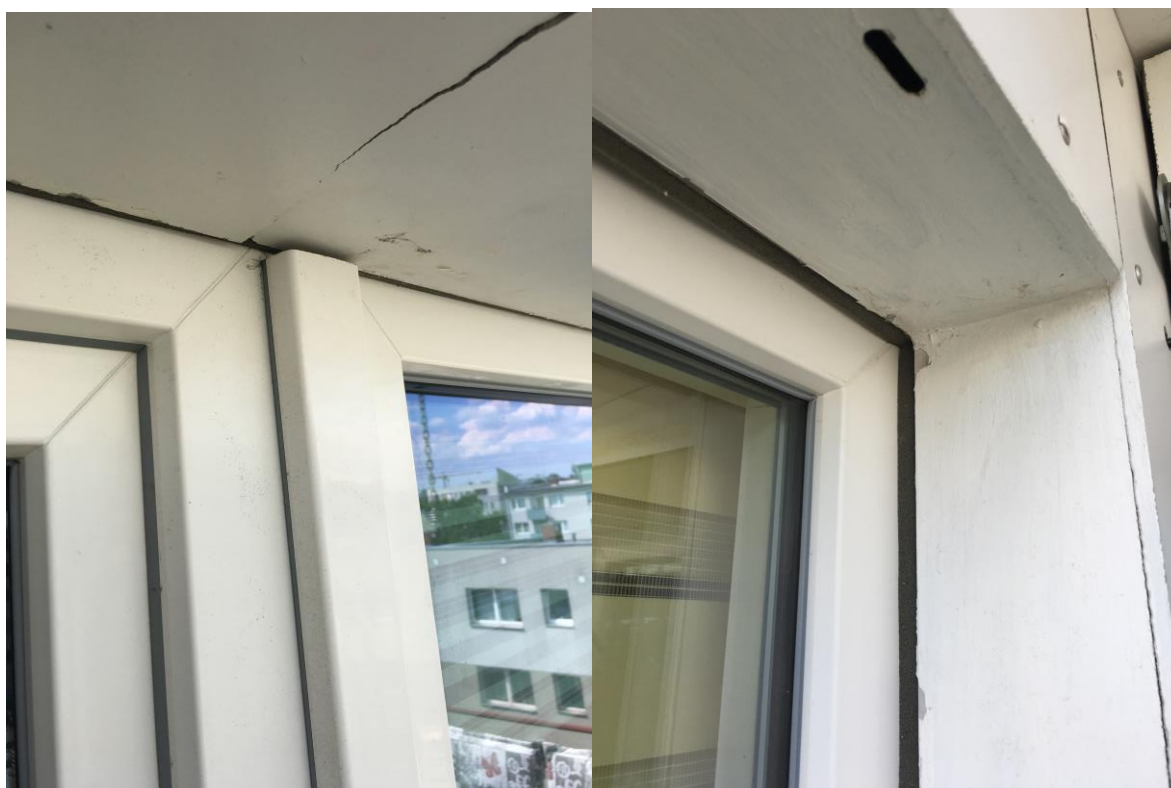
The sealing has also been done correctly here, even though at a first glance the result does not look very satisfactory, again due to the fact that the building envelope was not renovated.

Figure 12. Door window outside detail

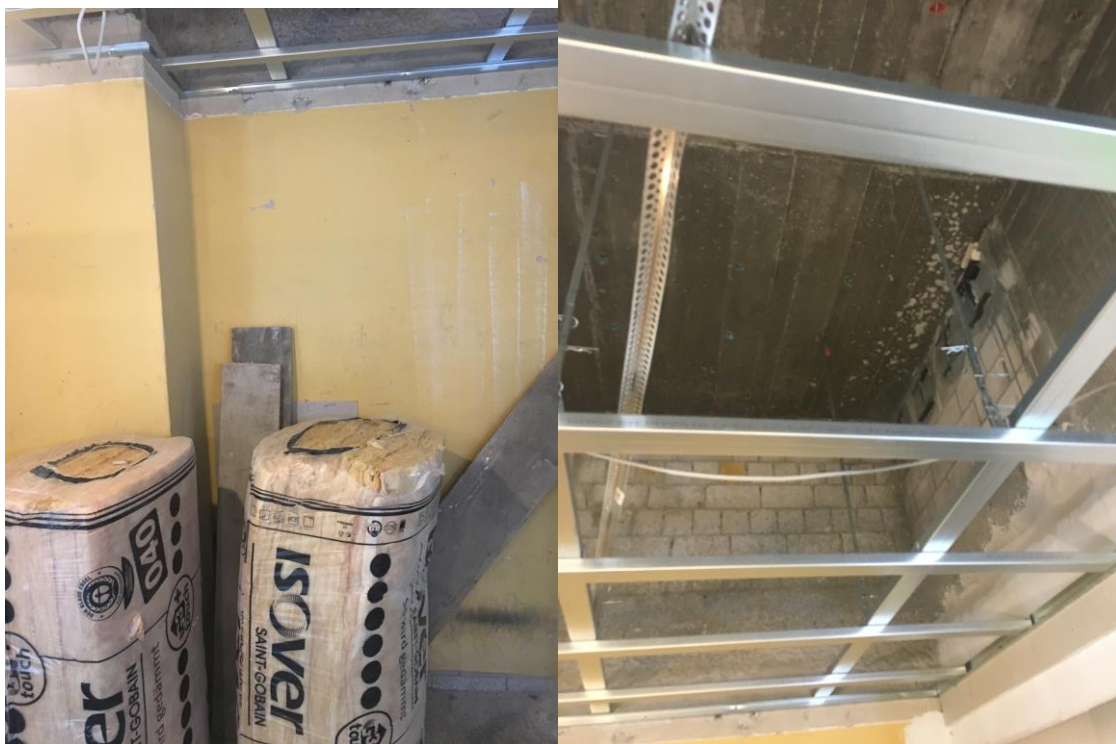
The last work that was going on, together with some minor cosmetic interventions in the stairwell, was the installation of insulation (mineral wool) on the ground floor ceiling, which was the only part of the building envelope still uninsulated, as seen below (as it had been decided not to renovate the building envelope as it had a satisfactory level of insulation already). By completing the envelope, thermal bridges will be greatly reduced, with a positive influence on the energy performance of the building and on the overall moisture safety.

Figure 13. Ground floor ceiling insulation being applied

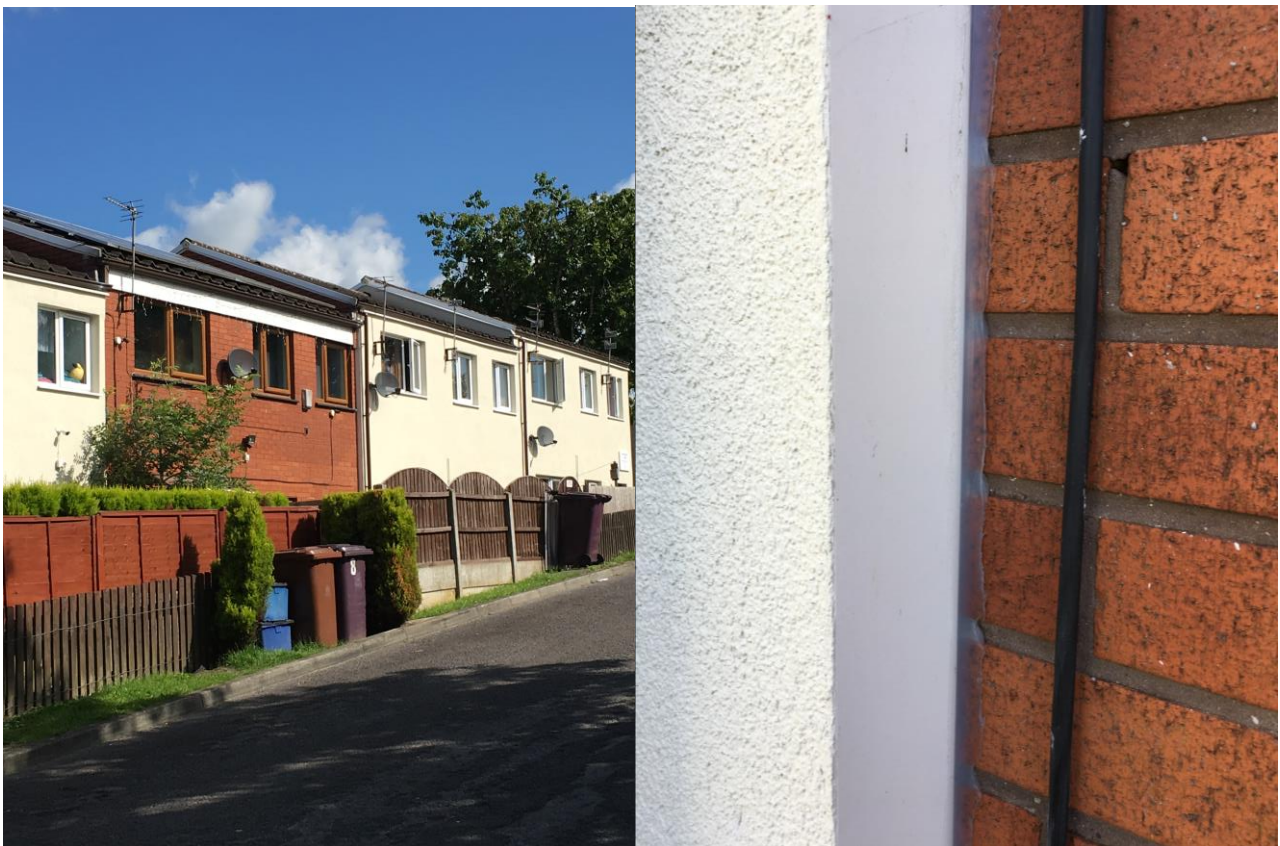
The figure below shows the difference between the renovated and unrenovated houses (some of those who owned the houses decided not to go for the renovation since they would have had to pay for the renovation themselves). Compared to the neighbouring districts, the overall impression is of much higher standard and quality. In the detail it can be seen the difference in wall thickness due to the external wall insulation (EWI) and the sealing in between.

Figure 14. Comparison between renovated (white) and unrenovated houses

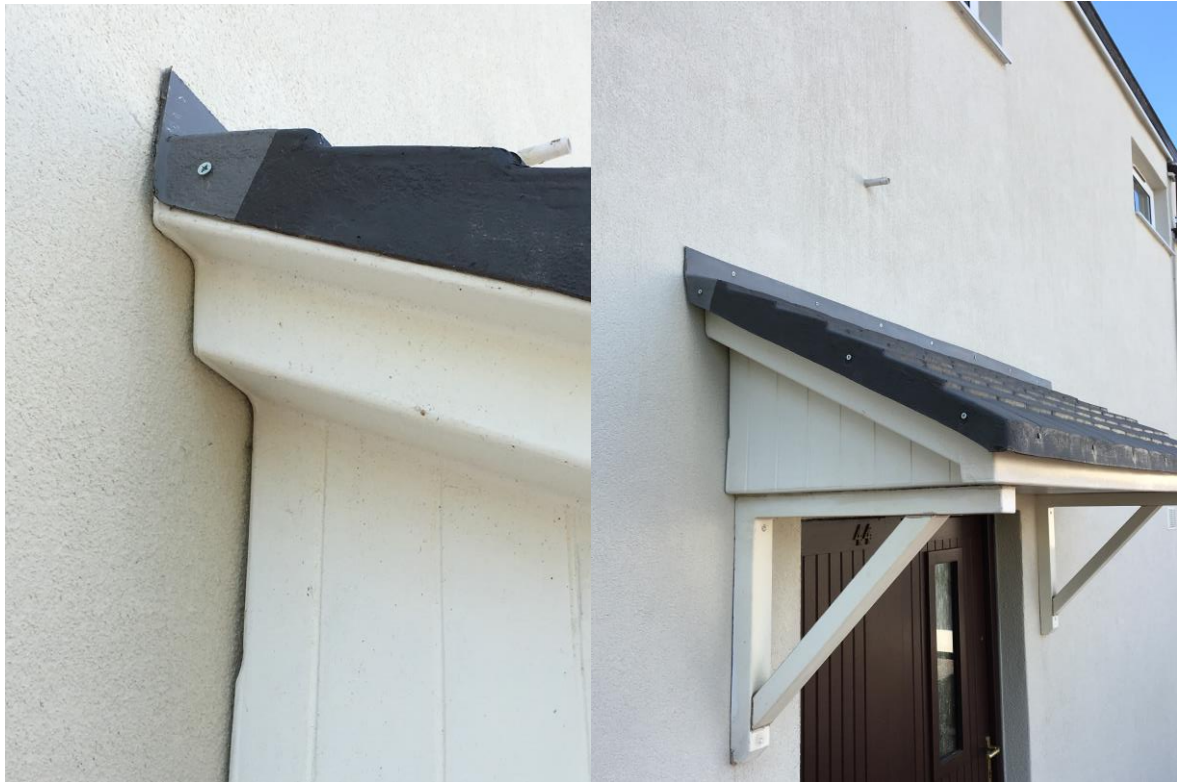
The awnings above the entrance doors were also installed correctly, without interrupting the airtight external envelope, as shown below.

Figure 15. Awning detail and view

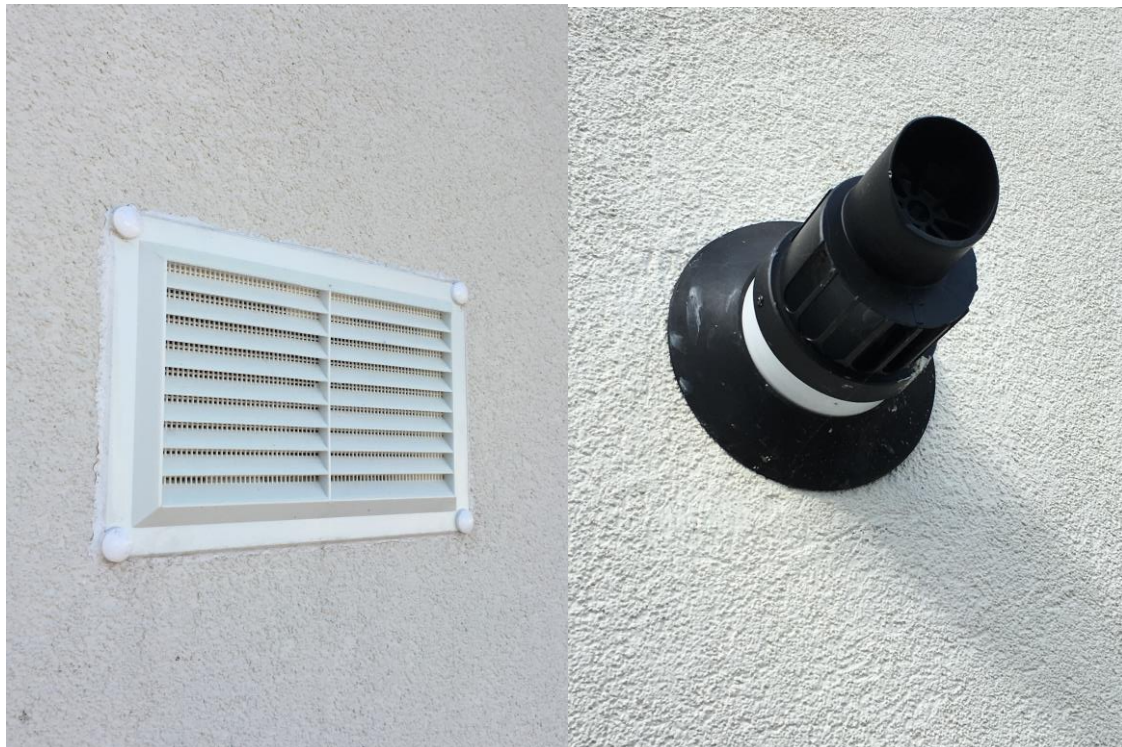
Where the wall had to be perforated to allocate ducting, air intakes or the gas system (only for the houses with gas heating), the holes have been sealed correctly, as it is shown in the figures below.

Figure 16. Detail of perforations in the EWI

Sealings made correctly, as reported. The final installations were also sealed correctly.

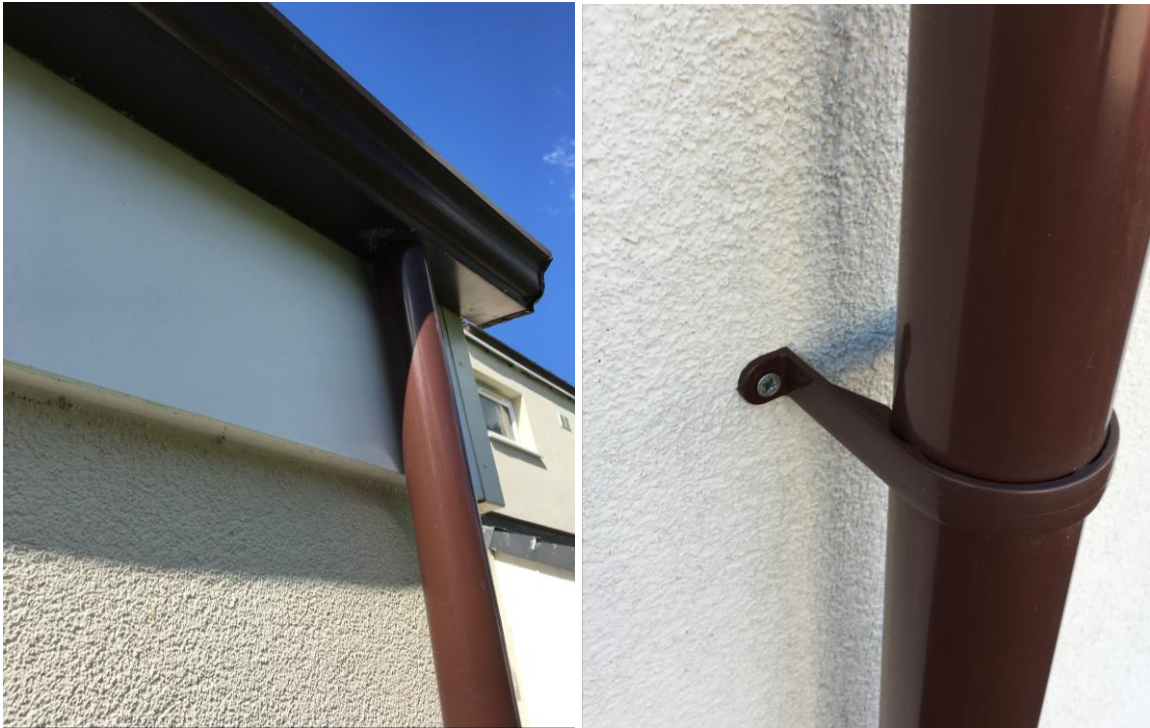
The new gutters are working correctly, conveying the runoff water into the collection wells on the ground. Special care was taken to make sure that the fastenings did not cause tear in the wall insulation, as shown in figure below.

Figure 17. New gutter and fastening detail

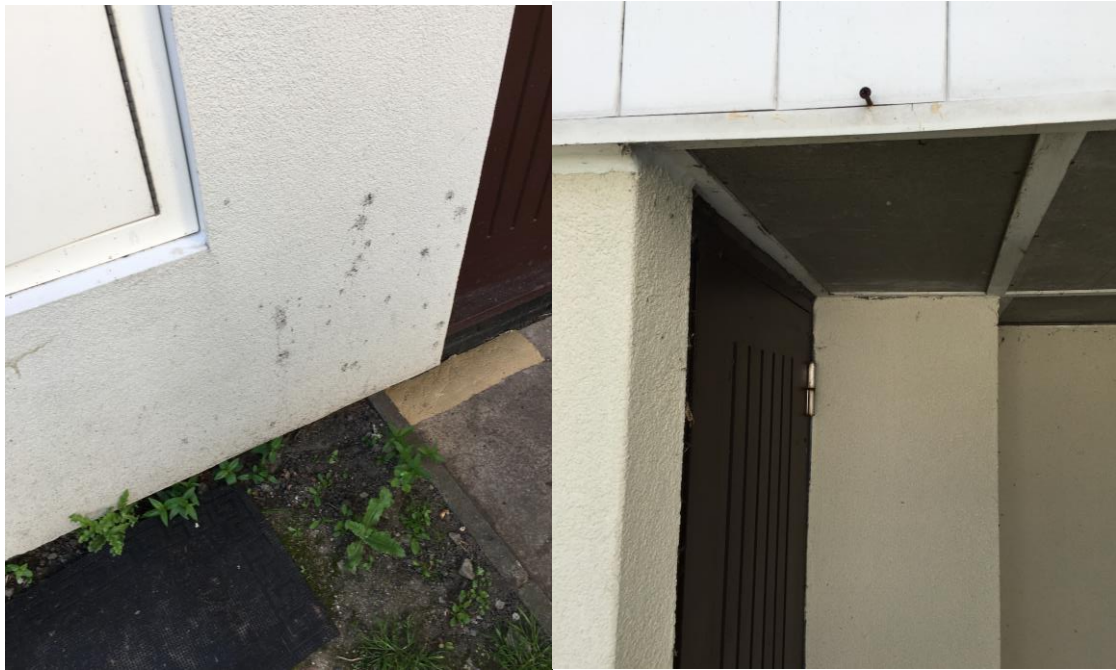
It should be noted that the render of the EWI can be washed so that it will maintain its appearance with minimal maintenance, ensuring a good result throughout the years. In the figure below it can be seen how the wall, dirty as some mud splashed on it, will be washed with water to regain its original colour: this is an interesting solution that is worth being picked up for other renovation works. Also, some parts were not renovated since they were deemed to be in good conditions and with a good U-value, something we could confirm during the visit.

Figure 18. EWI to be washed (left) and part where additional insulation was not installed (right)

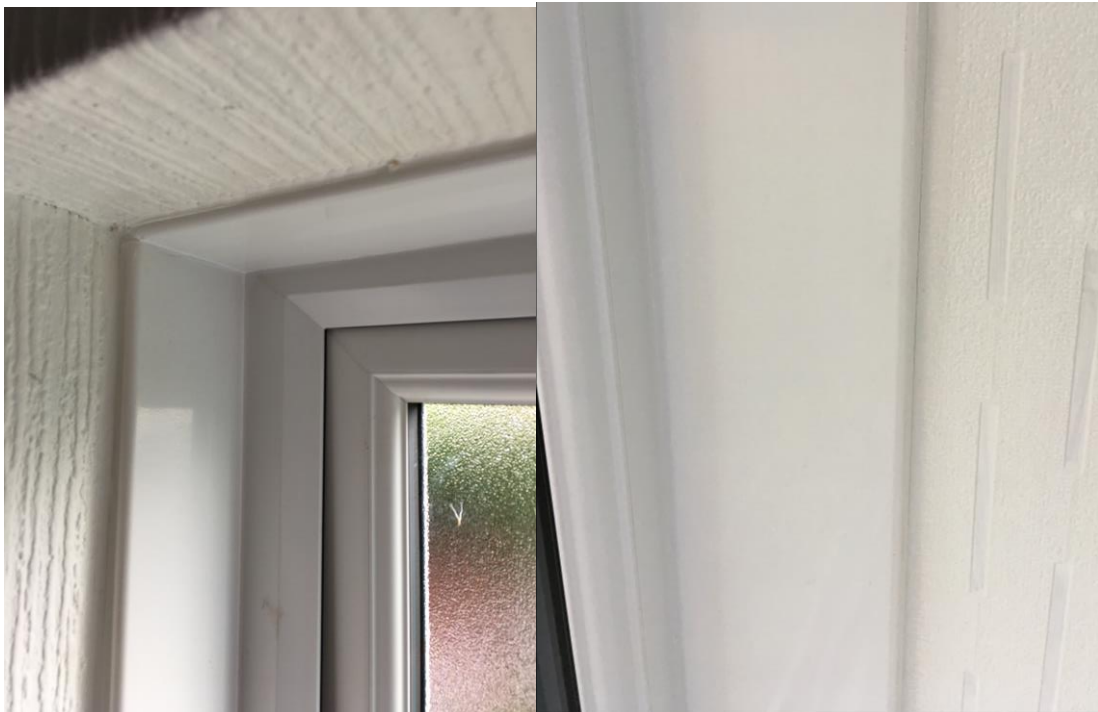
The new windows, which had been installed correctly as already shown in the previous report, with good sealing to protect from external moisture and driving rain, have proven to be a source of improved comfort as the tenants remarked during the inspection on the inside of the dwellings. The better glazing and air tightness avoid cold draughts and give a higher surface temperature on the inside, which results in an improved indoor operative temperature. The pictures below show some detailing on both sides.

Figure 19. Window details, inside

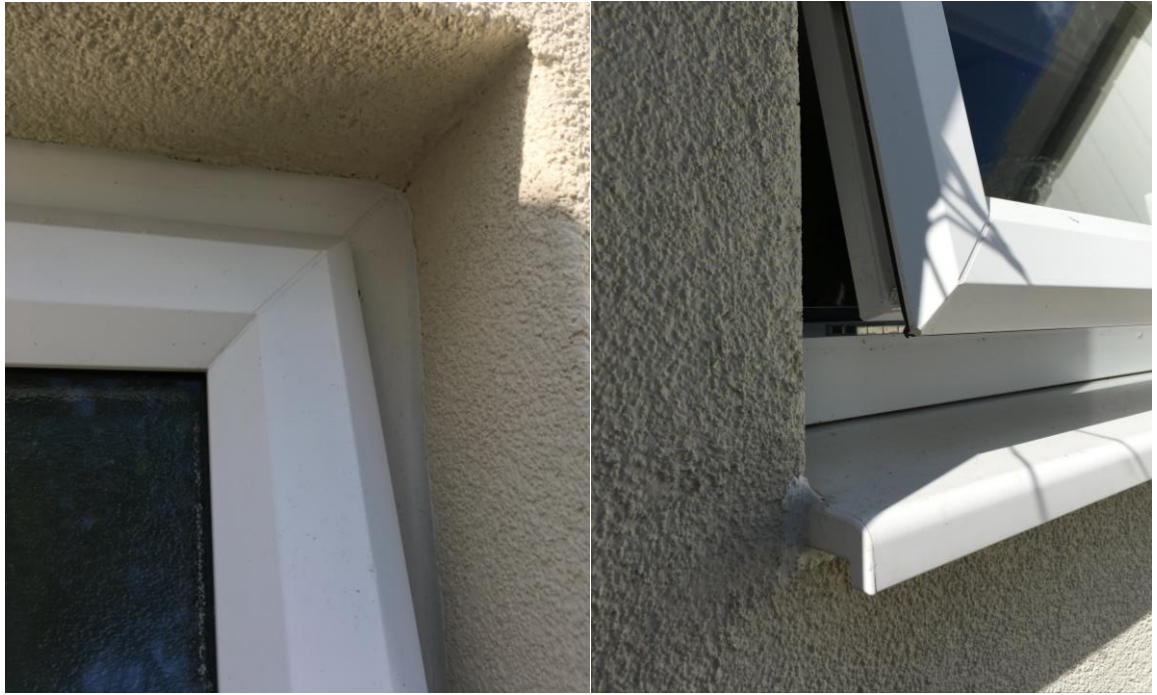
Figure 20. Window details, outside
