Finalisation of the renovation works

D 3.7

Project acronym	DREEAM
Grant agreement number	680511
Project title	Demonstration of an integrated Renovation approach for Energy Efficiency At the Multi building scale

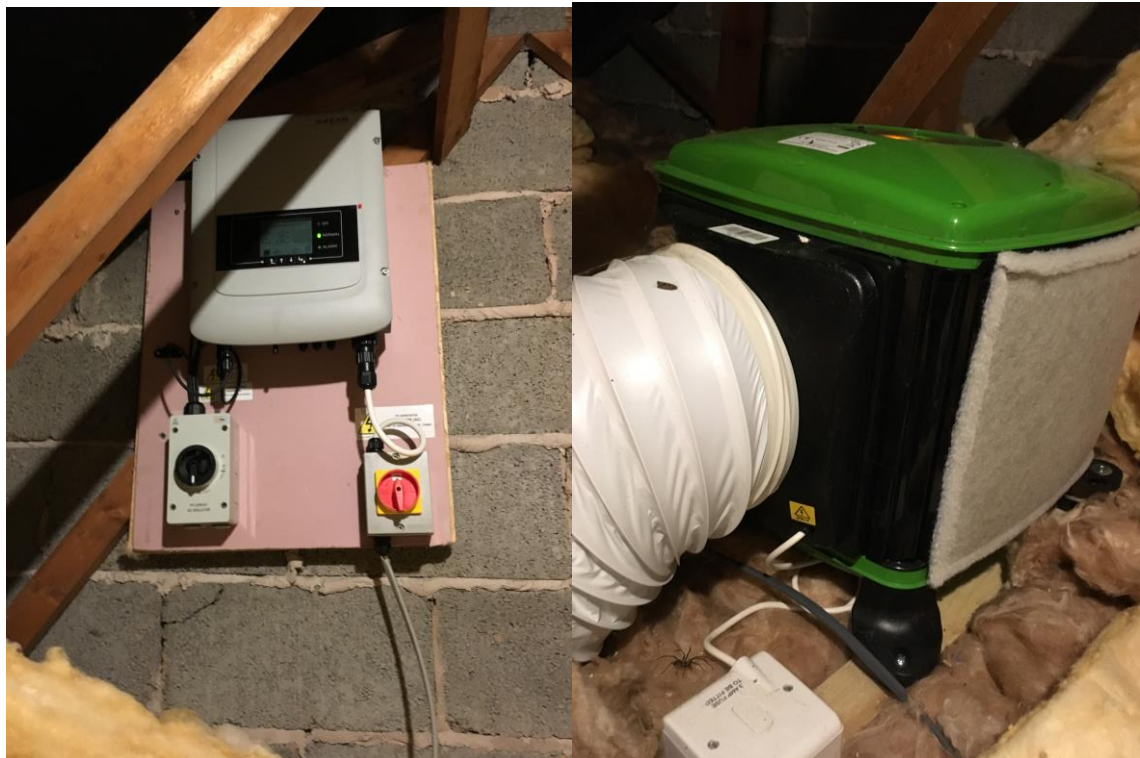
The mechanical ventilation system installed in the cold attic was working properly and as far as we could see the ducting was installed correctly so that the loose insulation is not blocking the air intake and the sealing was done correctly. In the same cold attic, the inverter for the photovoltaic panels was installed, as shown in the figures below.

Figure 21. Inverter for the PV panels (left) and ventilation unit (right)

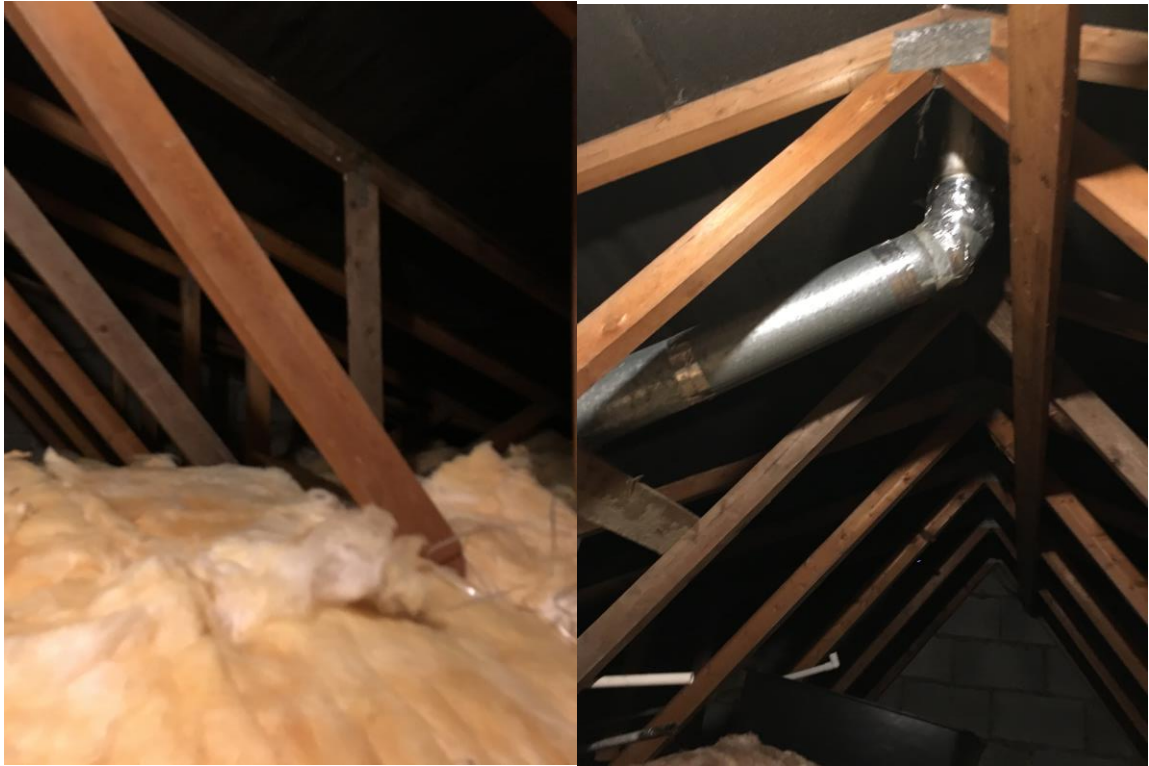
Figure 22. Loose insulation detail (left) and ducting for the gas boiler exhaust (right)

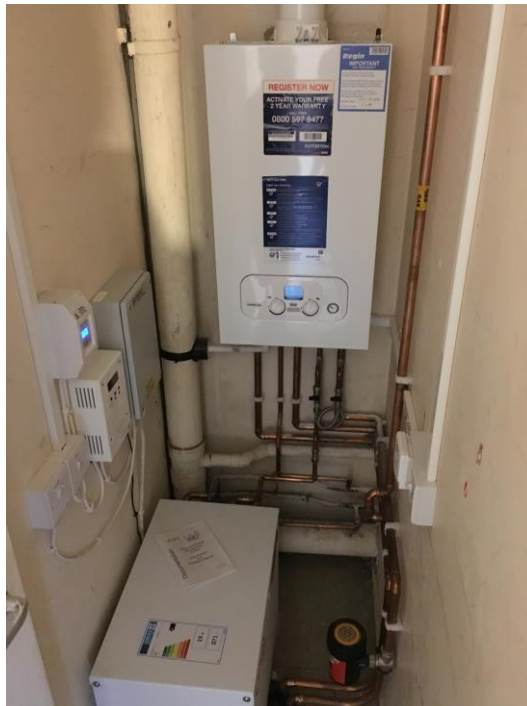
The new combination boiler that was installed in place of the previous boiler is working correctly and, being much smaller than the previous boiler, as shown in the figure below, it was possible to install in the same room the gel unit that works as a battery for the photovoltaic panels, storing the excess electricity as heat in the gel inside the box, to be used when the heat demand requires it. This technology is becoming getting popular in Scotland but there are still very few applications in England.

Figure 23. Combination boiler and gel heat storage (the box on the ground)

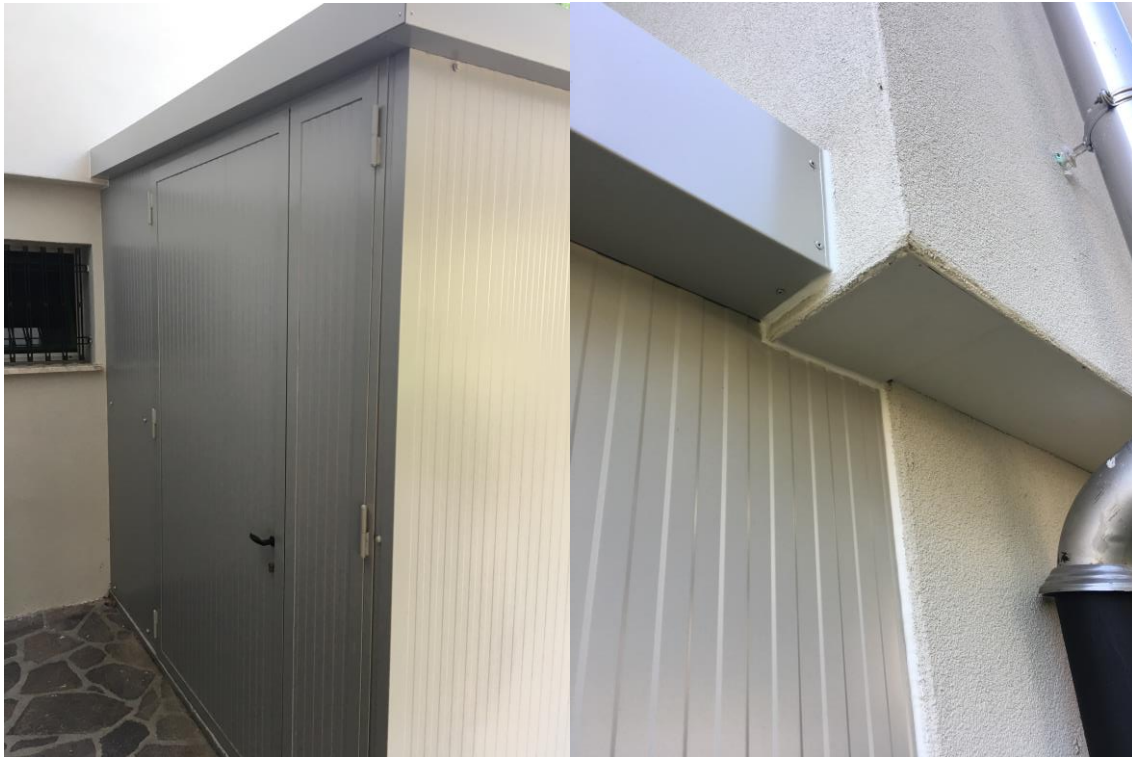
Most of the detailing has been already reported in the previous deliverable, here a few details of the EWI are shown below, as the addition of the room that houses the thermal storage of the solar thermal, and how it was joined with the tower and its EWI.

Figure 26. Thermal storage for the solar collectors and joining to the building detail

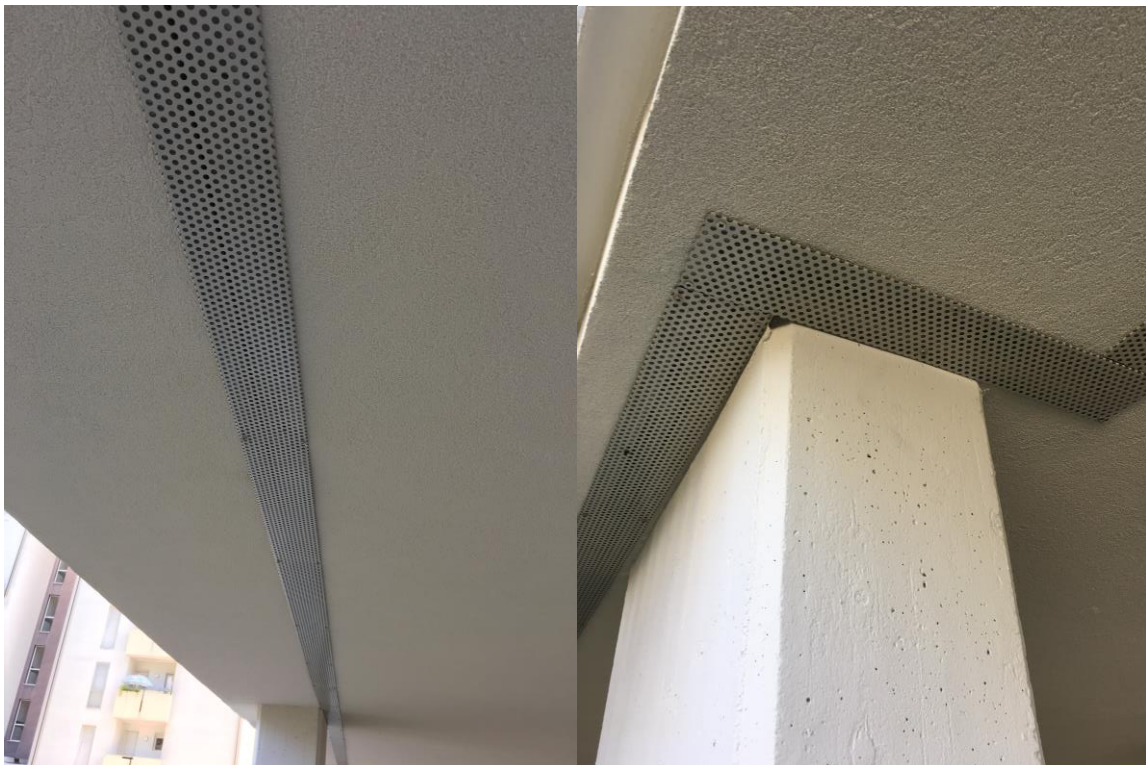
Where the piping of the gas system goes through the EWI, as it can be seen from the grate in the figure below, an aerogel layer was applied to counter the reduced thickness in insulation and prevent thermal bridging. The grate is required by the law, so that the piping will run externally to the wall.

Figure 27. Gas system piping detail

We noticed that repairing works were done correctly, and that measures were taken to prevent thermal bridging from the piping installed in the external envelope, such as with the aerogel behind the external gas piping.

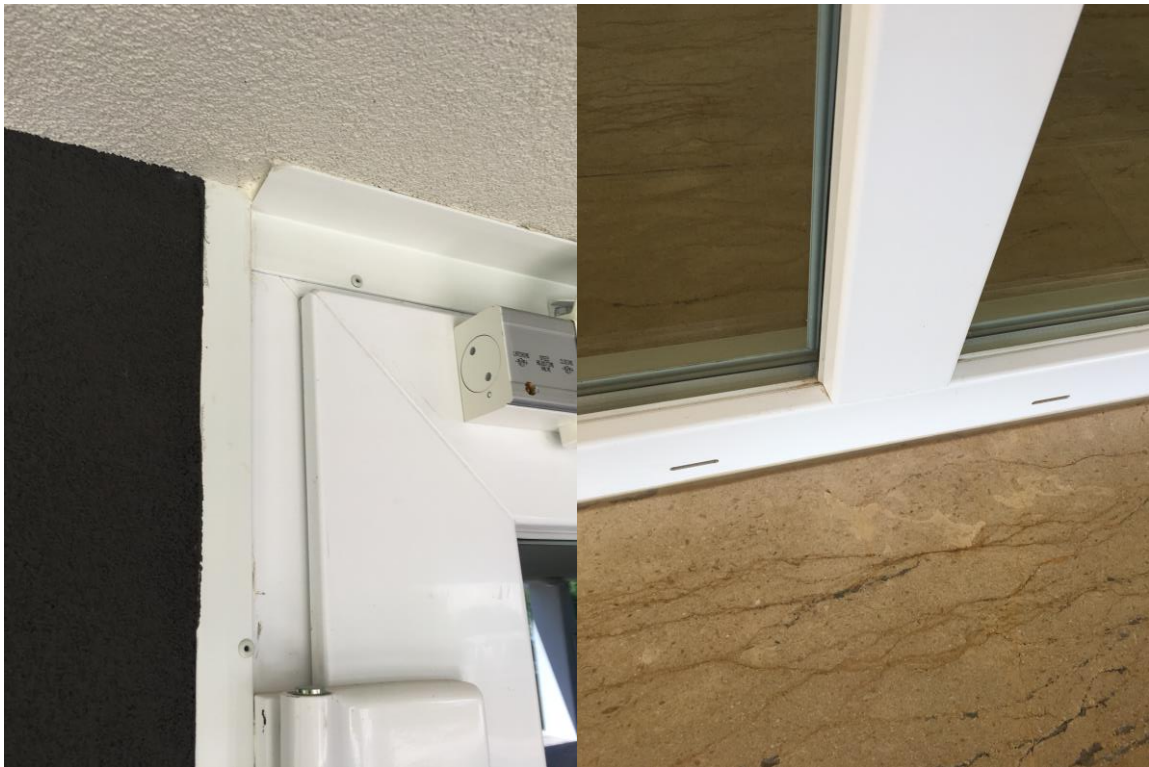
The new PVC front door was installed correctly and the sealings are good, as shown below. Some issues have been reported though about difficult opening, probably due to the thermal expansion of some joints.

Figure 28. PVC front door details

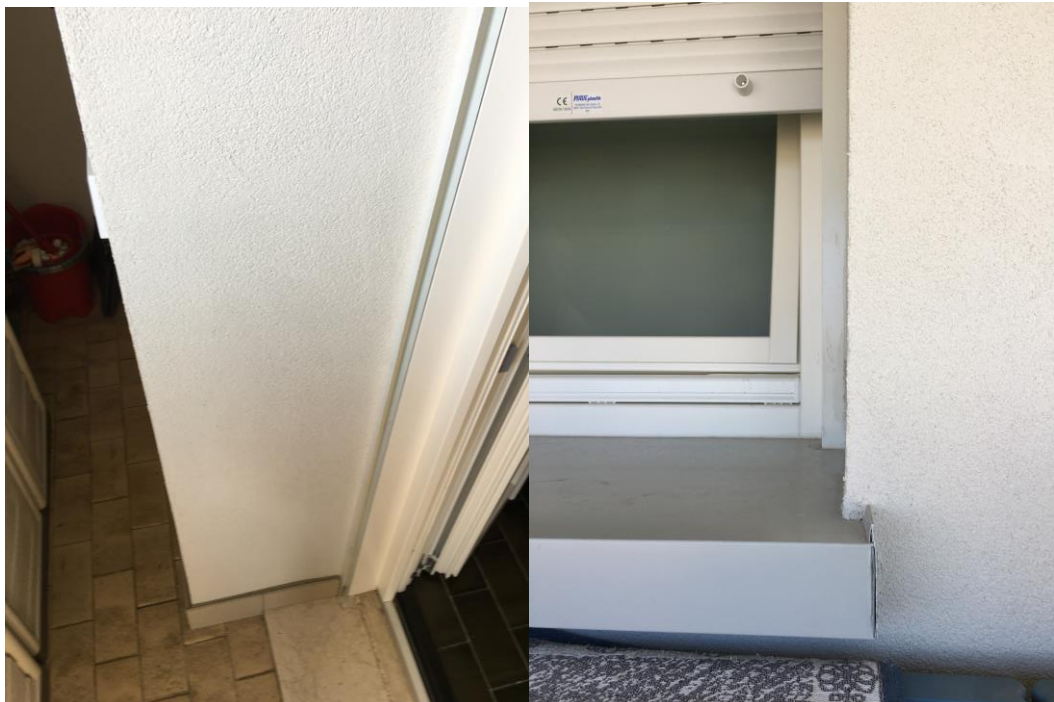
The EWI has been installed properly also at the terrace level, even though some tenants have been complaining about the reduced space that the additional insulation implies on already small terraces.

Figure 29. EWI on terraces. Note the reduced space and the toilet window detail.

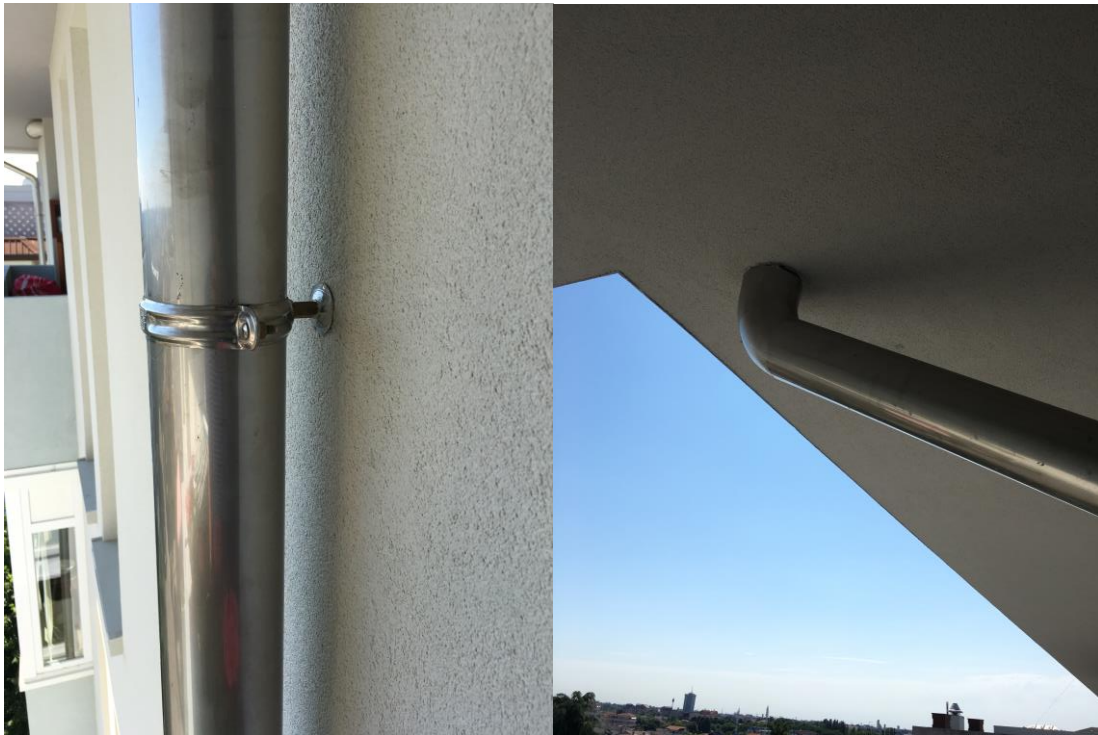
Now that the works are finished it is possible to see the quality of the sealings and detailing that we could see being done in the previous visit, where workers were still installing the ducting and the EWI.

Figure 30. Sealings where the EWI was perforated (fastening and ducting)

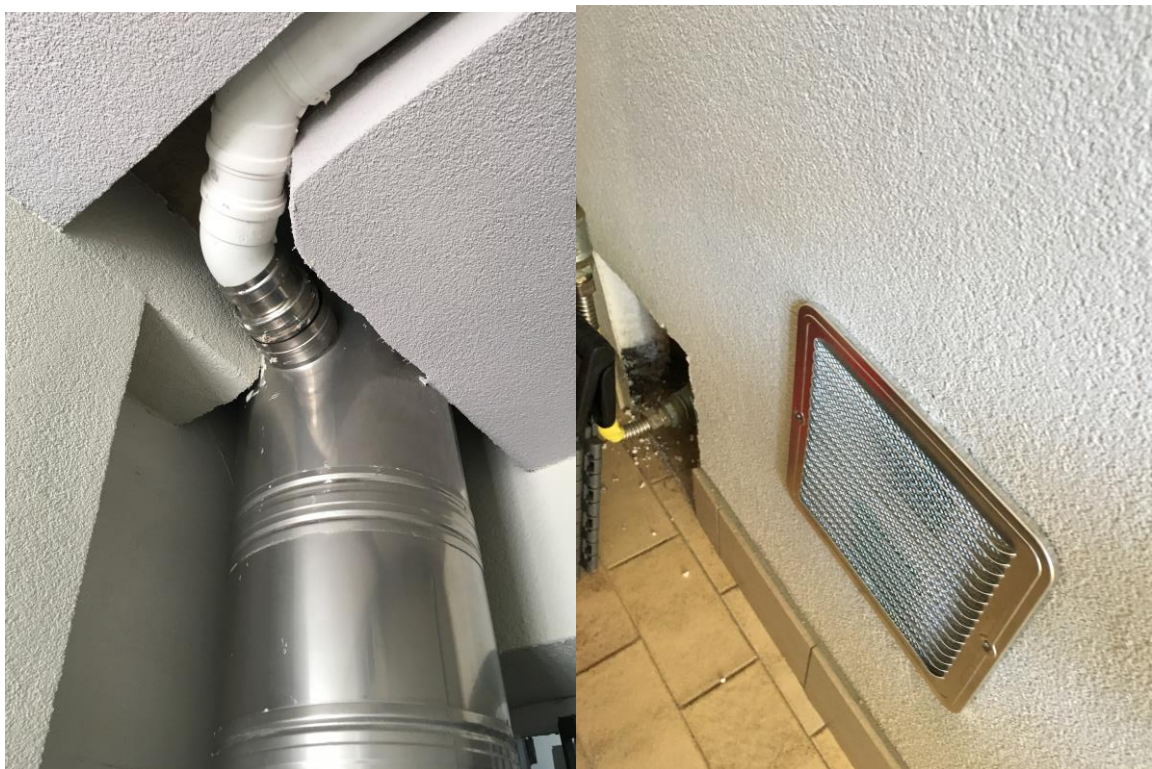
Figure 31. Integrated ducting in the EWI (gas unit exhaust)

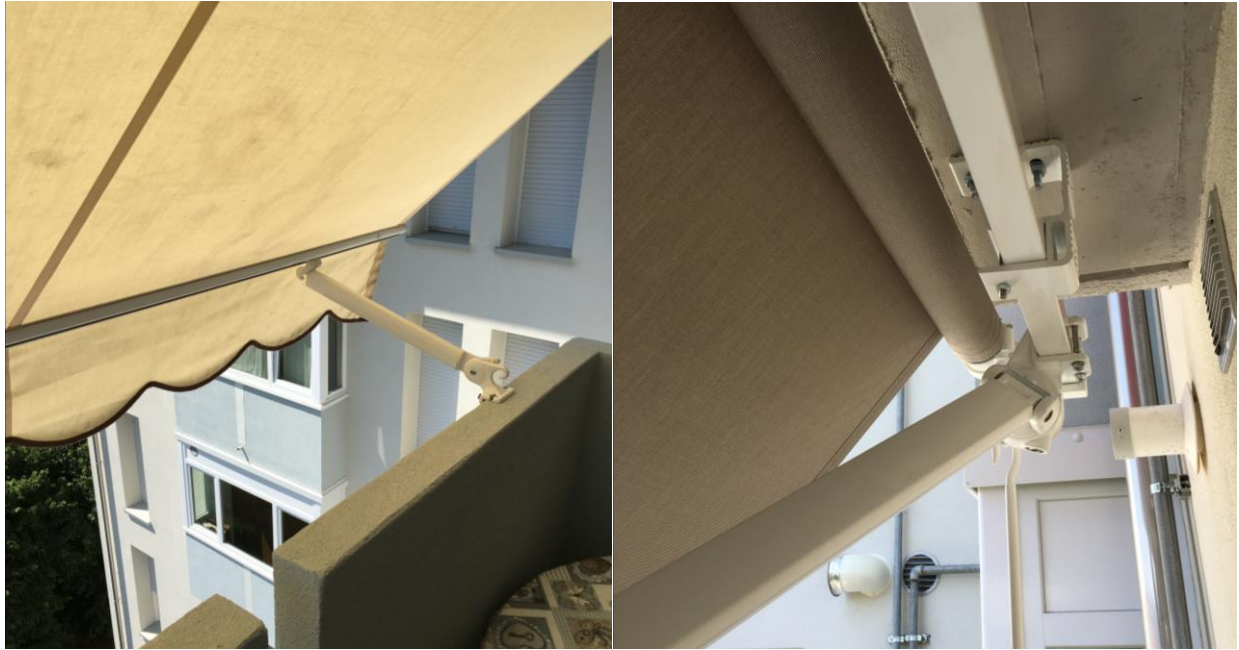
Wherever tenants wanted to install external curtains on the balconies, a smart solution was adopted, as shown below: the structure rests on the concrete balconies above and below, and not on the walls (where the EWI was installed), therefore not affecting the moisture performance of the building.

Figure 32. Curtain structure details

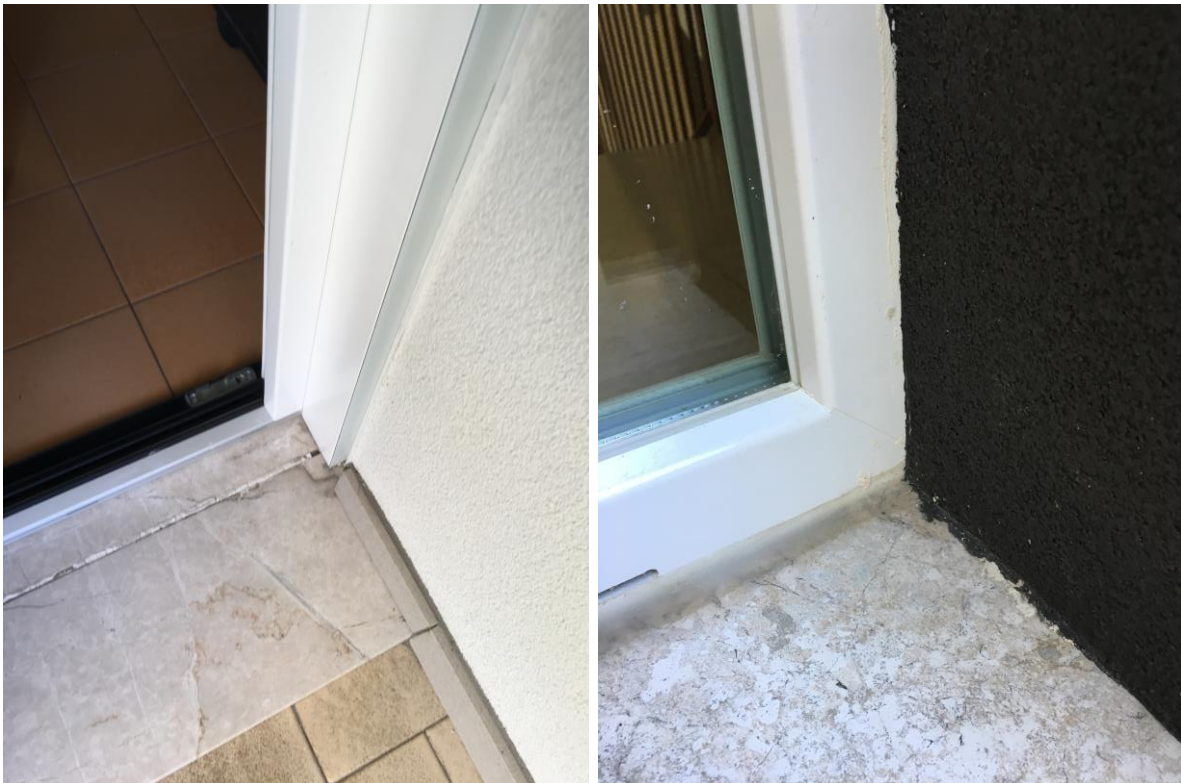
The windows have been installed correctly with adequate sealing ensuring air tightness (now paramount since the mechanical ventilation was installed) and moisture safety, as shown below:

Figure 33. Window installation details: apartment door window (left) and stairwell (right)

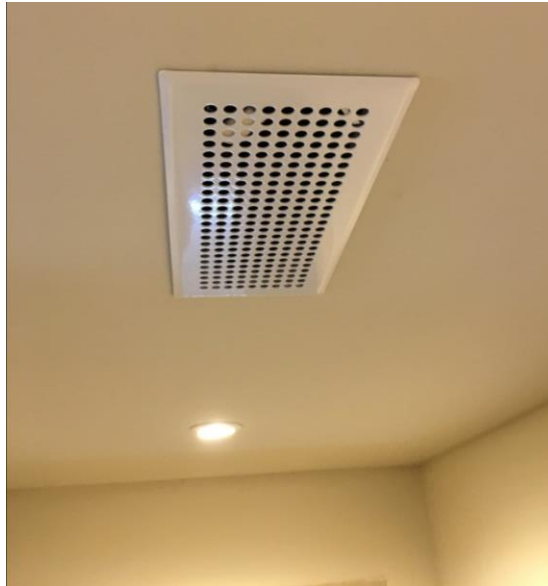
Concerning the mechanical ventilation, the decentralised units were installed in the apartments and are working as they should. The air handling units have been installed in the hall ceiling of every apartment, now only the outlets are visible, as shown in figure below. The air intake is in the terrace, the filter being protected by a grate.

Figure 34. Ventilation system outlet (corridor, one in every room)

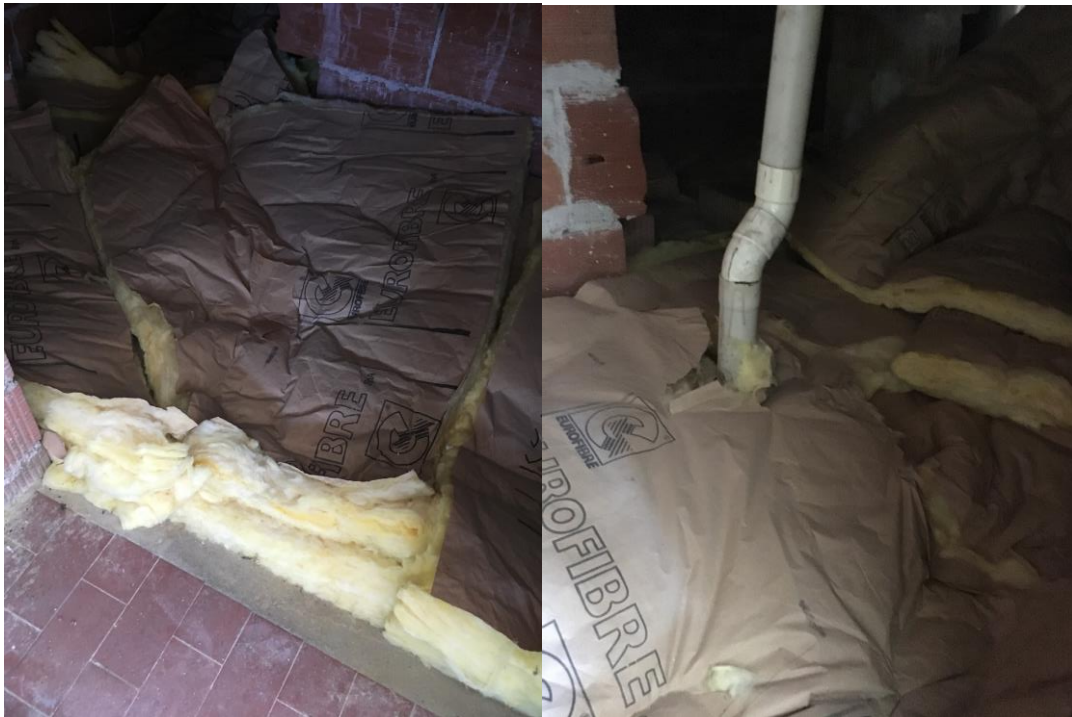
The cold attic has been insulated with mattresses of mineral wool, as shown below, to guarantee continuity in the U-value of the building envelope.

Figure 36. Cold attic insulation with mineral wool mattresses

The mineral wool mattresses were rolled out so that they cover all of the cold attic. The sealing around the polystyrene insulation on the floor of the warm attic is airtight. No airtightness tests were performed, only visual checks.

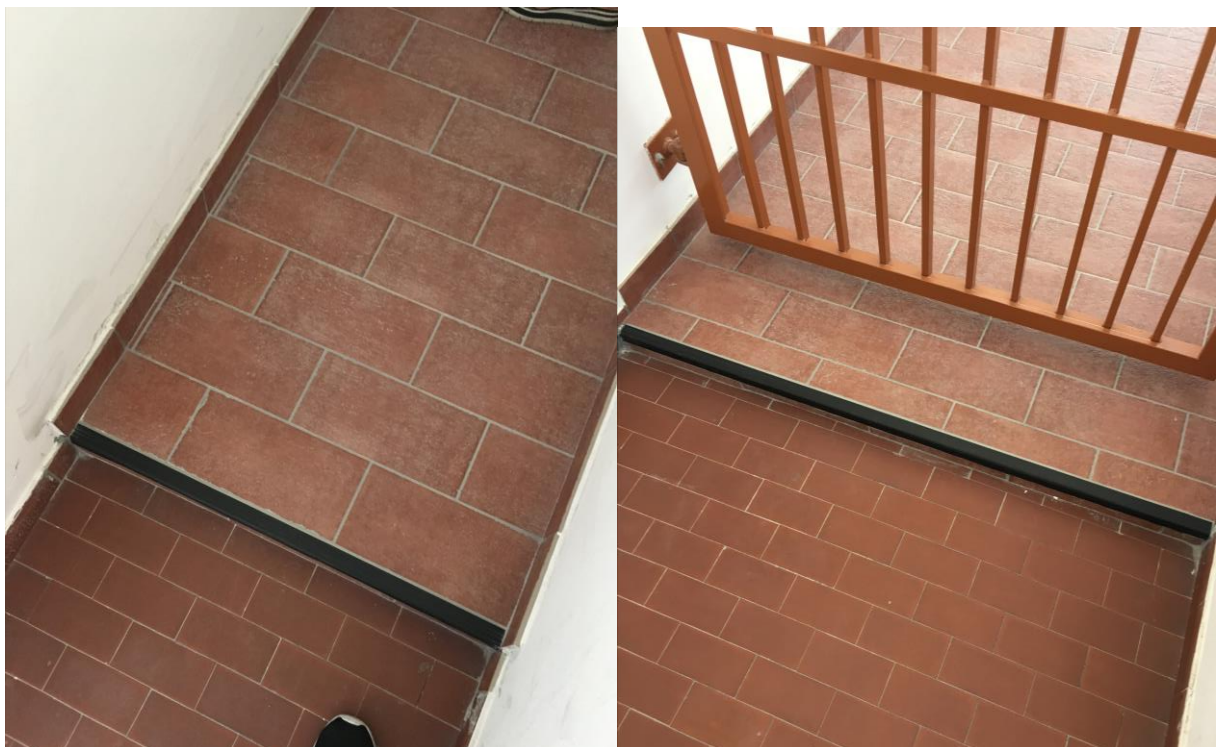
The floor of the warm attic (the room where clothes are hung to dry) was insulated as well with a layer of polystyrene, as the small step reveals the now slightly raised floor, shown in the figure below.

Figure 37. Raised floor after polystyrene insulation
