Second site visit

D 3.5

PROJECT INFORMATION	
Project acronym	DREEAM
Grant agreement number	680511
Project title	Demonstration of an integrated Renovation approach for Energy Efficiency At the Multi building scale

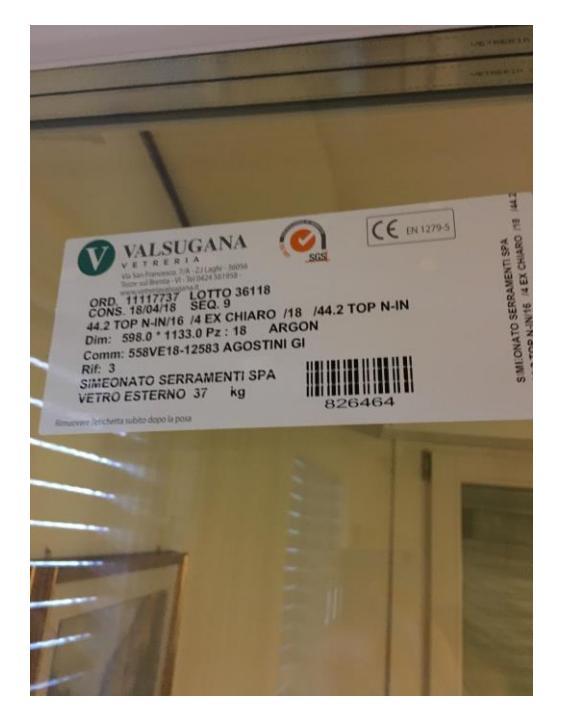
When the materials or components arrive at the workplace, the site manager and his assistances (from ATER) check daily that the DPP label (Dichiarazione di prestazione, performance declaration), verify that the performances indicated on the label correspond to those of the tender (for example that the window has the desired wind resistance grade or transmittance level).

Figure 1. Product label on a window

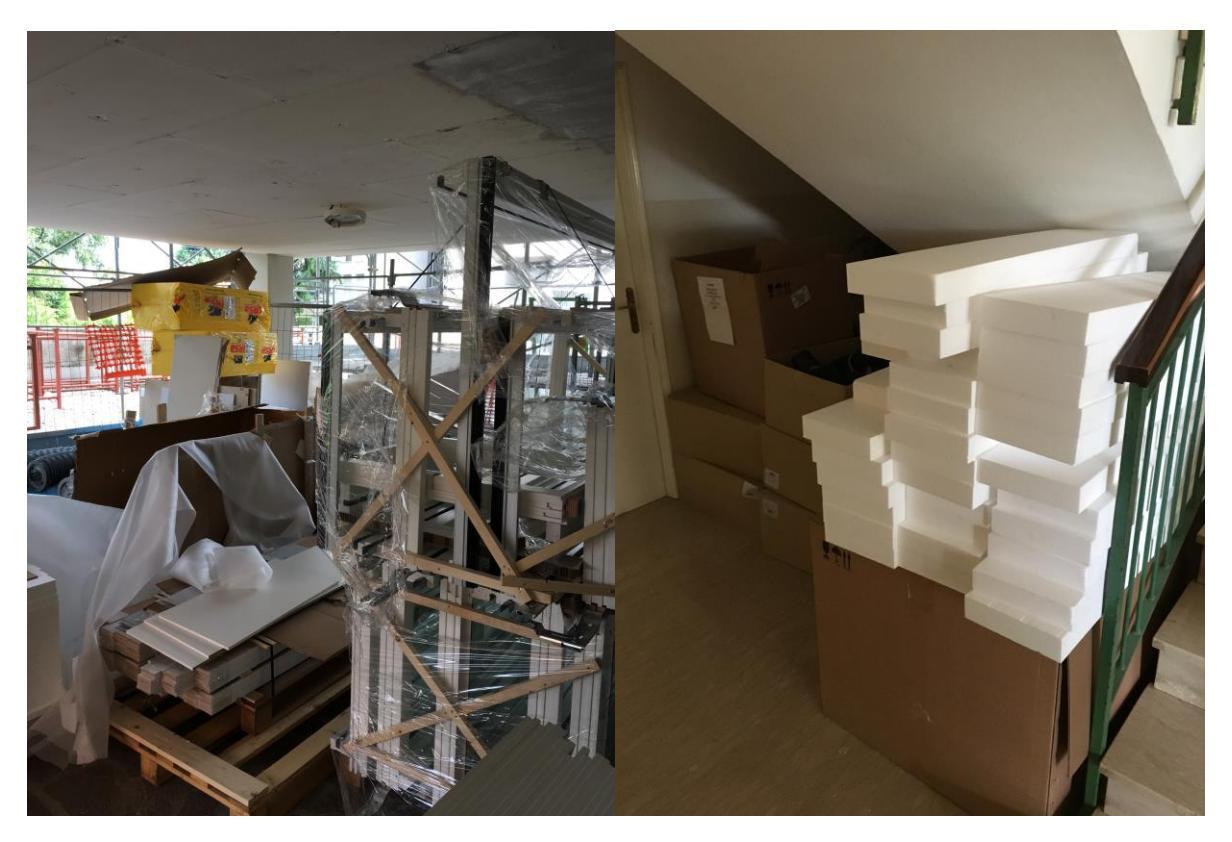
Exploiting the fact that the buildings have a portico in the ground level, most of the materials were stored there to protect them from the weather. Some material was stored in the staircase as well,

Figure 2. Material storage under the portico (left) and in the staircase (right)

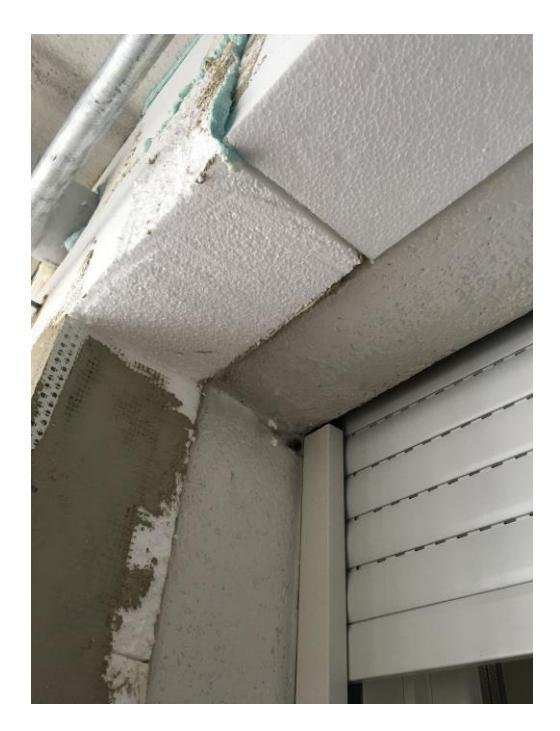
The external XPS insulation has been installed in both of the two buildings: the ongoing work is about rendering the panels. Painting the walls will be the last stage since it is a work that has to be done the same day or with a time interval of maximum one day for every façade so that there will not be colour differences on the same surface. The external wall insulation (EWI) increases considerably the thickness of the wall, as it can be seen in Figure 3. It can be noticed as well the space left for the aerogel panels.

Figure 3. External wall insulation thickness detail

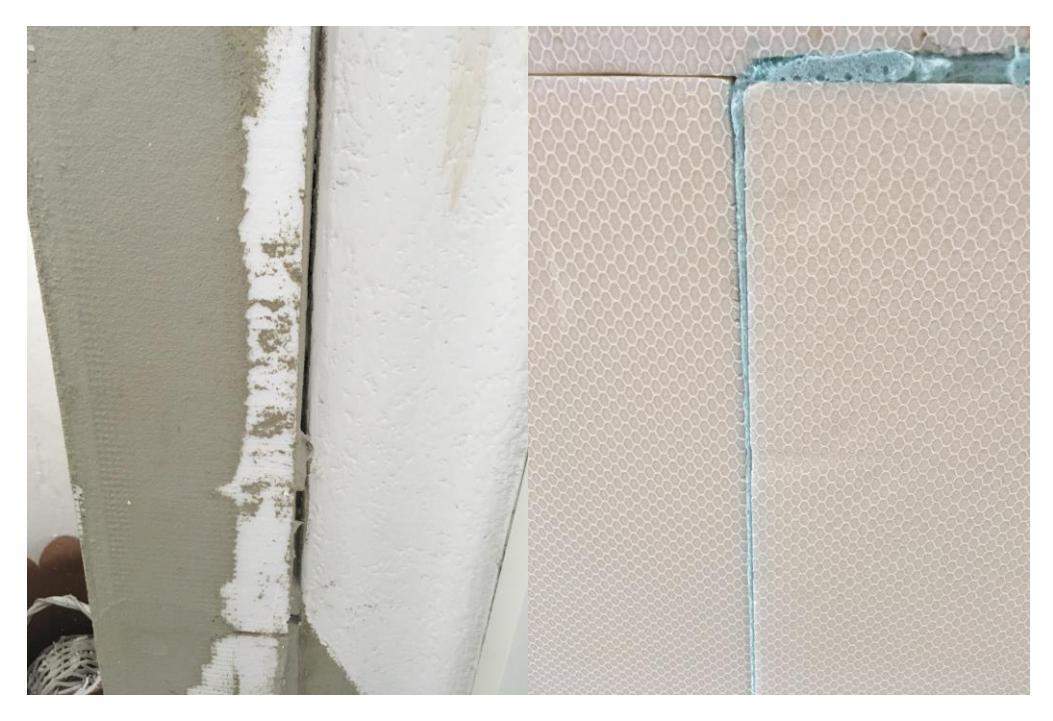
So far, the detailing has been made correctly with some minor imprecisions in the joining of the boards or adherence to the wall (which might be due to the fact that the wall is not perfectly perpendicular to the ground), as it can be seen in Figure 4. The works are not done yet so there is still room for fixing the minor imprecisions.

Figure 4. Adherence of EWI to wall (left) and joints detail for insulation boards (right)

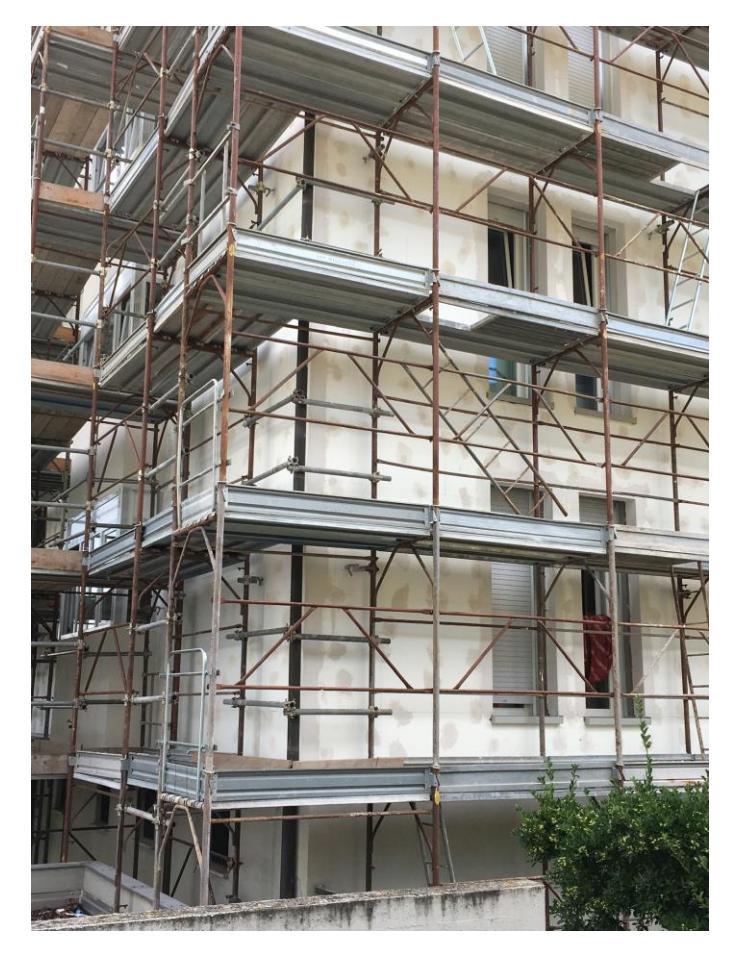
The EWI has been anchored correctly to the wall by using the prescribed number of plastic screws: this was a very important point since too few pins would have made the installation weak and too many would have compromised the moisture safety of the wall, affecting the moisture permeability of the wall, due to the presence of too much plastic, which has a lower moisture permeability. This becomes especially relevant since the old windows are replaced with high-performance ones that account for high air tightness as well: before the building was breathing for the most through the infiltrations provided by the windows, exchanging not only heat but moisture as well with the outside. The darker spots in Figure 5 show where the EWI is anchored on the wall.

Figure 5. Façade with EWI installed, to be rendered and painted

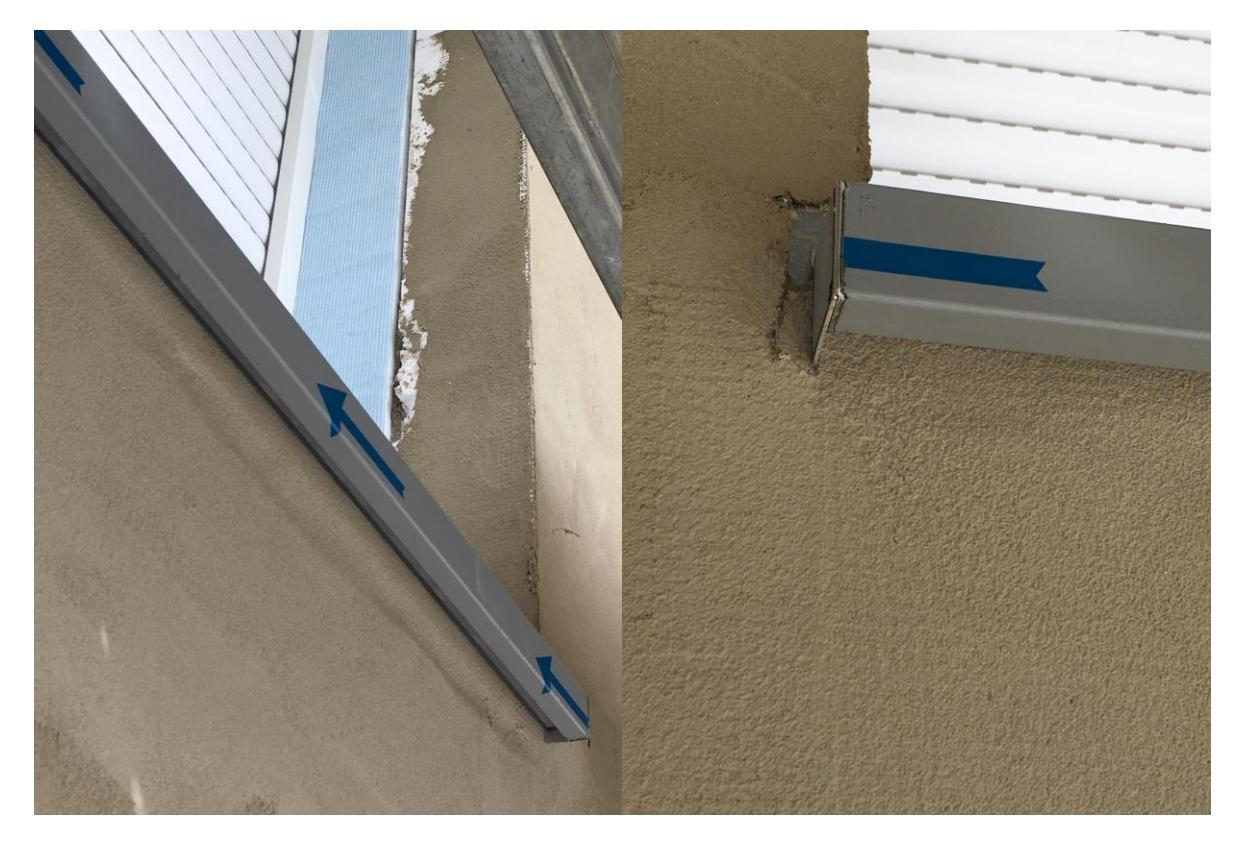
Replacing the window sills would have meant a very disruptive intervention, therefore it was decided to install the new sills on the existing ones, which worked out well. As it can be seen in Figure 6, the result is satisfactory, with a correct sealing at the edges of the window sill. It was decided to lay a thicker layer of aerogel where necessary to meet the same thickness of the surrounding wall.

Figure 6. Window sill detail

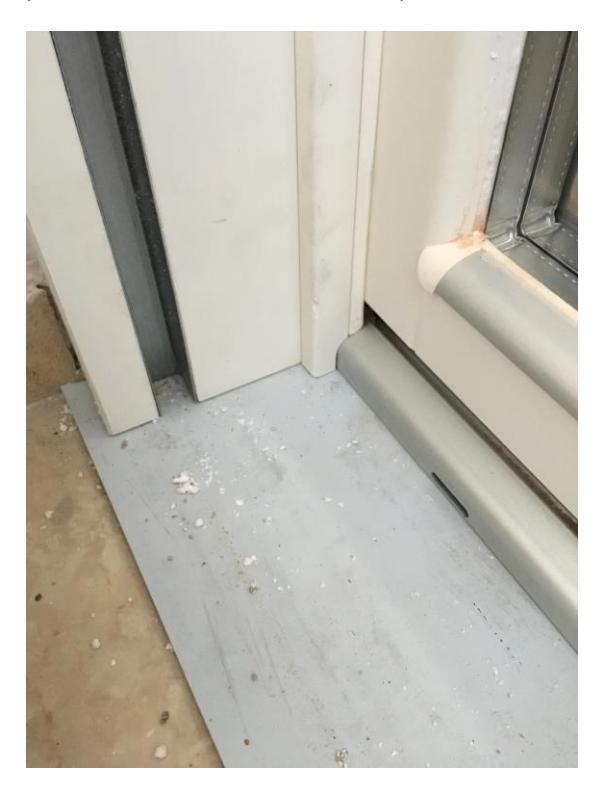
Windows themselves have been installed correctly. The metal plate (see Figure 7) provides an additional protection from outside rain. It should be said that generally in Italy windows are more protected from rain due to the presence of shutters, which act as a first break again rain and wind.

Figure 7. Door window detail

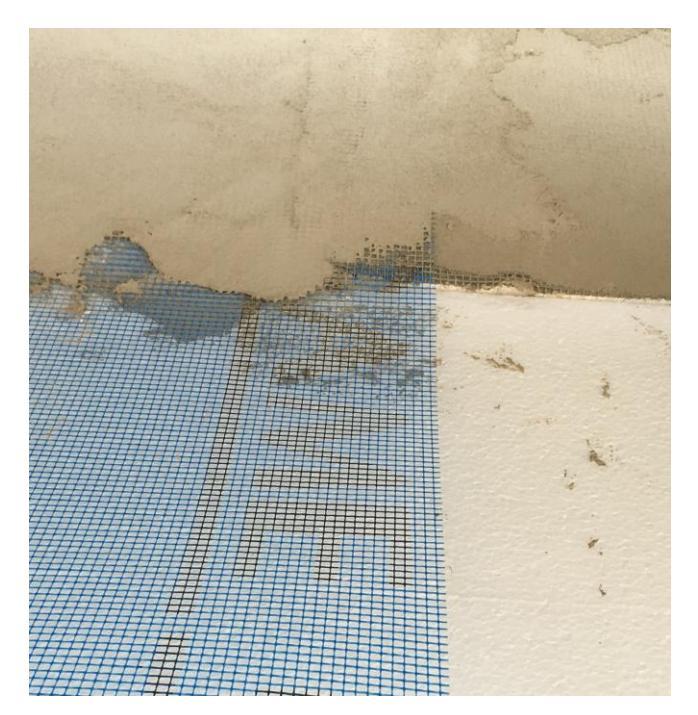
To see in detail how the render has been applied to the EWI, see Figure 8. It can be noticed the mesh upon which it is applied (light blue). The finishing layer and the painting has to be done on the same day for the whole façade so that there will not be differences in colour due to the different temperature and humidity conditions that might arise if the work is done in separate stages.

Figure 8. Detail of installation of render on the EWI through a mesh

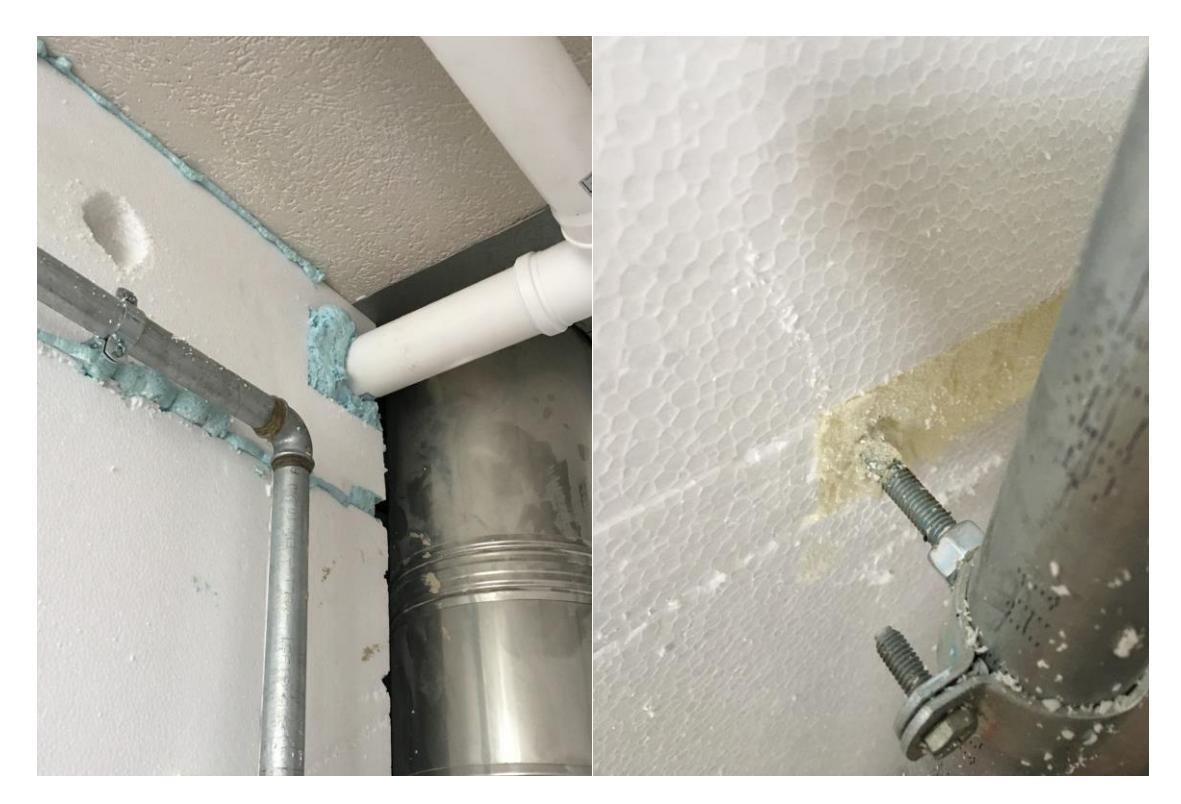
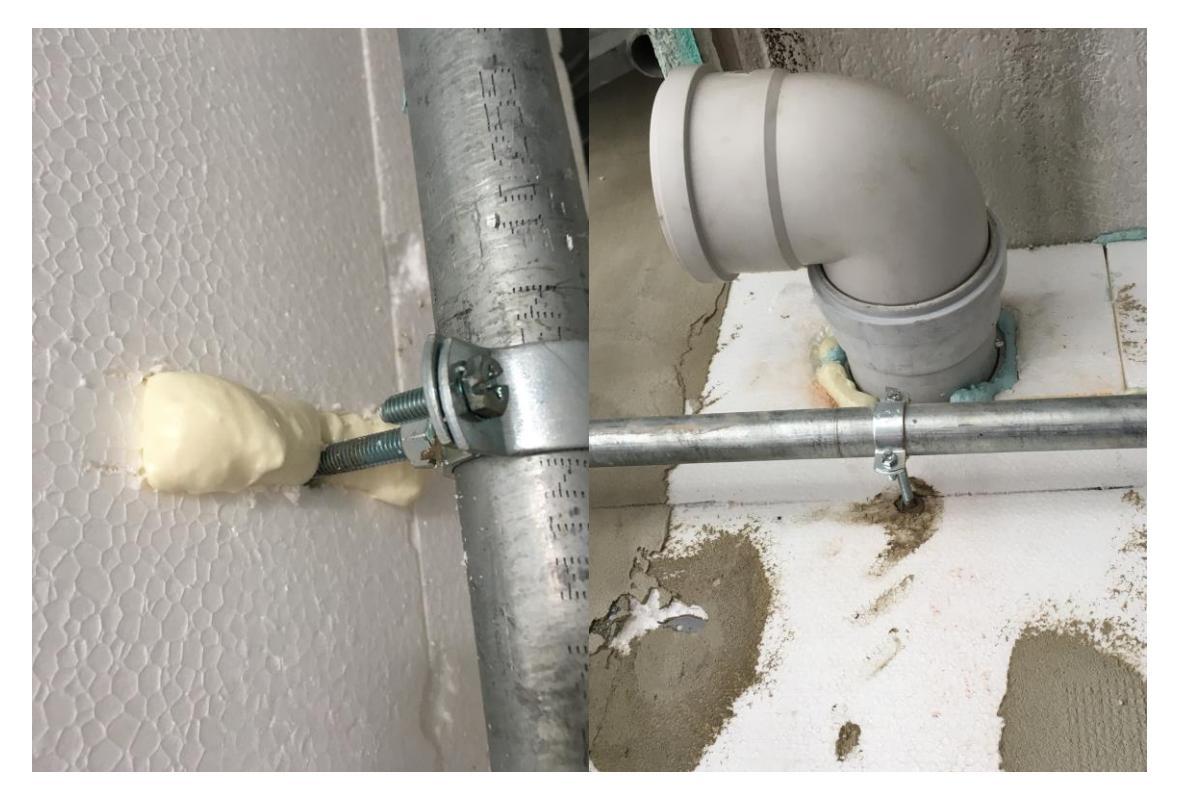
It was noticed during the visit that, whenever there was a perforation in the building envelope, due for instance to pipes or screws, special care was taken to insulate it with foam, to avoid thermal bridging and improve air tightness. The figures below give some examples (finishing is still to be done).

Figure 9. Details of perforations in the building envelope

Figure 10. Details of perforations in the building envelope

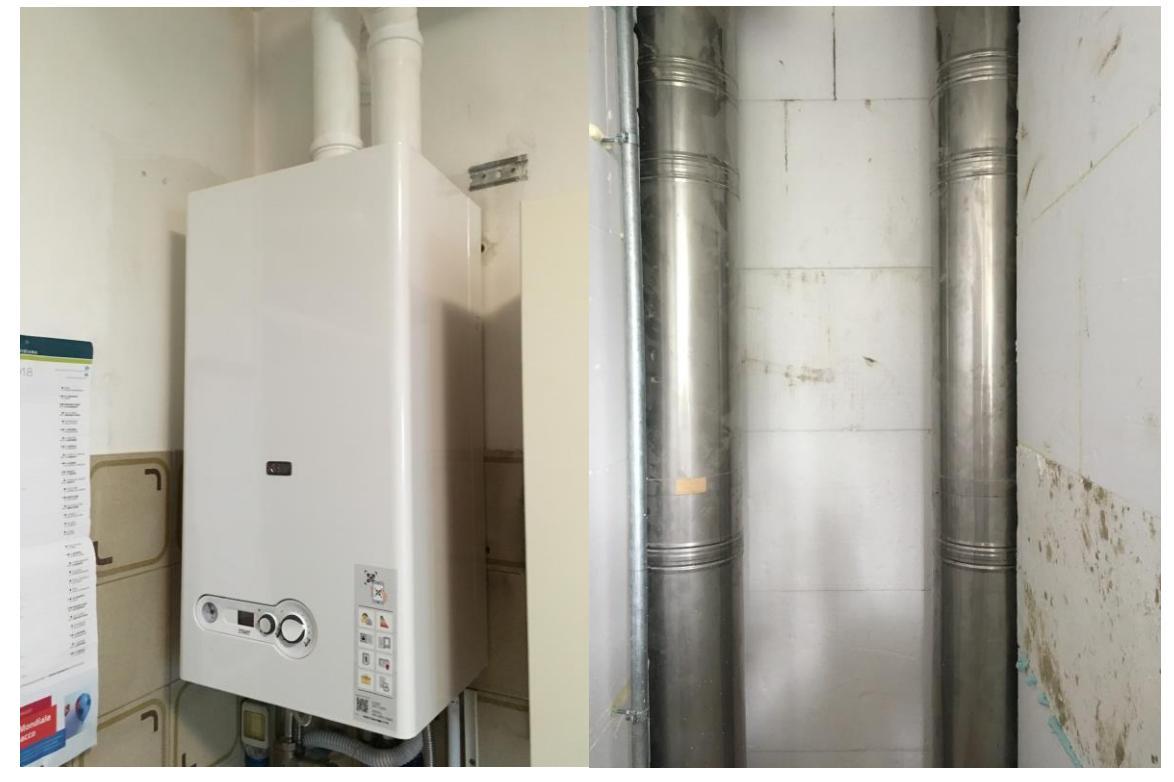
New gas boilers have been installed in the apartments, and the old piping has been replaced since leaks were reported.

Figure 11. New gas boiler (left) and piping system

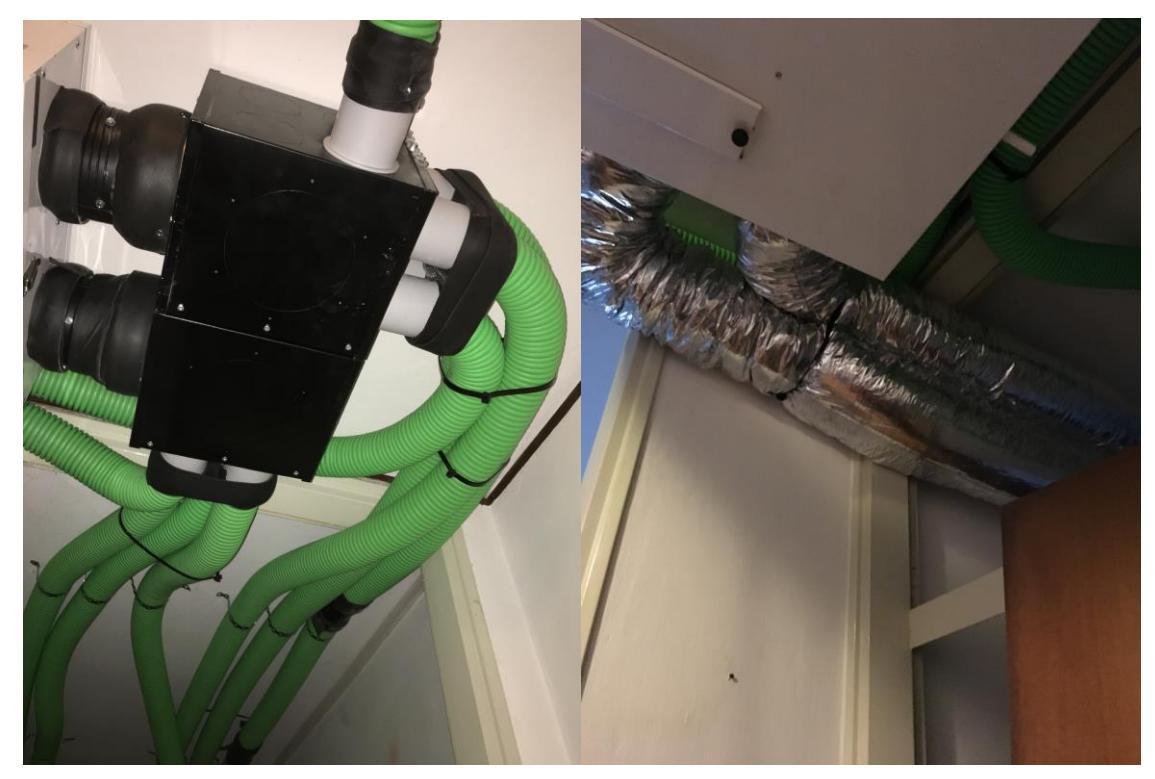
All the works have been performed with the tenant living in the apartments. Mechanical ventilation was also installed, together with a small fuse box for its control. As it can be seen in Figure 12, the piping (well insulated) runs on the ceiling and it will be hidden by a false ceiling.

Figure 12. Air handling unit (left) and detail of insulated air ducting

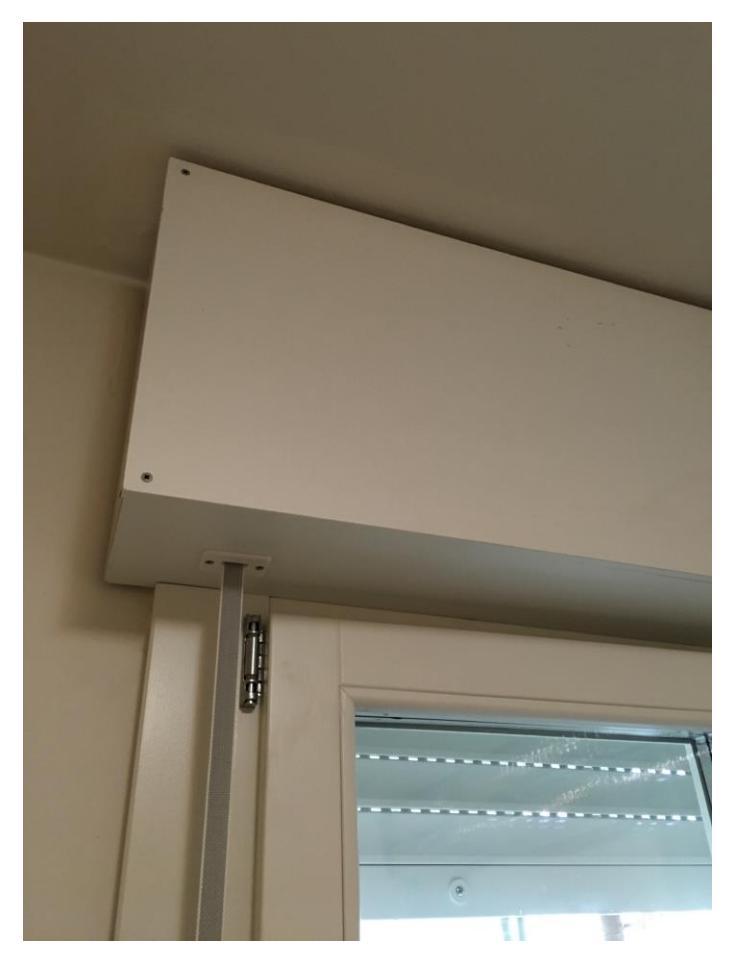
The box containing the roller shutters was also insulated, as it is often overlooked and a critical thermal bridge as the wall is thinner.

Figure 13. Detail of roller shutters box

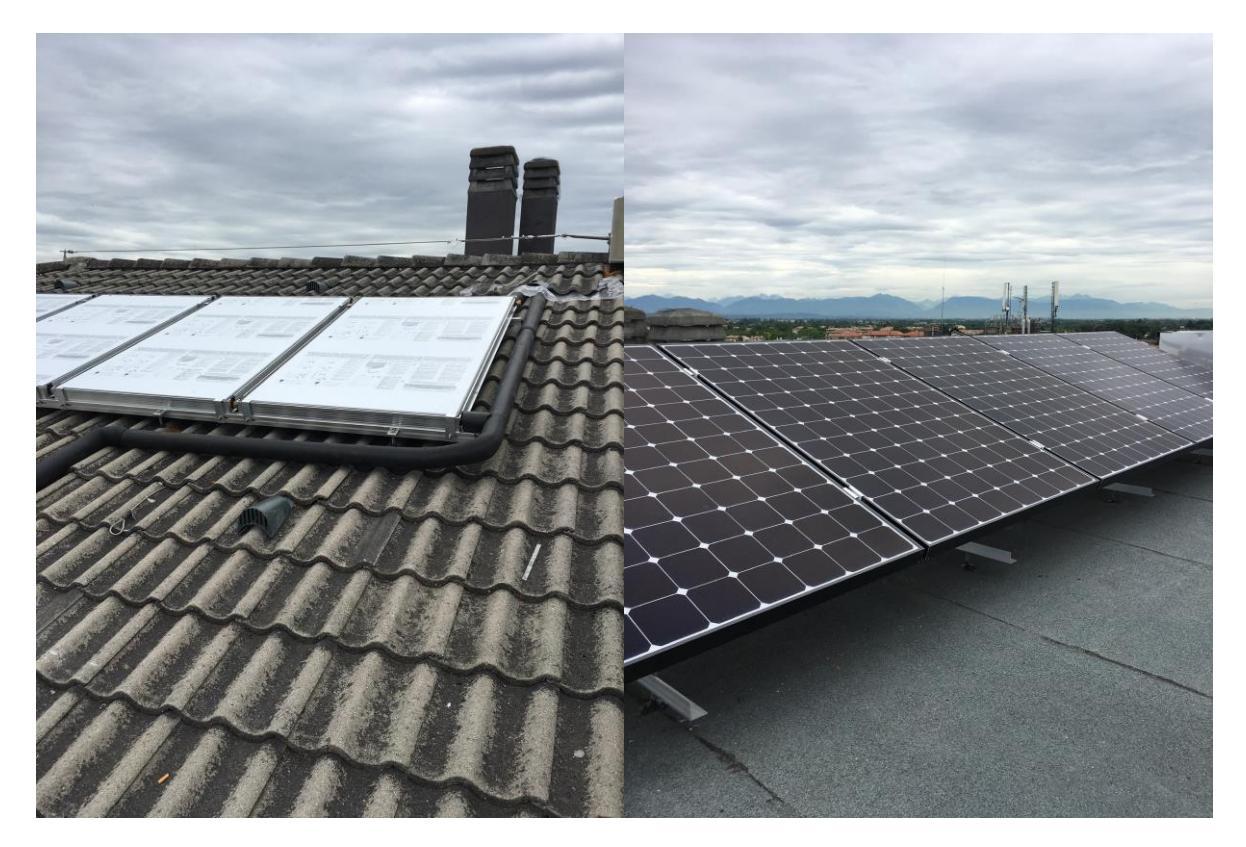
As for the renovation of the roof, the cold attic was insulated with mineral wool, a new waterproof membrane was installed and the roof tiles have been replaced where broken (the ones in a good state were just put back). Then solar collectors and photovoltaic panels were mounted. A metal safety rope was also mounted at the top in order to allow for safe maintenance works.

Figure 14. Solar collectors (left, with the safety rope at the top) and photovoltaic panels

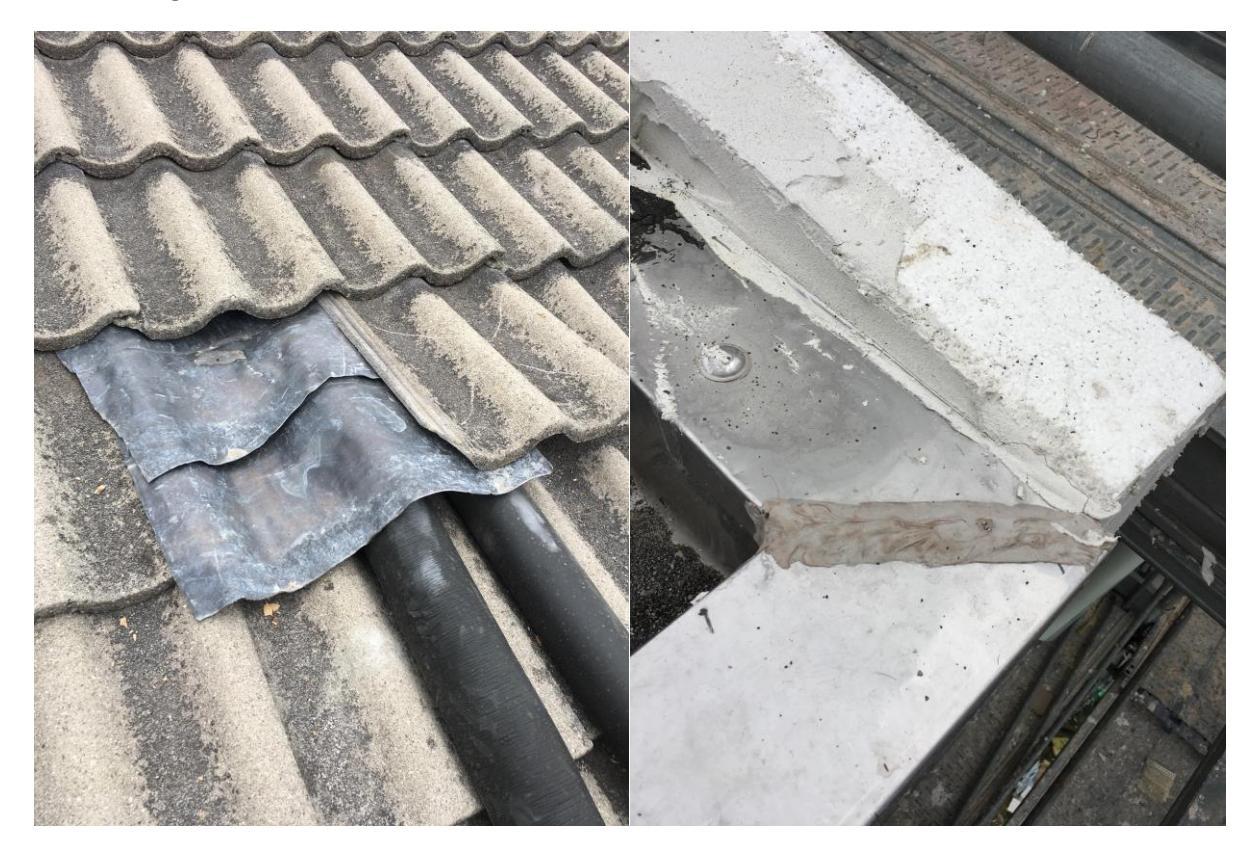
The works were not completely done yet but as far as we could see the details were satisfactory, as shown in Figure 15.

Figure 15. Piping for the solar collectors (left) and gutter detail

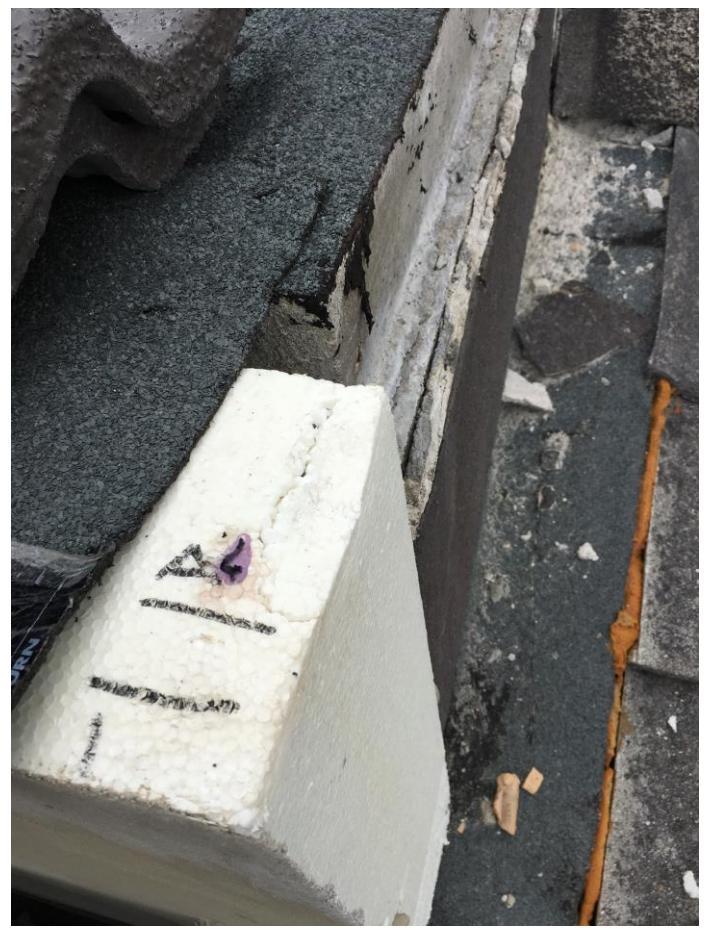
The detailing in correspondence of the EWI was not done yet as the roof felt was installed since it cannot be sealed directly to the XPS.

Figure 16. Detail of EWI at the roof level

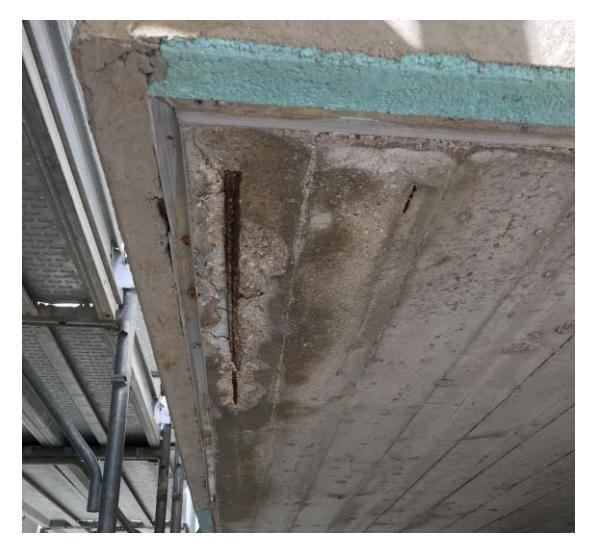
We could notice that repairing works were done correctly, as in Figure 17.

Figure 17. New plaster (blue) on the external wall

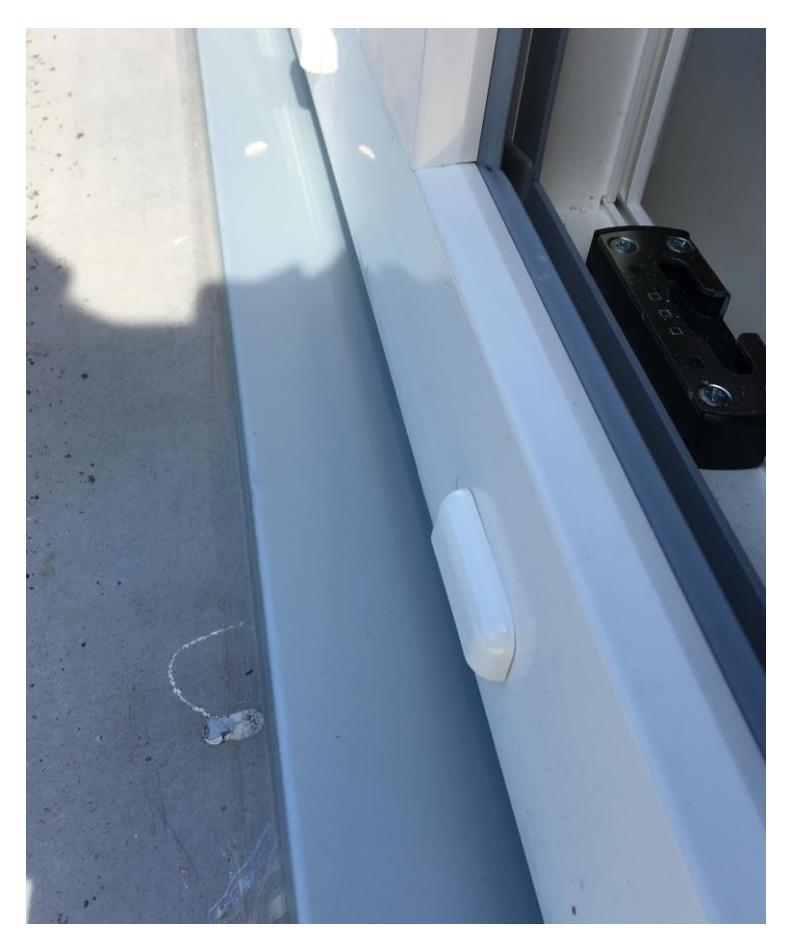
The outside has been sealed correctly, as it can be seen in figure. The silicone seal was still drying at the time of the visit, and we could notice that it was done very accurately.

Figure 18. Outside detail of window sealing

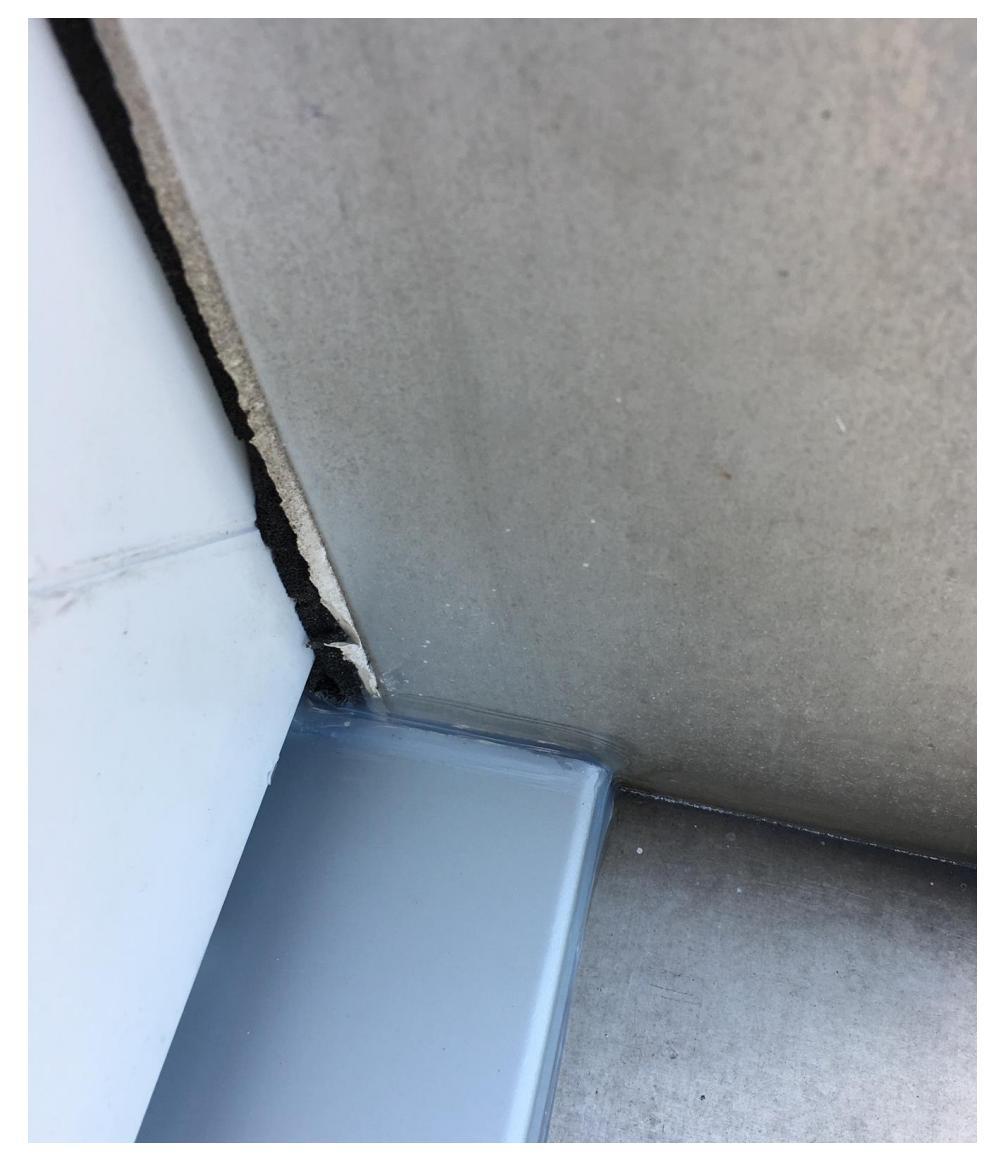
There is still some detailing to do on the outside window-wall connection, as it can be seen in Figure 19.

Figure 19. Detail of lateral window sealing

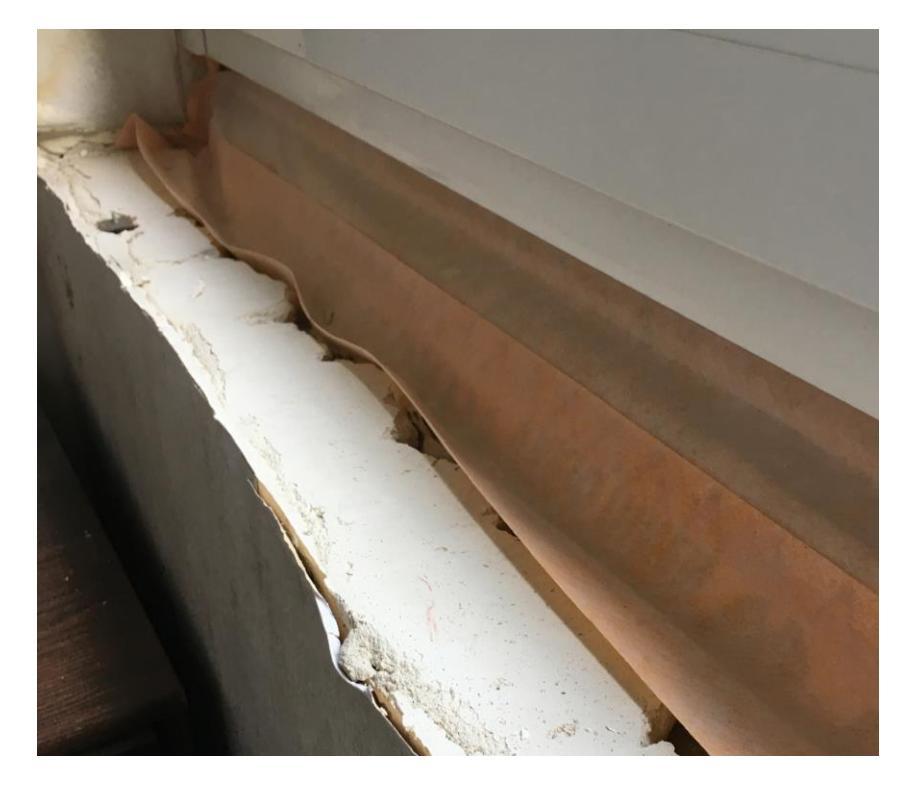
It was possible to see how the air tightness measures were about to be implemented: the foil (in orange in the figure) was exposed before finishing the installation. We noticed that, even though the work is not finished, it could have been done better to guarantee a complete air tightness. As it can be noticed in Figure 20, there should be more foil so that it would be fastened to the flat horizontal part for better adhesion (the overlap between the two sheets is sufficient though).

Figure 20. Window sill detail

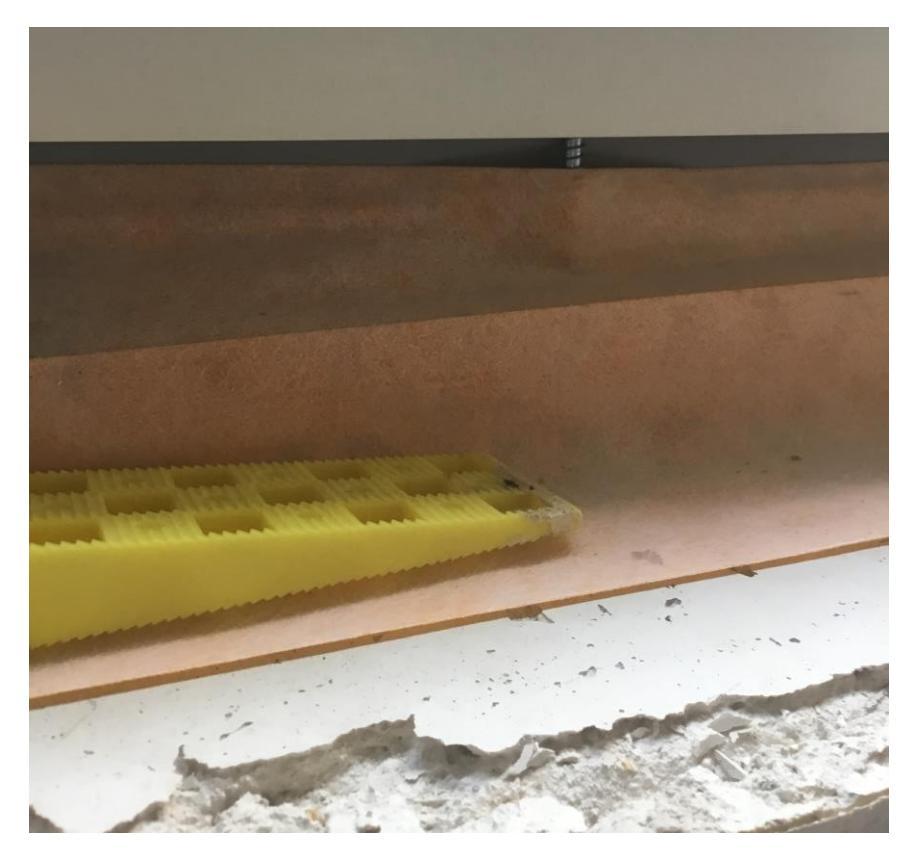
The foil has been installed more correctly in another window, where it has more surface on the sill, as shown in Figure 21. However, it would be recommended to use more foil so that it would cover almost all of the sill for better adhesion and consequent air tightness.

Figure 21. Window sill detail

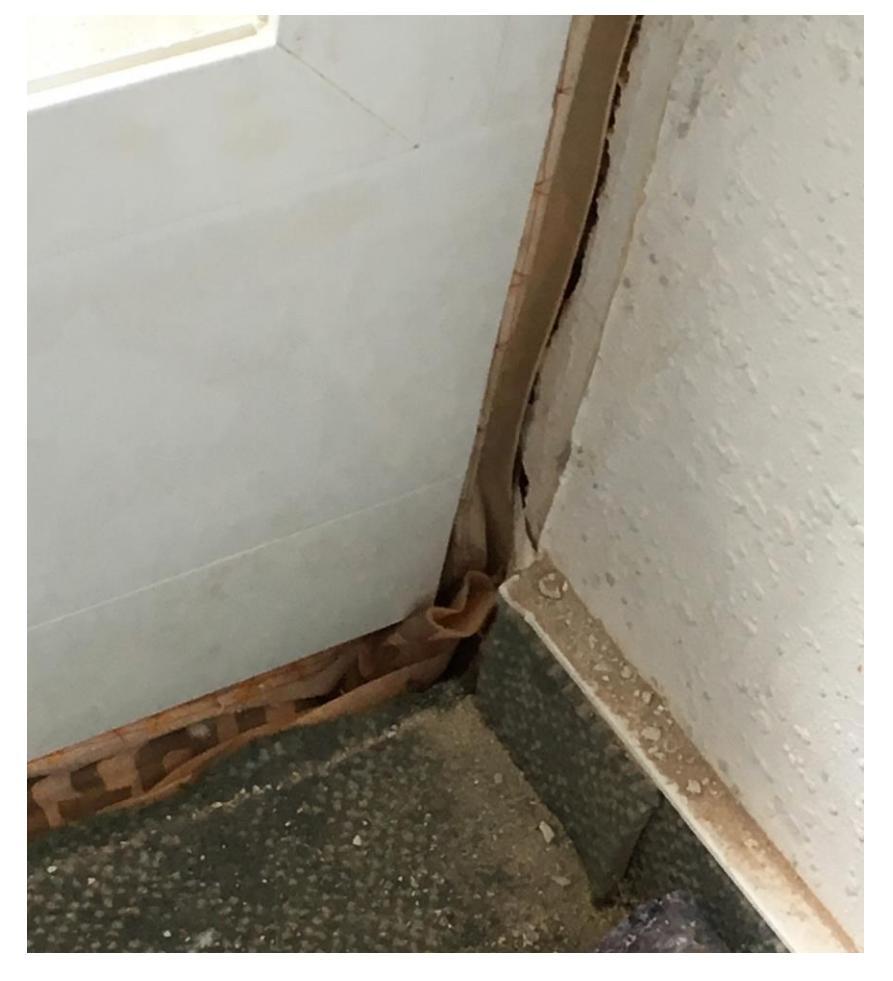
The foil should be also crammed with more care around perforations and joints, as it is shown in Figure 22.

Figure 22. Detail of junction between floor, wall and door window

It can be noticed that the foil is not crammed accurately in the space between the door window and the wall, and there is also space between the wall under the window and one of the screws that were used for the installation, as shown in Figure 22.

A blower door test could be made to check the air tightness of the apartments prior and after renovation, to see the impact of the new windows.

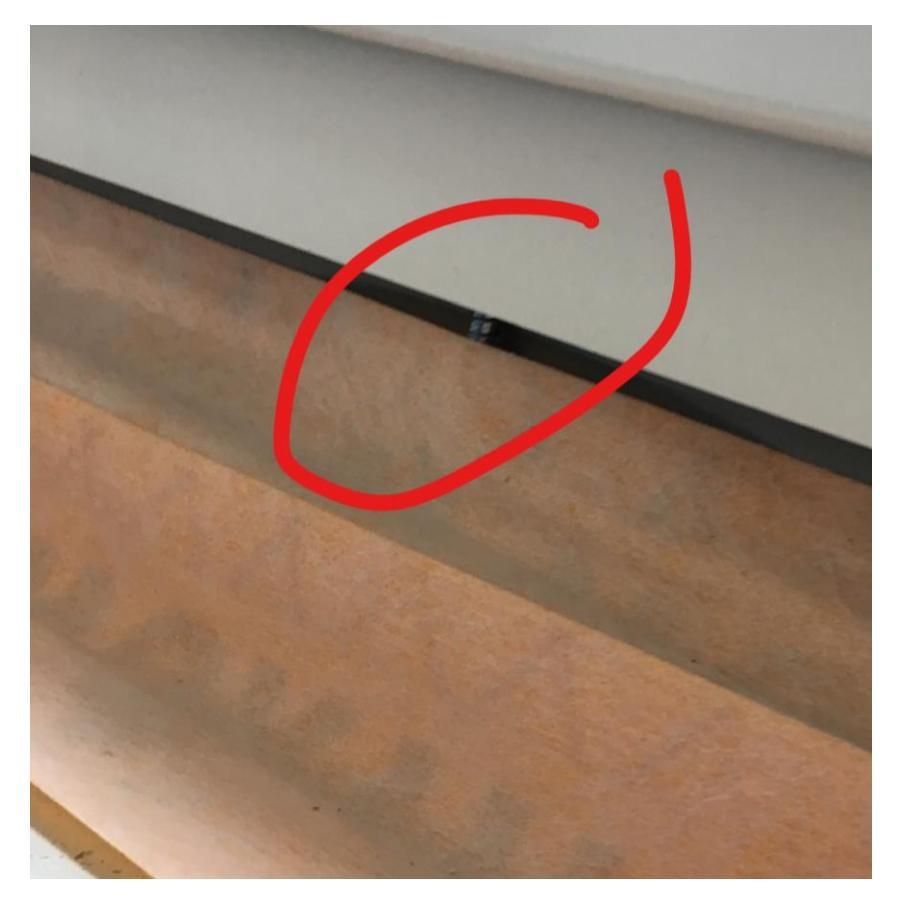
Figure 23. Detail of window air tightness: the red circle indicates the position of the screw

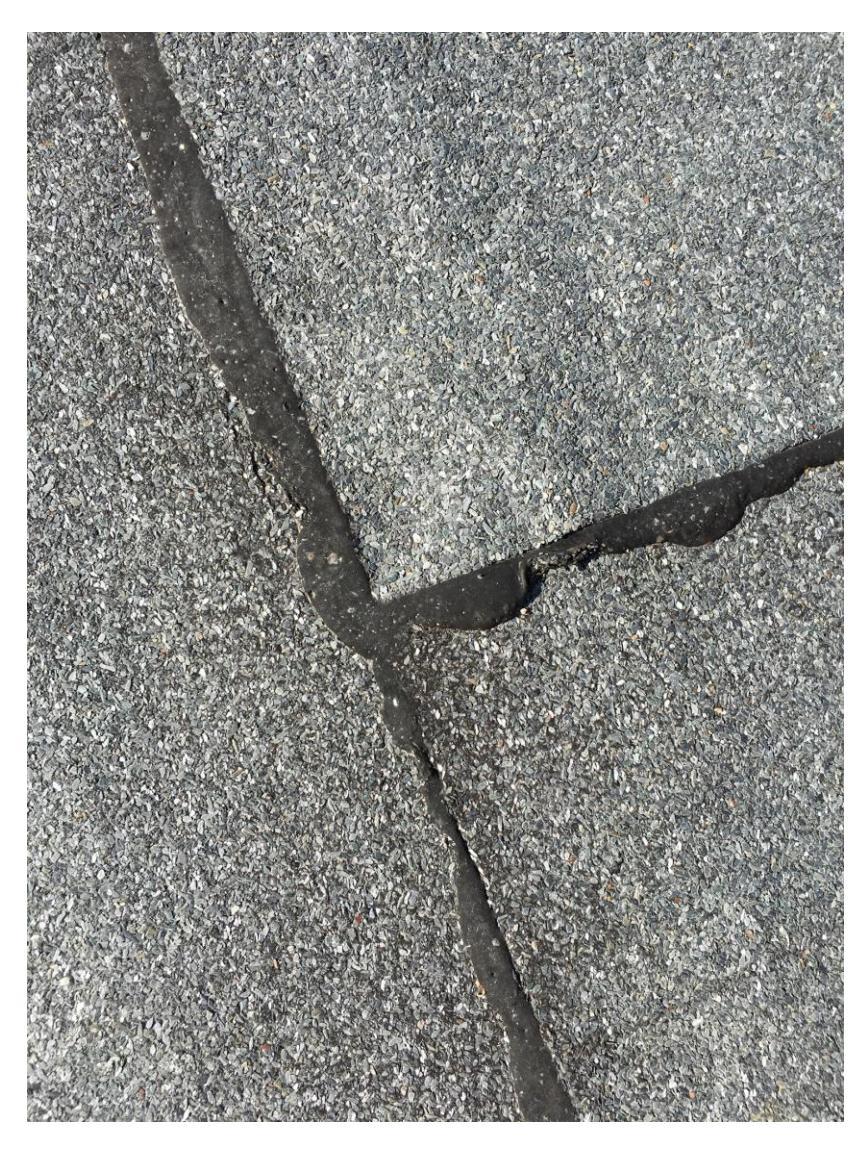
At the time of the visit, the works were completed: the roof was provided with insulation and a new covering to allow the installation of solar panels (the works have not started yet). Overall the work was done correctly, and it looks like the sealing of the roofing felt is watertight, as shown in Figure 24.

Figure 24. Details of joints in roof covering membrane

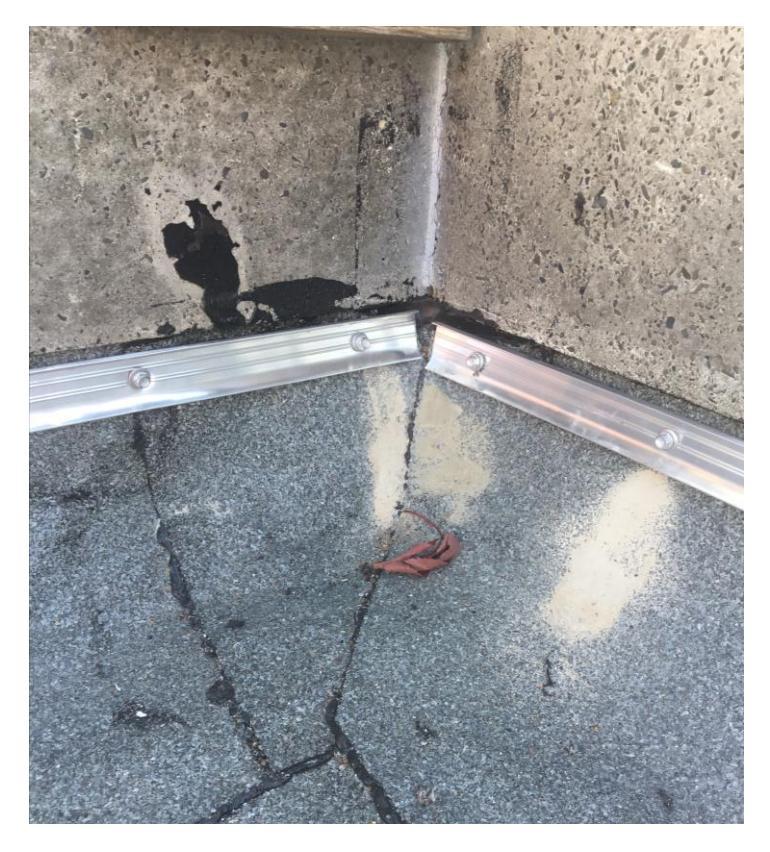
There are some details though that might not ensure a perfect water tightness of the roof, especially at the sides, as shown in Figure 25.

Figure 25. Detail of metal plates and corner joints in roofing membrane

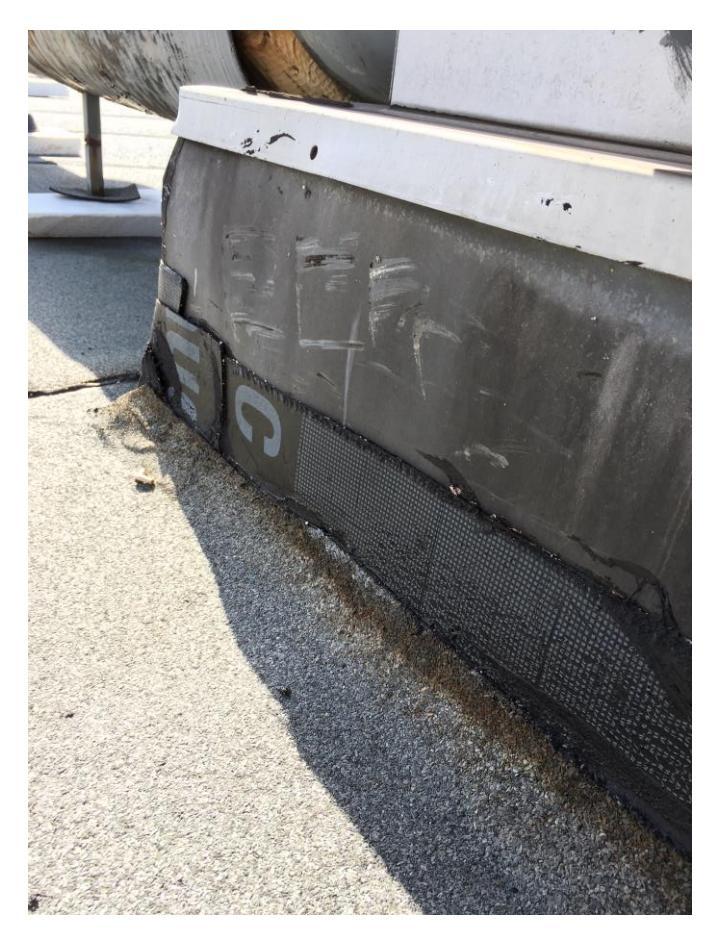
Some parts still needed the finishing details, as shown in Figure 26.

Figure 26. Unfinished border detail

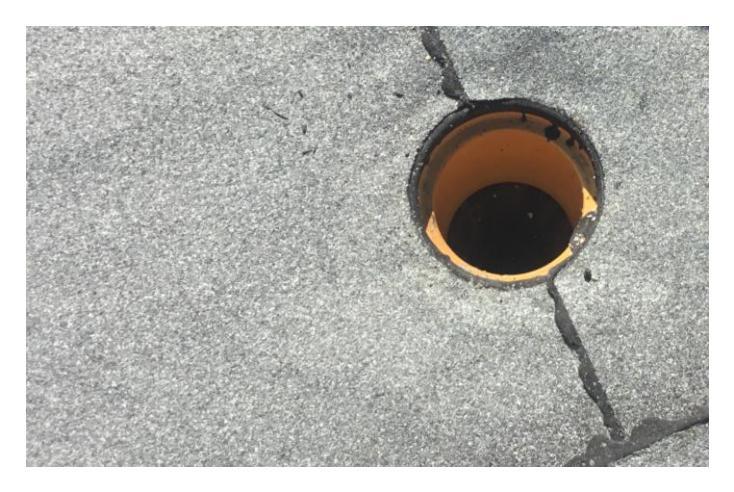
Since there are some pits for runoff of rainwater, as shown in figure Figure 27, it would be interesting to see if some kind of test had been planned to make sure that they happen to be at the lowest level in the roof surface for correct functioning and to prevent rainwater from staying on the roof after precipitations.

Figure 27. Pit for rainwater runoff
