Second site visit

D 3.5

PROJECT INFORMATION	
Project acronym	DREEAM
Grant agreement number	680511
Project title	Demonstration of an integrated Renovation approach for Energy Efficiency At the Multi building scale

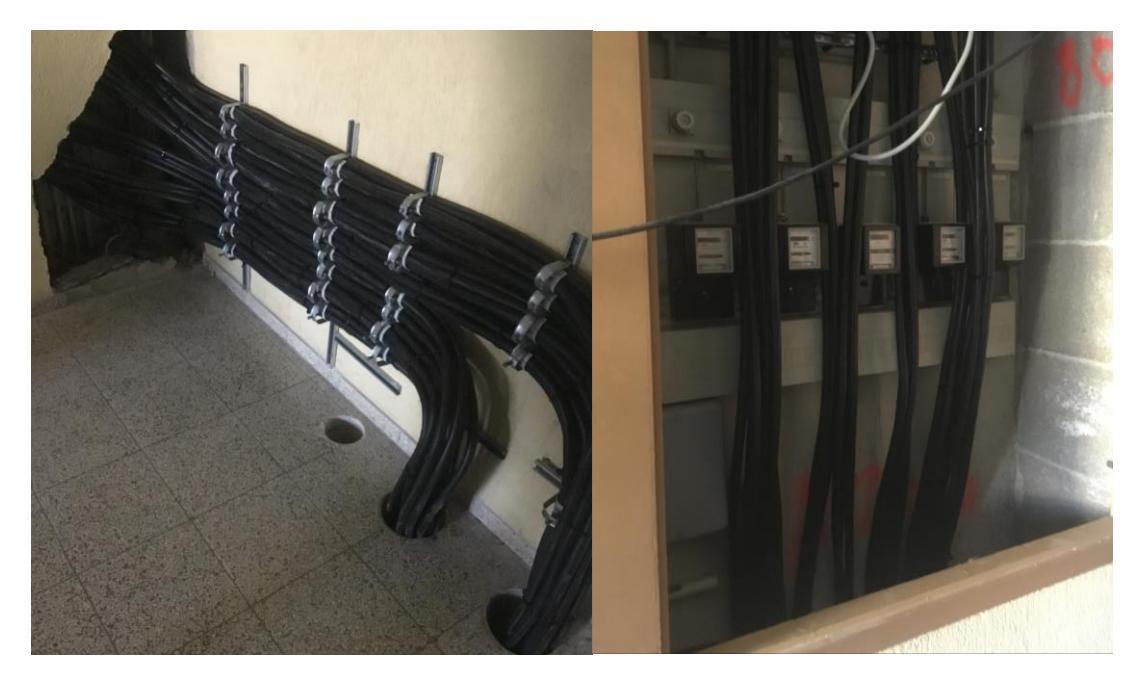
In order to use the electricity that will be produced by the PV panels, the apartments were being provided with new energy meters and cabling necessary for its distribution.

Figure 28. Cabling and meters

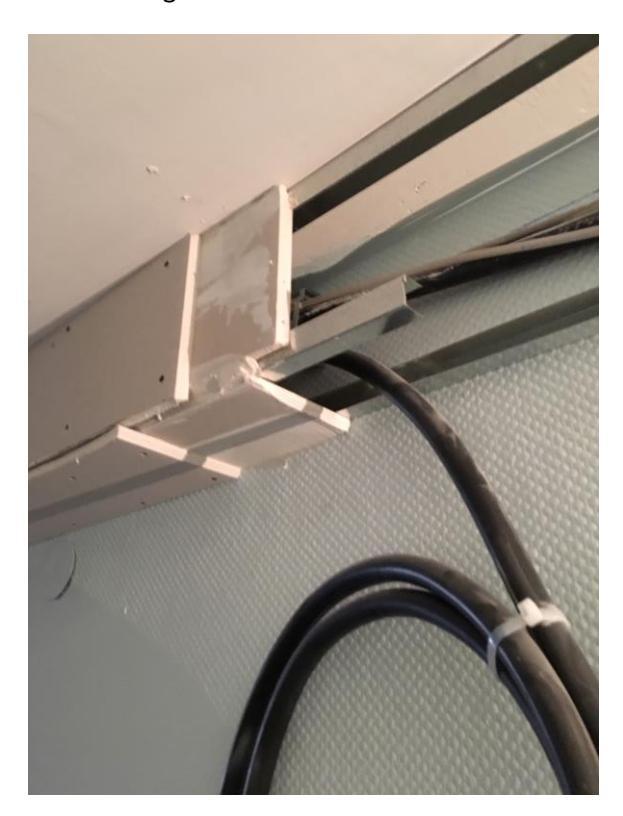
The cables are being routed in the apartments, through a wooden structure with metallic guides, as shown in Figure 29.

Figure 29. How the cables are laid across the floors

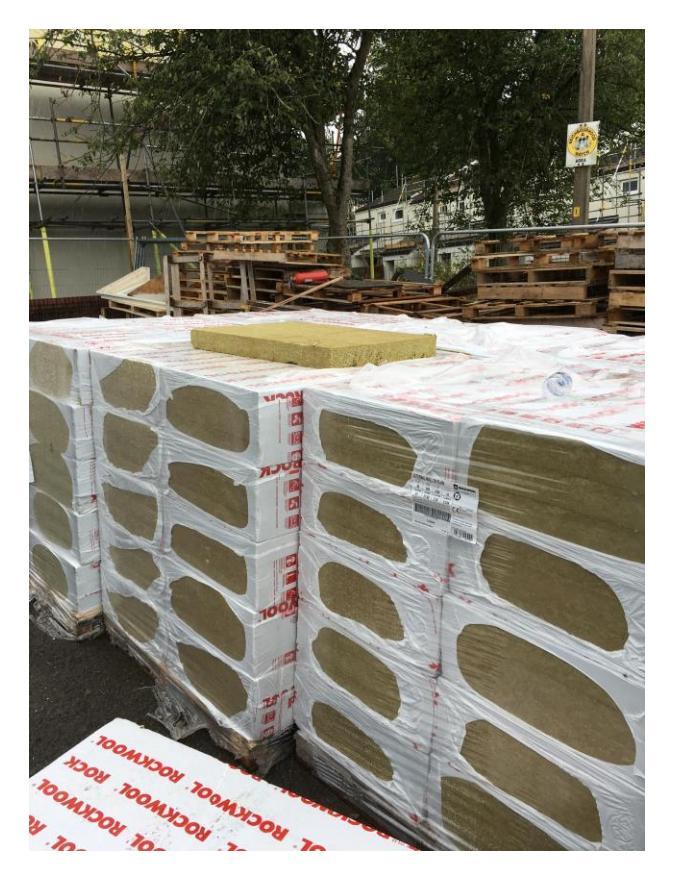
We noticed that only mineral wool was stored outside exposed to rain, see Figure 30. It was still wrapped in its original packaging so there was no problem with that. Mineral wool is a material that is not affected by water anyway so there was no risk for damage (but it should be dry at the time of installation).

Figure 30. Mineral wool storage

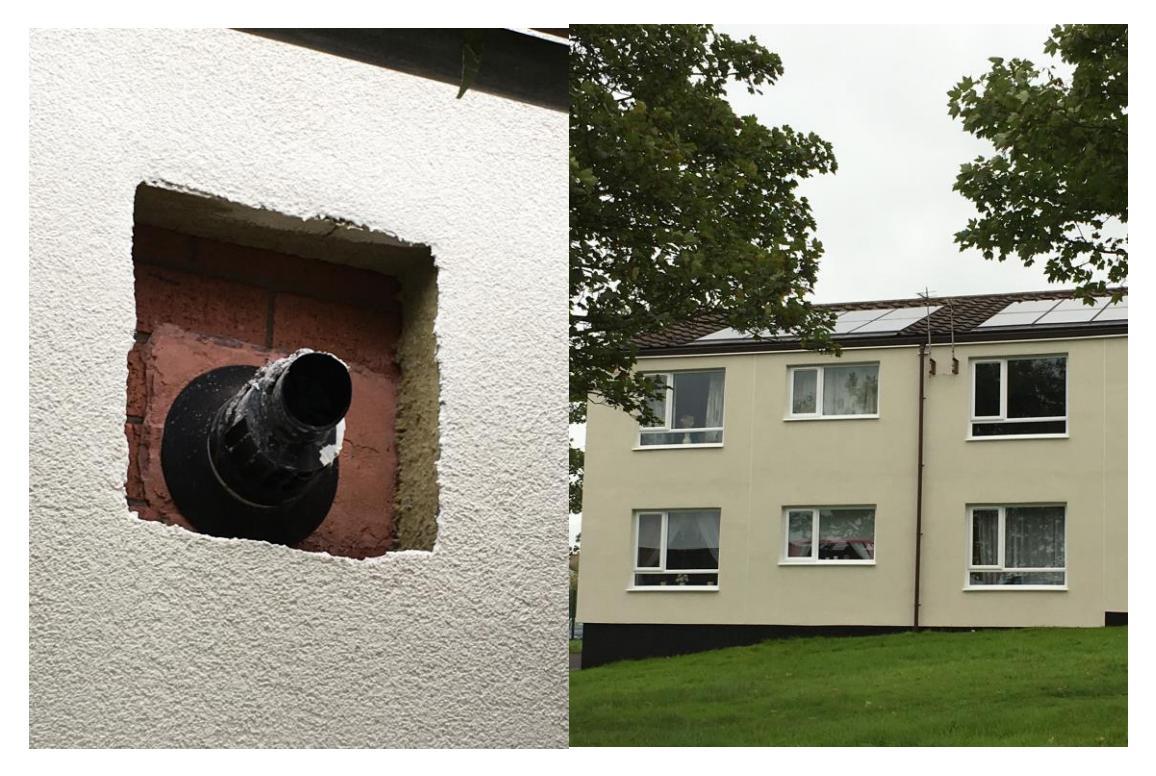
The EWI was installed on the existing brick wall and rendered, as seen in Figure 31 where the detailing is still to be done. That resulted in a complete facelift of the district.

Figure 31. Detail of external wall insulation (left) and the result on a completed house

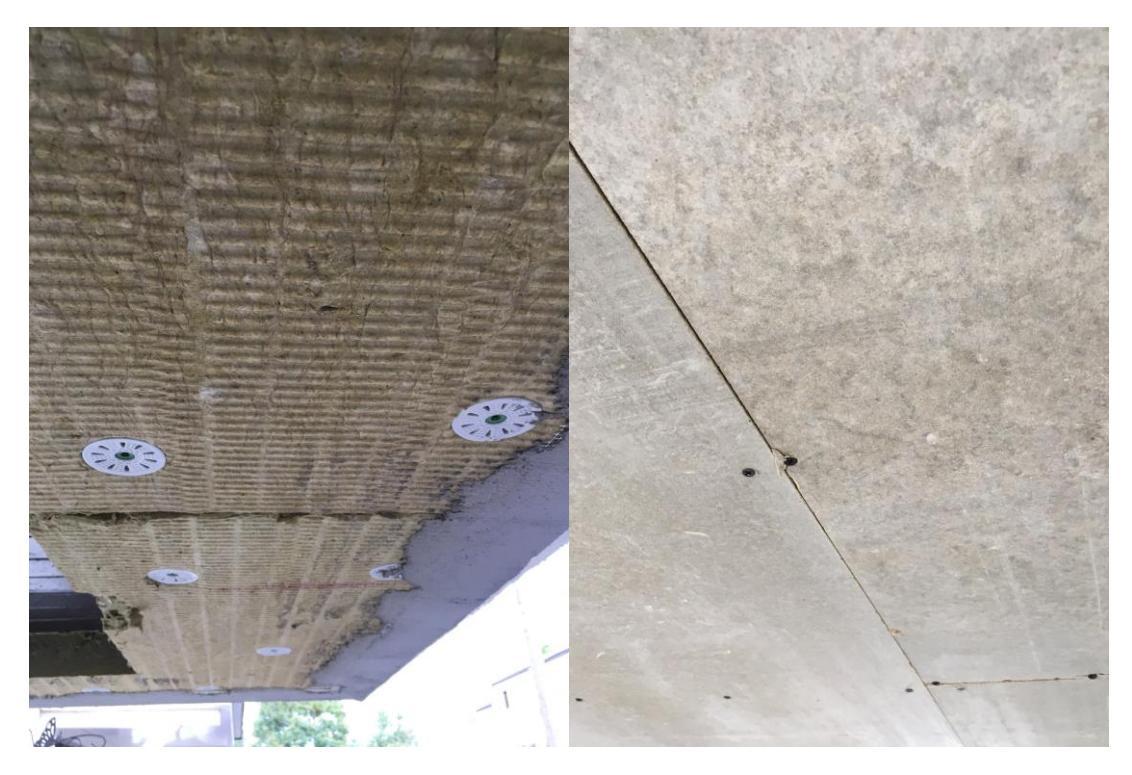
There is still some work to do in the passage under some houses but the insulation was anchored correctly to the existing substrate. It will not be rendered but rather fixed with boards, as shown in Figure 32.

Figure 32. EWI being installed in the passage, and the completed work with wooden boards

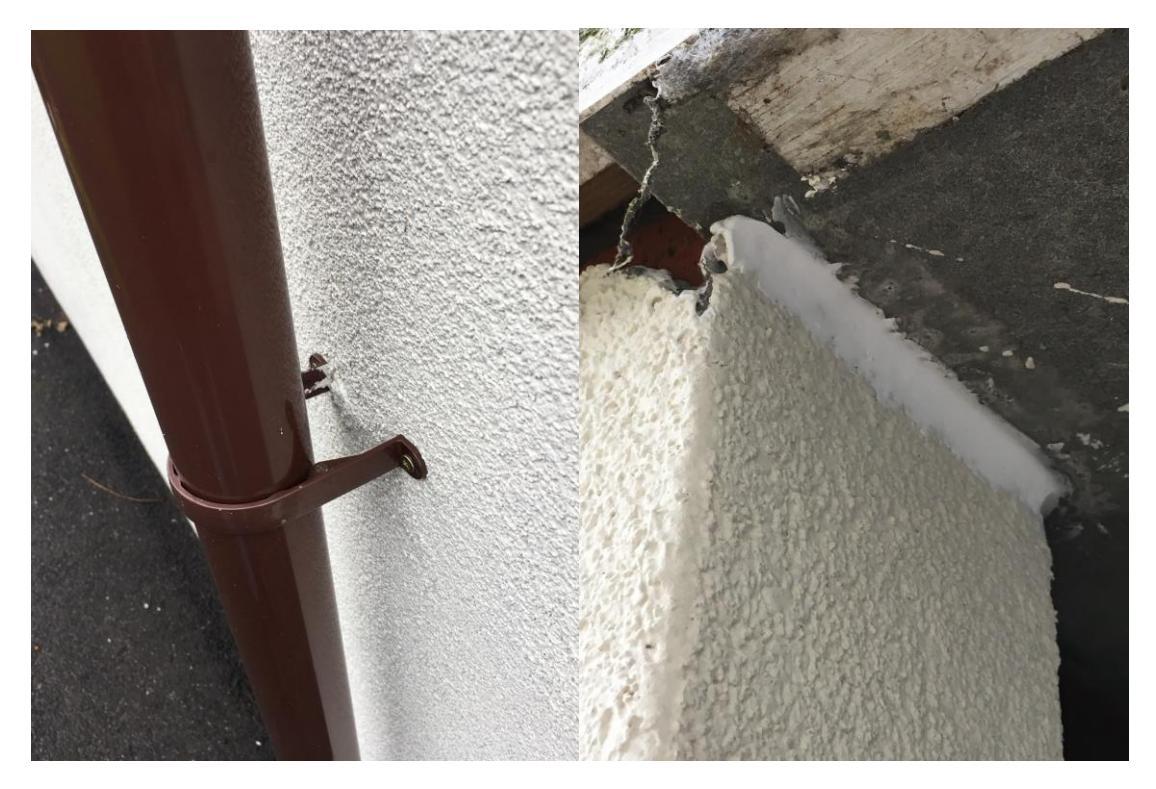
The work is being done with satisfactory attention for details, to prevent moisture related problems. Critical points as junctions and perforations are being sealed, as shown in Figure 33.

Figure 33. Details on the building envelope

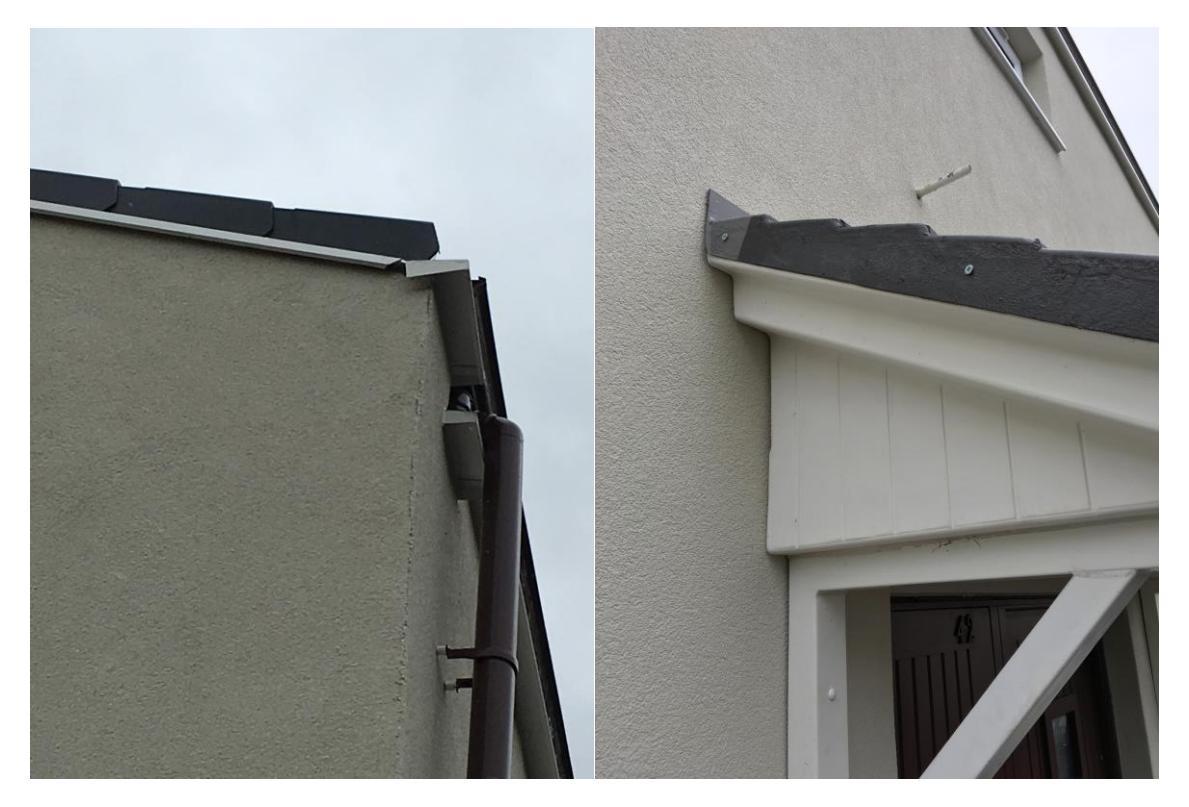
The absence of a protruding roof exposes the building somewhat more to rain but measures were taken to ensure moisture safety, as shown in the detail around the roof fascia and above the entrance

door, as shown in Figure 34. We could not get to the roof, but it looks as if there is enough margin for the metal plates to extend over the joints.

Figure 34. Roof fascia detail (left) and door entrance. Notice the position of the metal plates

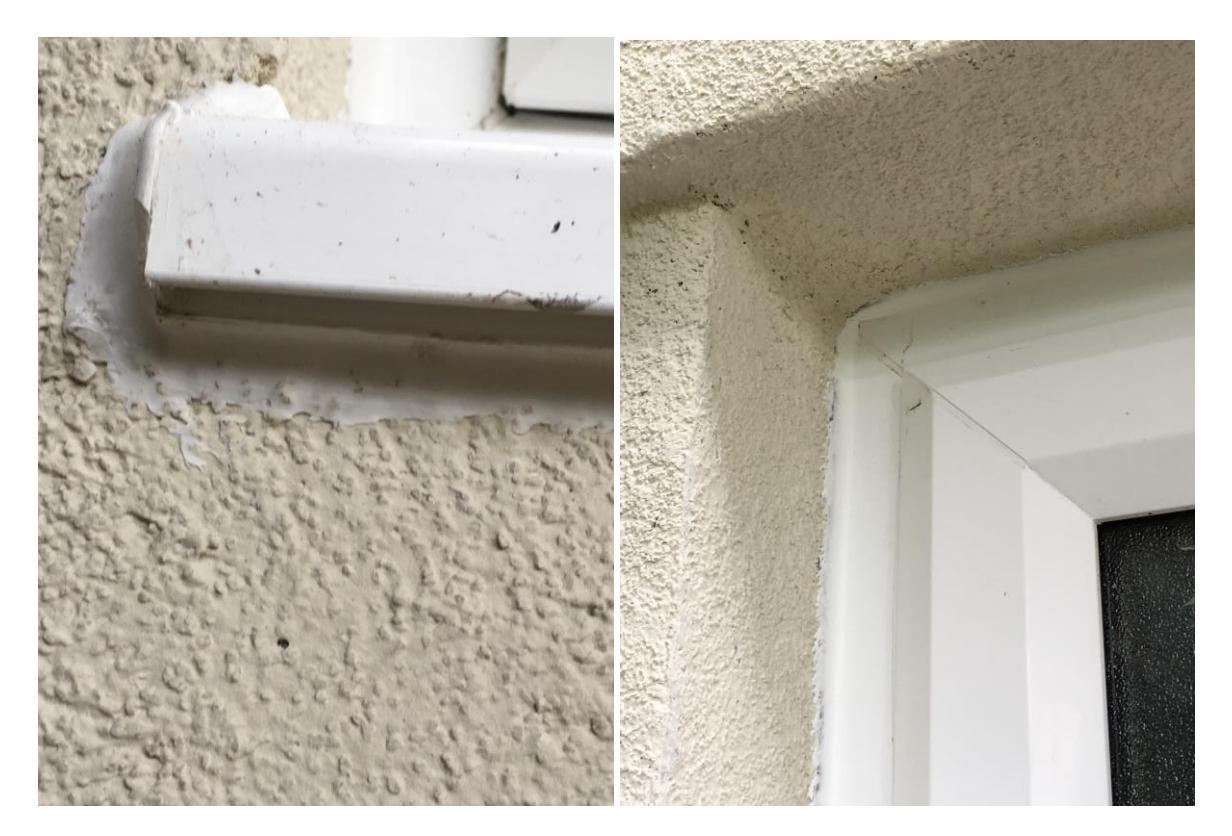
What we could assess in more detail is the window installation. We could not follow the very installation itself as we did in Berlin but the result looks good, as the sealings around the frame and sill are done correctly on both sides, as shown in Figure 35 and Figure 36.

Figure 35. Windows detail, outside

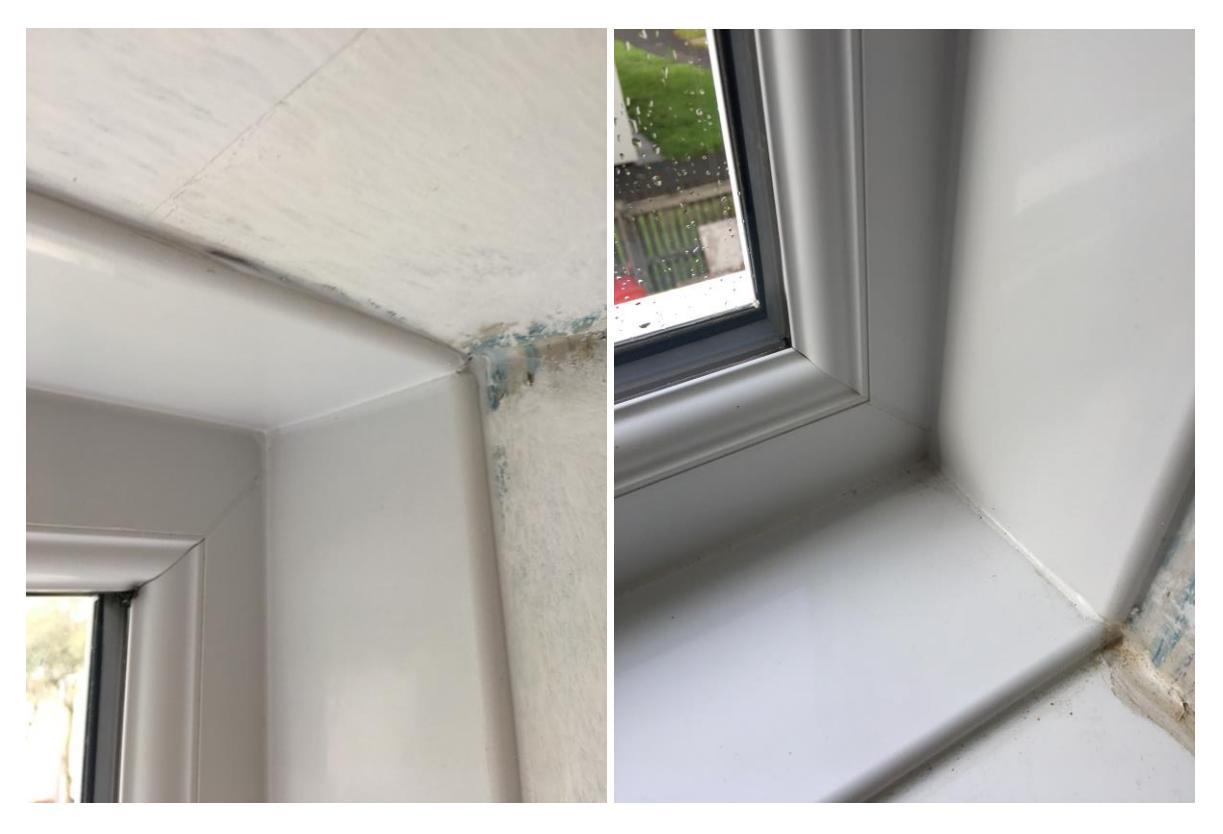
Figure 36. Windows detail, inside

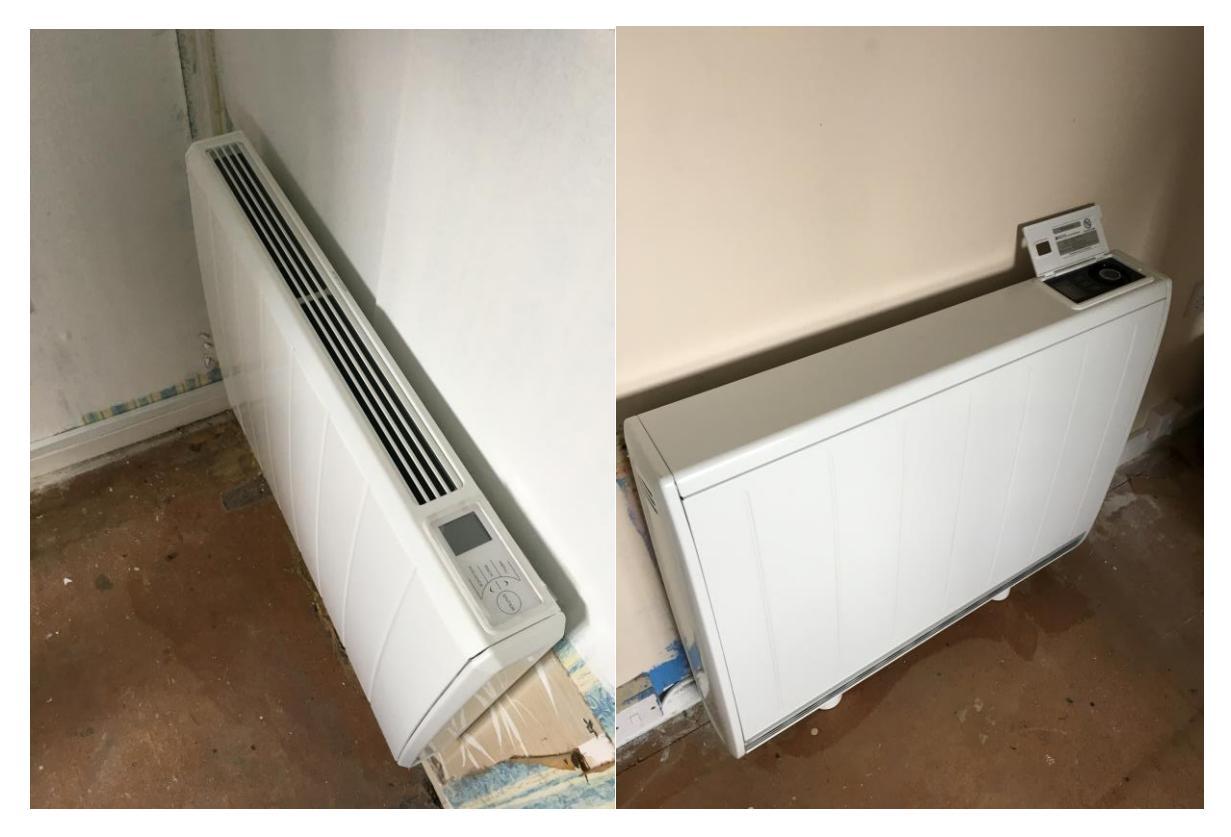
Radiators were being installed in the correct positions, according to plans, as shown in Figure 37. It is possible to set the temperature and to program them. There is a small electric heater in the bathroom as well just for enhanced comfort.

Figure 37. New installed electrical radiators

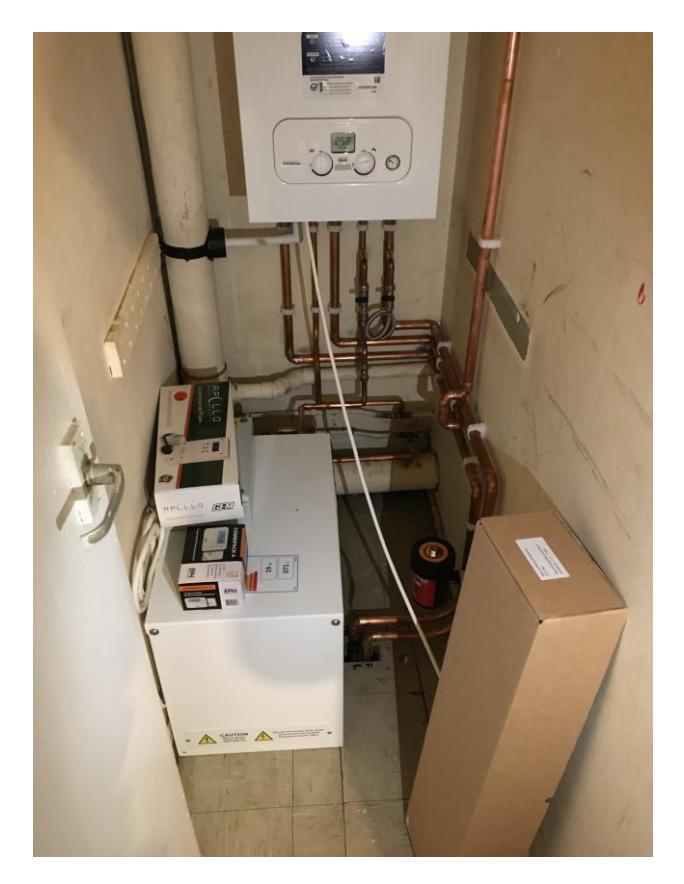
New efficient boilers were installed in all properties, depending on if they were electric or gas-fired. They are also better insulated than the old ones, which accounts for an improved energy savings. In a dwelling an innovative gel-based heat exchanger (the box on the ground in Figure 38), basically a heat battery that will work with any heat source, is about to be tested. It is connected to the photovoltaic system and uses the electrical charge provided by the panels to set the heat off.

Figure 38. New boiler and Sunamp heat battery box

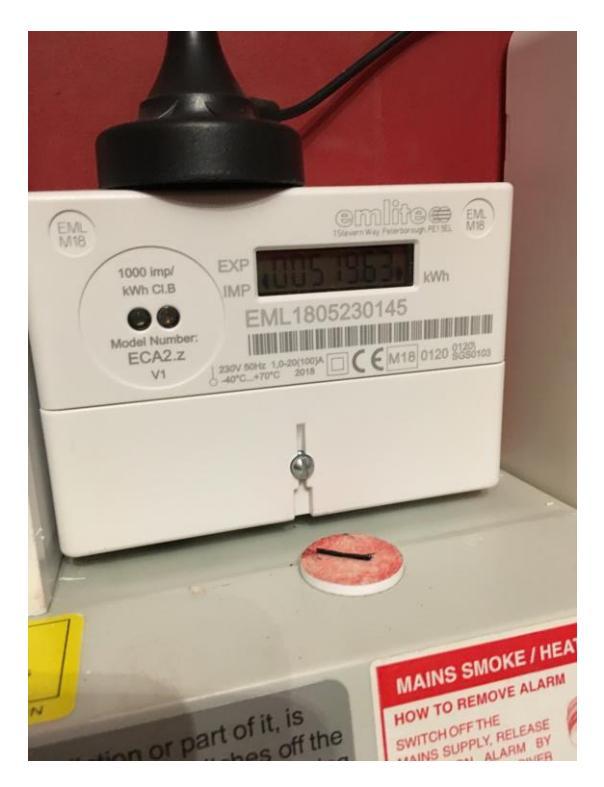
In the buildings where photovoltaic panels are installed (1.2 kWp), there is a small panel where the tenant can check the energy production.

Figure 39. Panel for photovoltaics energy production monitoring

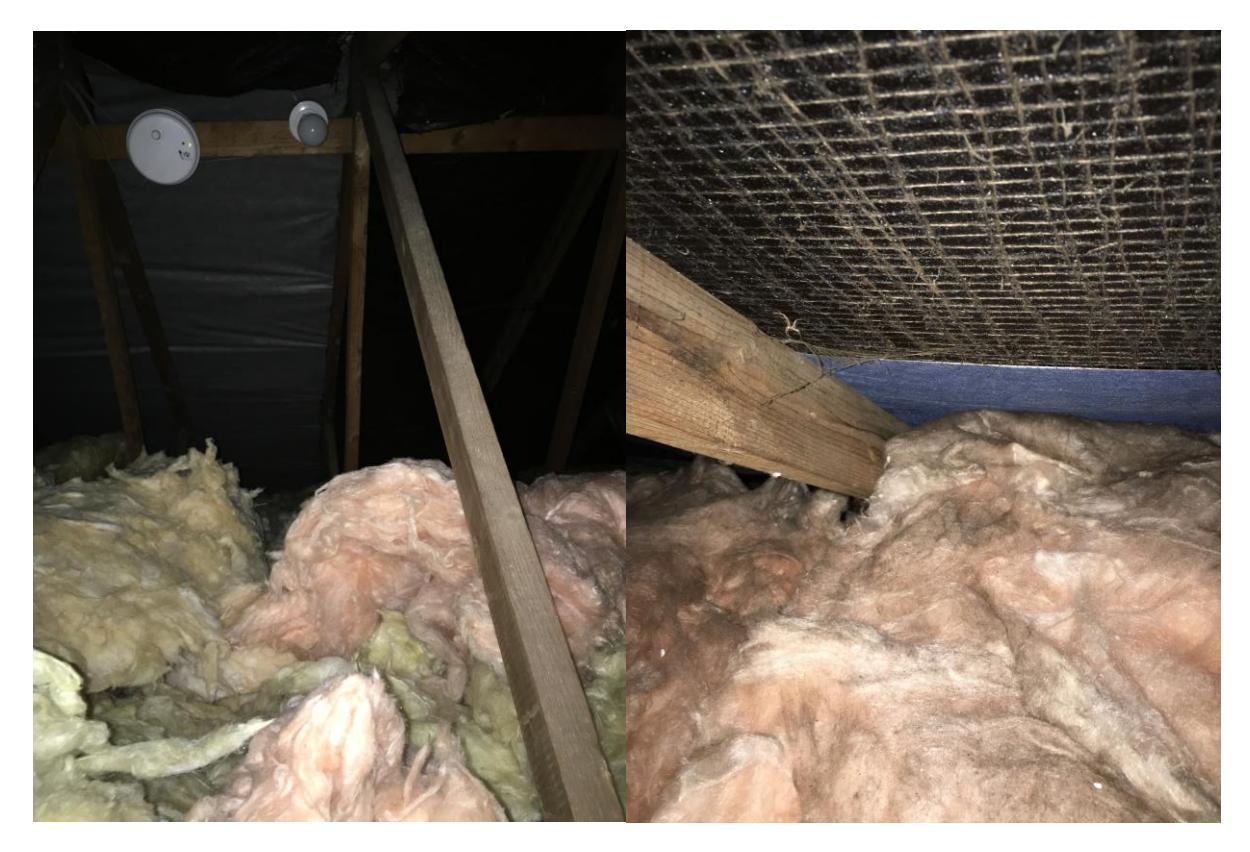
The new mechanical ventilation unit is installed in the cold attic, which has been insulated with loose wool, as it can be seen in Figure 40. Since the inverter for the solar panels is mounted there, a smoke detector was installed for safety. We noticed that the wool is put in a somewhat disorderly way but it should not be a problem as long as the minimum thickness is ensured and it does not interfere with the air intake duct.

Figure 40. Cold attic insulation. Notice the smoke detector (left) and the weatherproofing close to the roof eave (right)

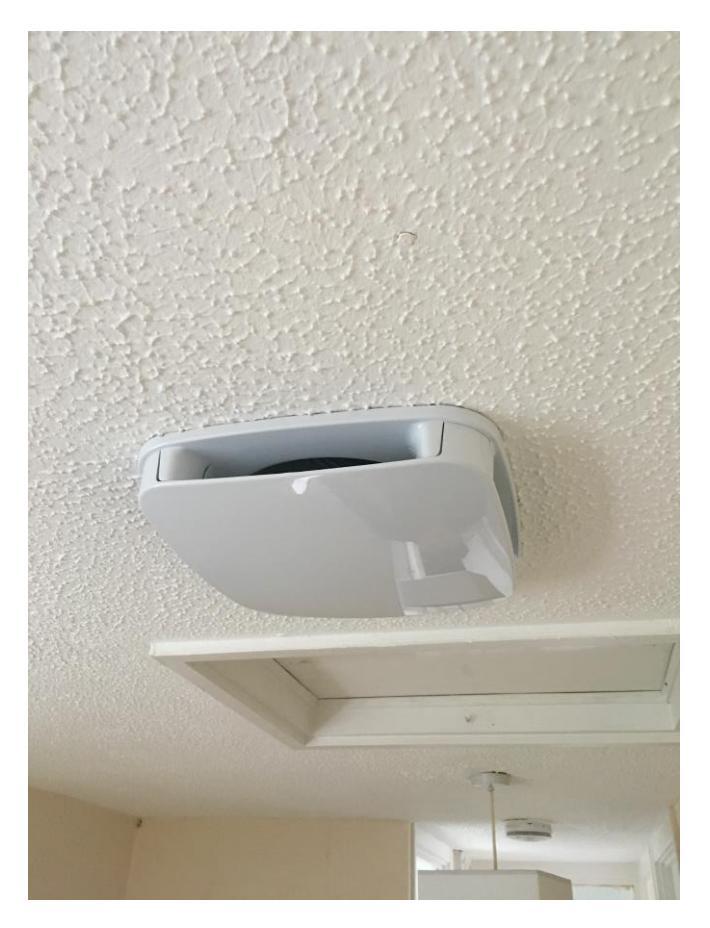
The ventilation concept is to have something "semi-passive": the most important feature of the ventilation system is to take humidity out of the building. Figure 41 shows the air intake inside the dwelling, located on the second-floor ceiling.

Figure 41. Ventilation terminal on the 2nd floor ceiling
