Finalisation of the renovation works

D 3.7

Project acronym	DREEAM
Grant agreement number	680511
Project title	Demonstration of an integrated Renovation approach for Energy Efficiency At the Multi building scale

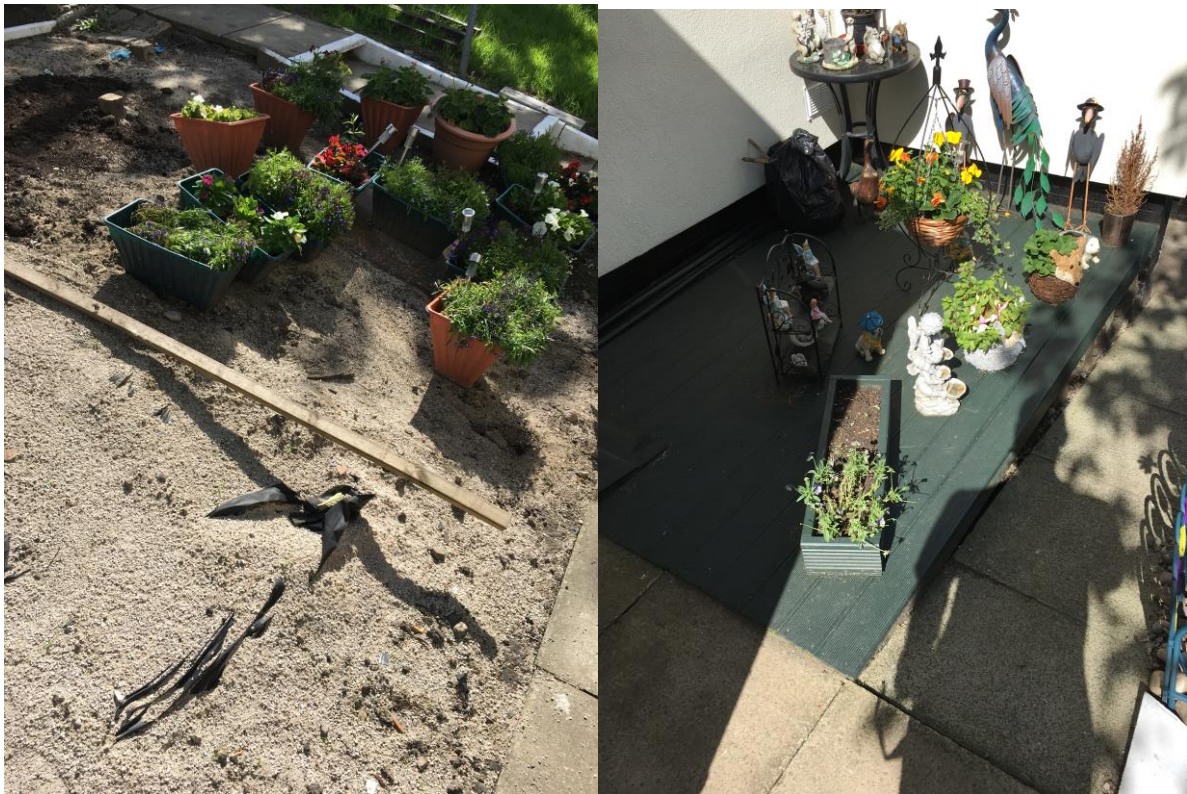
in case they have any complaints or remark, without going through the call centre: this is a strategy that worked especially with “difficult” tenants that prefer to rely on a personal relationship with the housing association. Mr. Patel told us that the contractors agreed to put some in-kind input to perform some little additional works on the tenants’ request, a sign that now tenants are caring more for their renovated houses and take pride in making it look good. One example is that people are now doing more gardening, as shown in the picture below (taken with the tenants’ permission). Improving the housing conditions is therefore an excellent way to tackle social isolation and the starting point to begin solving some of the problems that nowadays affect troubled suburbs.

Figure 24. Some neighbours have rediscovered the pleasure of keeping a blooming garden. The flooring in the right picture was done as in-kind contribution by the contractor, under request from the tenant.

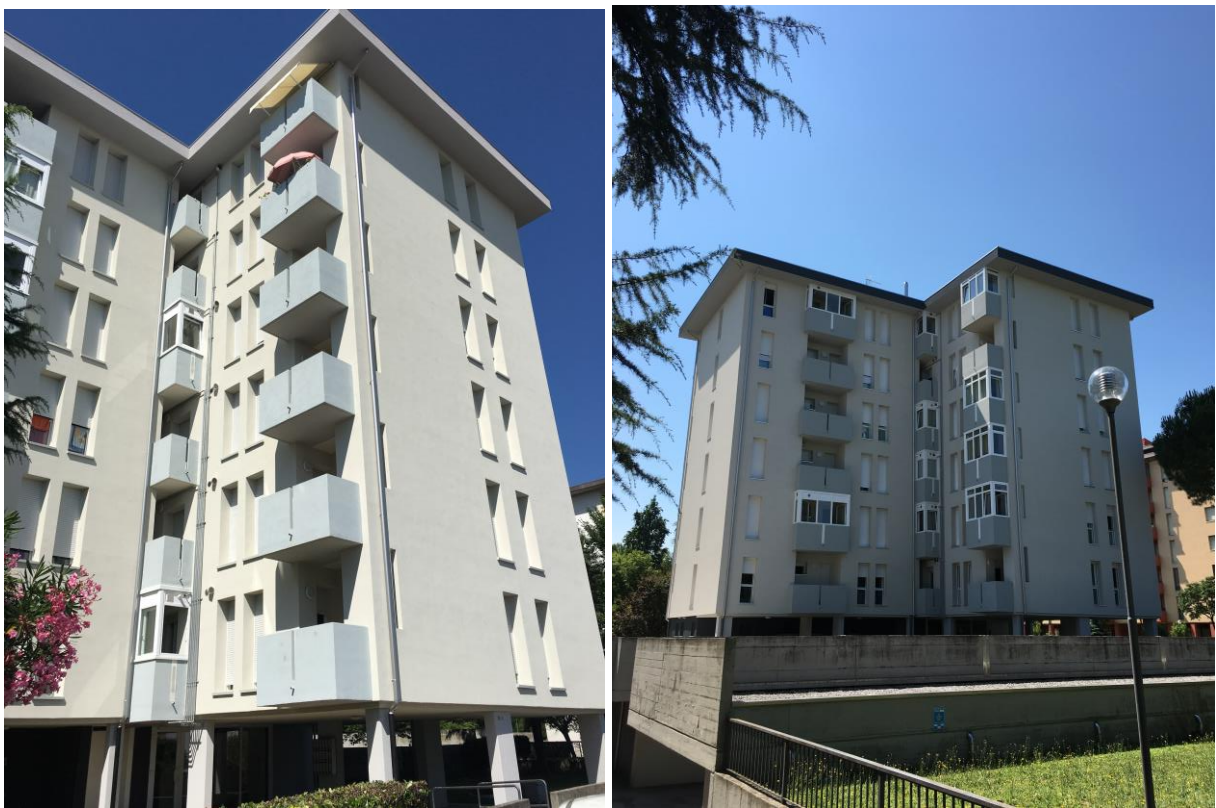
Now that the scaffolding has been removed, it is possible to see how the towers look with the new EWI, as shown below.

Figure 25. View of the renovated towers

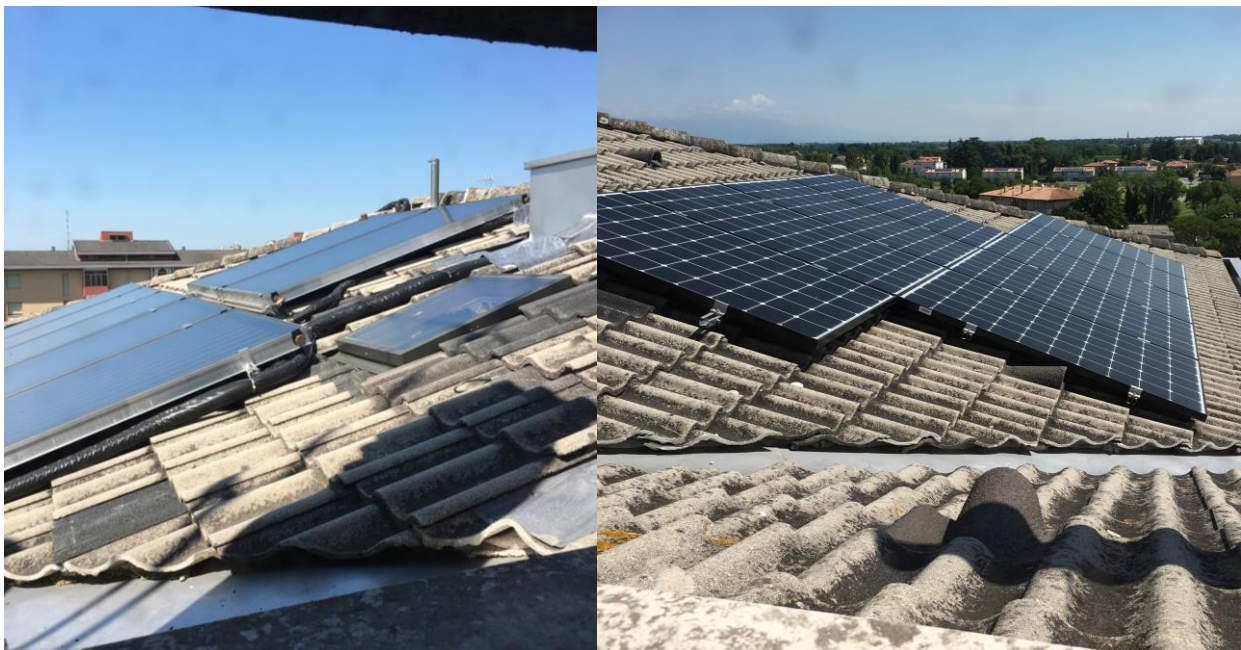
Both the photovoltaic panels and solar collectors have been installed on the roof, which was not possible to inspect due to safety reasons. The picture below was taken from the top floor and shows how the installation looks. There are still some issues with the connection with the grid therefore the PV panels have not been put to work yet, but everything (inverter and thermal collector) is installed and ready to go.

Figure 35. Solar collectors (left) and photovoltaic panels (right)
